GROUP Service Campaign	MODEL 2014~2015MY Soul (PS)
	NUMBER SC 117 (REV 1, 03/31/2015)	DATE March 2015
VOLUNTARY SERVICE CAMPAIGN		
SUBJECT: SOUL (PS) – ACU LOGIC UPDATE (SC117)

This bulletin provides information related to the update of the Airbag Control Unit (ACU) logic of some 2014~2015MY Soul (PS) vehicles, produced from July 21, 2013 through November 26, 2014, to reduce the likelihood of rollover airbag deployments in a few extreme driving events; typically at low speeds and involving parking valets and/or prolonged multi-level garage driving. To install the new logic, the ACU should be updated using the GDS/KDS download, as described in this bulletin. Kia is requesting the completion of this Service Campaign on all affected vehicles, including dealer stock, prior to delivery. For confirmation that the latest reflash has been done to a vehicle you are working on, verify ROM ID using the tables in this TSB.

Volume: XIX
Number: TC15-009
Date: 03/19/2015
 Action
 Retain
 Information

Group Vice President, Product Quality and Service Support
Subject: Limited Service Campaign (LSC) ESD
2005 through 2008 Model Year Tacoma Vehicles
Frame Inspection

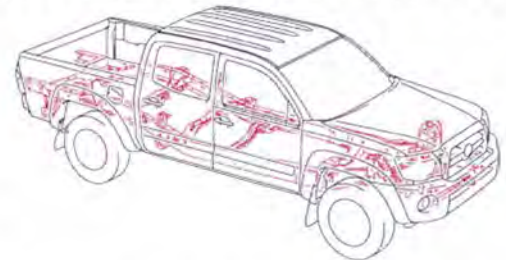
- Toyota has received reports that certain 2005 through 2008 model year Tacoma vehicles operated in specific cold climate areas with high road salt usage may exhibit more-than-normal corrosion to the vehicle's frame.
- This condition is unrelated to, and separate from, normal surface rust which is commonly found on metallic surfaces after some years of usage and/or exposure to the environment.

- If the vehicle's frame passes Toyota's inspection, no further action is required.
- If significant rust perforation is found, the dealer will replace the vehicle's frame at **no charge** to the owner.
