**NUMBER:** 19-002-15**GROUP:** Steering**DATE:** April 08, 2015

Clunking Noise From The Steering Column While Turning The Steering Wheel

2012 - 2015 (FF) Fiat 500

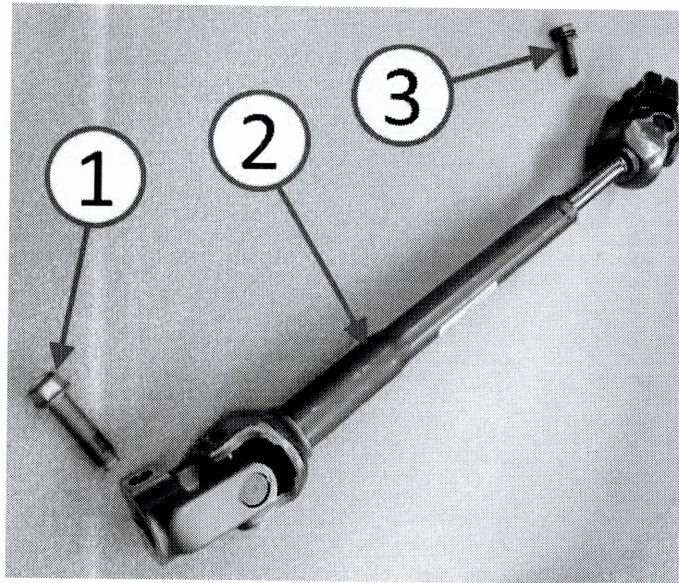
Fig. 1

- 1 - Bolt Hex Head M10 (I-shaft to gear)
- 2 - Intermediate Shaft (I-shaft assembly)
- 3 - Bolt Hex Head M8 (I-shaft to column)

8. Obtain the NEW I-shaft and bolts included in the I-shaft kit listed in the Parts Required section of this bulletin.
9. Install the NEW I-shaft and bolts. Tighten the upper M8 bolt (I-shaft to column) to 28 N·m (21 ft. lbs.). Tighten the lower M10 bolt (I-shaft to gear) to 55 N·m (40 ft. lbs.) (Fig. 1). Refer to the detailed service procedures available in DealerCONNECT> TechCONNECT> under: Service Info> 19 - Steering> Column> SHAFT, Intermediate> Installation.
