Service Bulletin

SPECIAL COVERAGE

SUBJECT: Special Coverage Adjustment – Unable to Remove Ignition Key

MODELS: 2005-2010 Chevrolet Cobalt
2006-2011 Chevrolet HHR
2006-2010 Pontiac Solstice
2007-2010 Pontiac G5
2005-2006 Pontiac G4/Pursuit
2007-2010 Saturn Sky
2003-2007 Saturn Ion
Equipped with Automatic Transmission

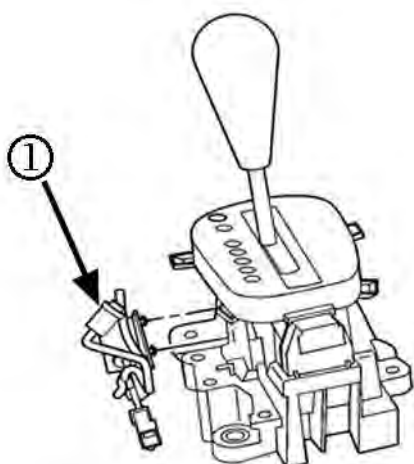
Important: For Ion models only, refer to *Diagnostic Starting Point - Automatic Transmission Shift Lock Control* and as necessary, *Shift Lock Control Solenoid (1) Replacement* in SI.
