IB12-N-001E

NO CRANK/NO START/NO SCAN TOOL COMMUNICATION - CRANK/NO START/NO FUEL PRESSURE/FUEL PUMP INOPERATIVE - EXTREME COLD WEATHER

- 2007-2015MY Isuzu N-Series
Equipped with 5.2L (4HK1) Diesel Engine and Diesel Particulate Filter (DPF)
- 2008-2015MY Isuzu N-Series
Equipped with 6.0L Gasoline Engines

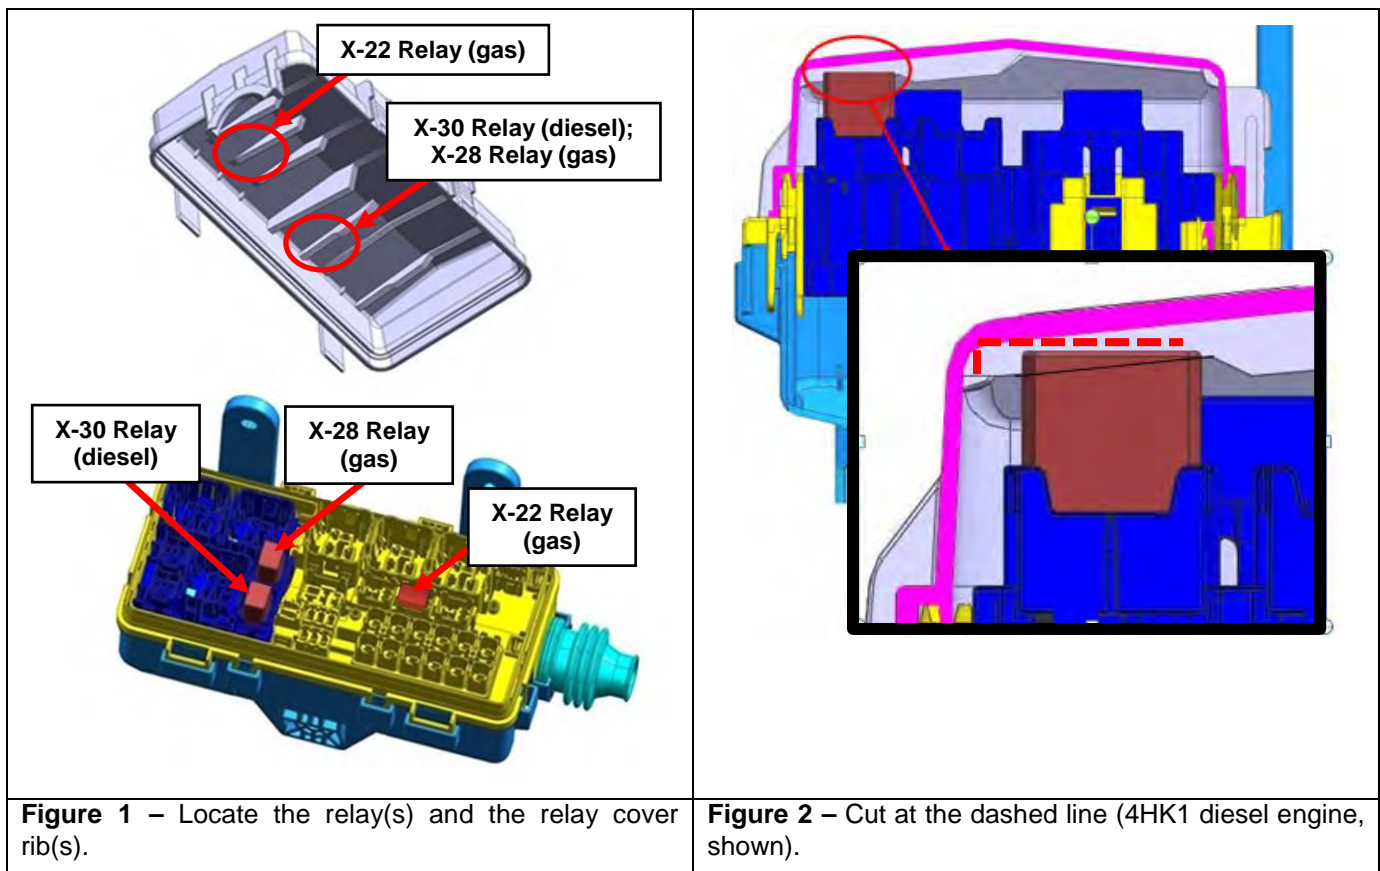
1. Remove relay box cover.
2. Remove the original ECM Main Relay in locations X-30 (diesel) or X-22 or X-28 (gas).
3. Install the new relay at locations X-30 (diesel) or X-22 or X-28 (gas).
4. Locate the relay box cover rib(s) as shown in Figure 1.

5. Trim the relay cover rib(s) approximately 3mm to provide clearance for the new relay(s).
6. Install the relay cover and confirm it seals properly. If the cover does not close properly, trim additional material from the cover until it correctly seals.
