## SB-10058067-7411

This article supersedes TSB 14-0056 to update the vehicle model lines, model years and Service Procedure.

### ISSUE

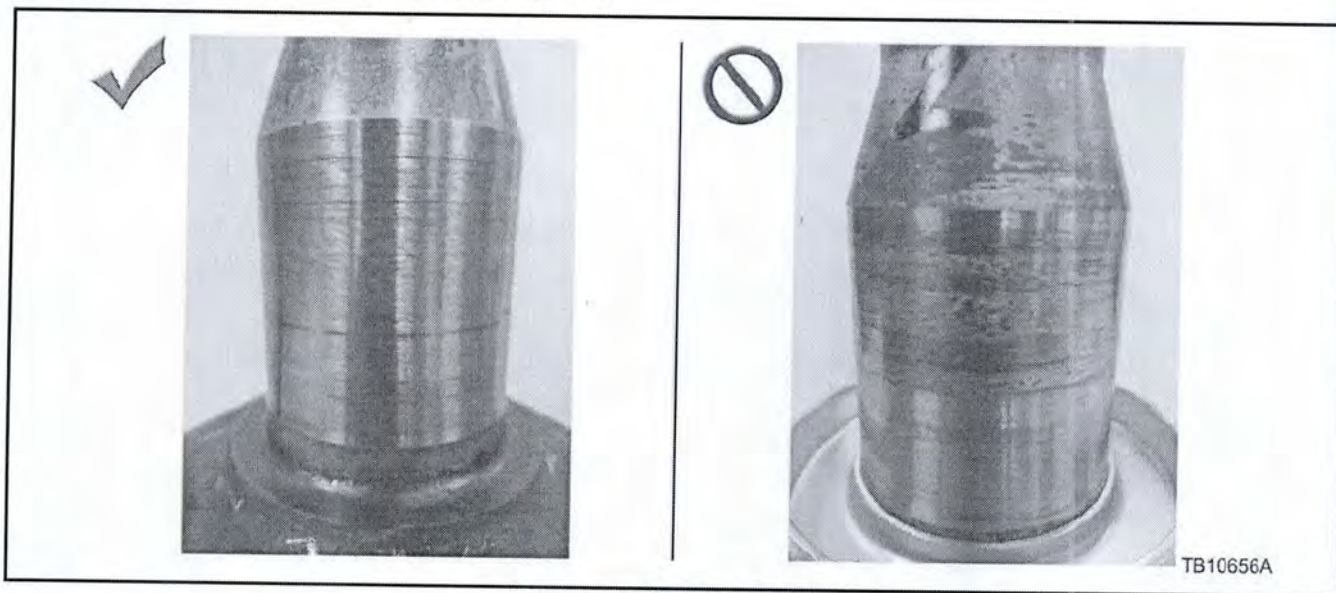
Figure 1 - Article 15-0079

Some 2009-2014 Escape, 2009-2011 Mariner, 2010-2014 Fusion, 2010-2011 Milan, 2012-2014 Edge/Explorer, and 2013-2014 Taurus/MKT/MKZ vehicles built on or before 10/14/2013 and equipped with a 6F35 automatic transmission may exhibit a fluid leak from the left hand (LH) transmission halfshaft seal due to wear on the transmission case bushing.

1. Remove the LH halfshaft. Refer to Workshop Manual (WSM), Section 307-01.
2. Inspect the halfshaft journal surface finish. (Figure 1)

- a. If the journal does not any have metal transfer from the bushing, the halfshaft can be reused. Use the service kit that contains only the bushing and seal.
- b. If the journal surface finish has metal transfer from the bushing, replace the front halfshaft. Refer to WSM, Section 205-04.
  - (1) The replacement bushing with the red Teflon® coating on the inside diameter of the bushing allows for the reuse of the original halfshaft if the halfshaft journal does not have any metal transfer from the original bushing.

3. Replace the transmission case bushing. Refer to WSM, Section 307-01.
