**SB-10058075-1971****FORD:**

2014-2015 Transit Connect

This article supersedes TSB 14-0181 to update the vehicle model years.

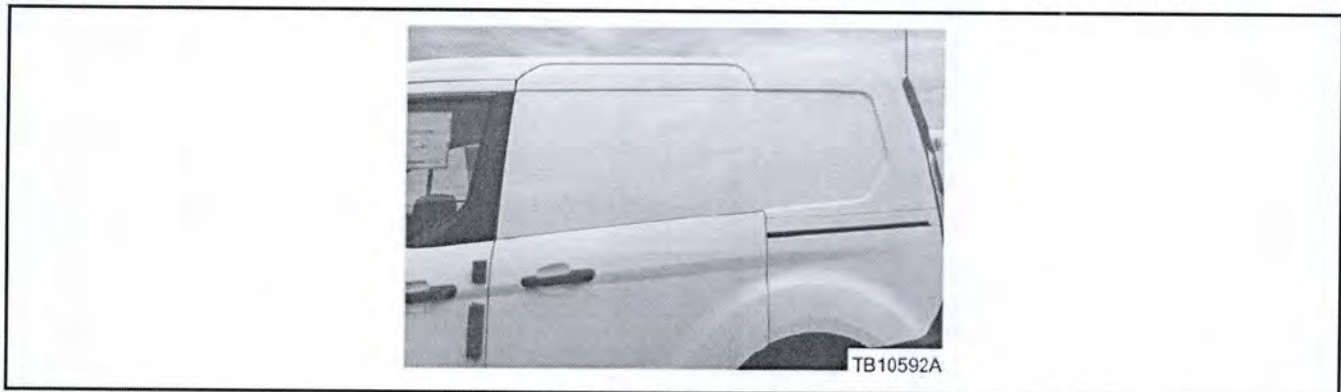
Figure 1 - Article 15-0085

Some 2014-2015 Transit Connect vehicles equipped with sliding door blanking panels may exhibit small scratches on the sliding door body panel, where the blanking panel meets the body panel. These scratches may be located on either door and anywhere around the blanking panel top, bottom or sides. The scratches may have broken through the paint to expose bare metal.

1. Are paint scratches present on the exterior of the left or right sliding doors near the blanking panels? (Figure 1)

- a. Yes - proceed to Step 2.
  - b. No - this article does not apply.
2. Remove the blanking panel. Refer to Workshop Manual (WSM), Section 501-11 General Procedures.
    - a. Blanking panel is removed in the same manner as fixed glass.
  3. Repair any scratches around and under the sliding door blanking panel, specifically those located outside the urethane bead and potentially exposed to weather (rain and humidity). (Figures 2-3)
