**star bulletin**

Date: February 3, 2015  
Order No.: P-B-47.10/63b  
Supersedes: P-B-47.10/63a, January 16, 2015  
Group: 47

**SUBJECT: Model 211, Model Years 2003- 2009 and  
Model 219, Model Years 2006- 2011  
Fuel Odor In the Area of the Fuel Tank**

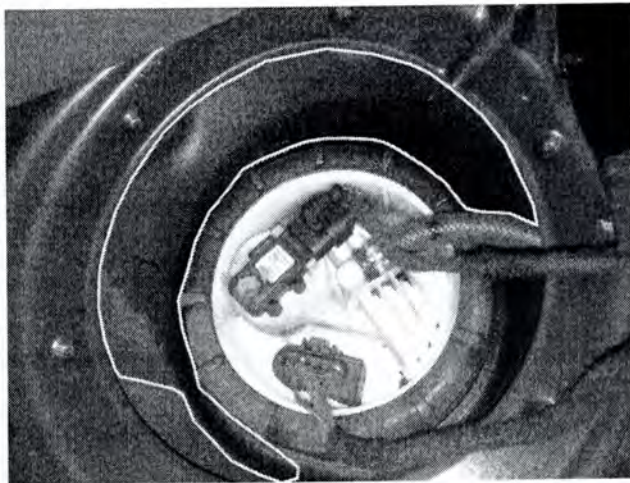
**Figure 3** (Fuel residue outlined)

**Note:** Fuel residue (outlined, Figure 3) and/or liquid fuel must be visible in photo.

- Provide symptom string: Power Generation / Fuel systems / Fuel system odor / Odor
- Attach (detailed) photographs of the suspect area to the case. (see example, Figure 3).
