POOR AUDIO SYSTEM RECEPTION OR WHISTLING-TYPE NOISE ON AM OR AM-HD BANDS ONLY - BUILT ON OR BEFORE 11/30/2013	TSB 15-0119
--	--------------------

2013-2014 Flex

This article supersedes TSB 14-0051 to update the Service Procedure, Parts List and Service Labor Time Standards.

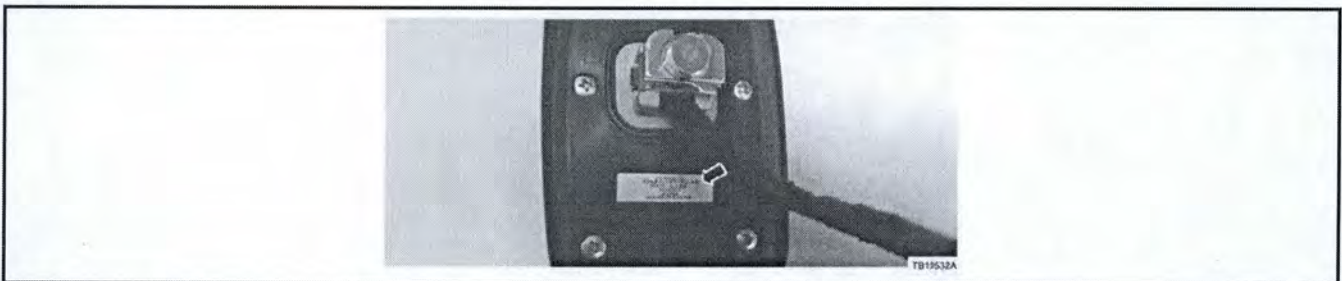
Figure 1 - Article 15-0119

1. Does the audio system exhibit reception concerns or abnormal noises on FM band and/or satellite radio channels?
 - a. Yes - this procedure does not apply. Refer to Workshop Manual (WSM), Section 415-00 for normal diagnosis.
 - b. No - proceed to Step 2.
2. Is the vehicle built on or after 3/02/2013?
 - a. Yes - proceed to Step 5.
 - b. No - remove the antenna base. Refer to WSM, Section 415-00.
3. Inspect the antenna base part number located on the underside of the part.
4. Is the part number either DA8T-19G461-AC or DA8T-19G461-AD? (Figure 1)

- a. Yes - install the original antenna base. Proceed to Step 5.
- b. No - replace the antenna base with revised service part. Refer to WSM, Section 415-00. Proceed to step 5.
 - (1) Make sure the new ground clip, provided in the antenna part kit, is secured as shown in WSM 415-00.
5. Replace both the front and rear antenna cables. Refer to WSM, Section 415-00.
 - a. Cut circuit VME43 approximately 5 cm (2") from the male side of connector C212.
 - b. On the replacement rear antenna cable kit, cut the exposed pin off the blue power wire.
 - c. Splice the rear antenna cable blue power wire, from the replacement antenna cable kit, to the 5 cm (2") portion of circuit VME43, on connector C212. Use wire kit and recommended solder splicing method located in Wiring Diagram, Section 5.
