HYUNDAI NEW THINKING. NEW POSSIBILITIES. Technical Service Bulletin	GROUP CAMPAIGN	NUMBER 15-01-019-1
	DATE JUNE 2015	MODEL(S) Elantra (HD) Elantra Touring (FD)
SUBJECT: ELECTRONIC POWER STEERING SYSTEM SOFTWARE UPDATE/REPAIR (SERVICE CAMPAIGN 931)

SUBJECT: SERVICE CAMPAIGN 931 – EPS SYSTEM UPDATE/REPAIR

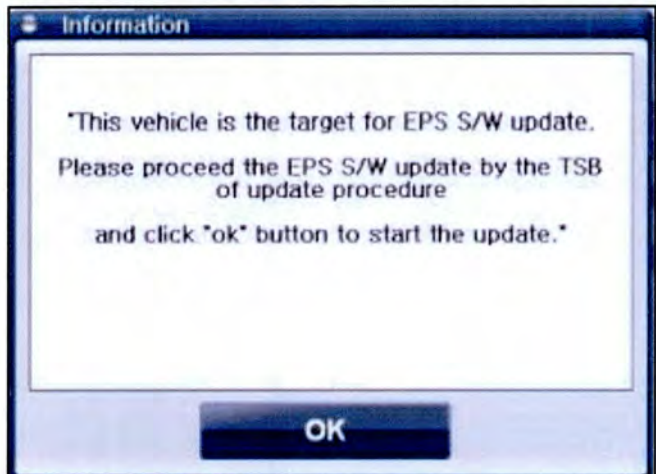
Message to update the EPS S/W. Proceed to the EPS S/W Update procedure section on page 7 of this TSB.

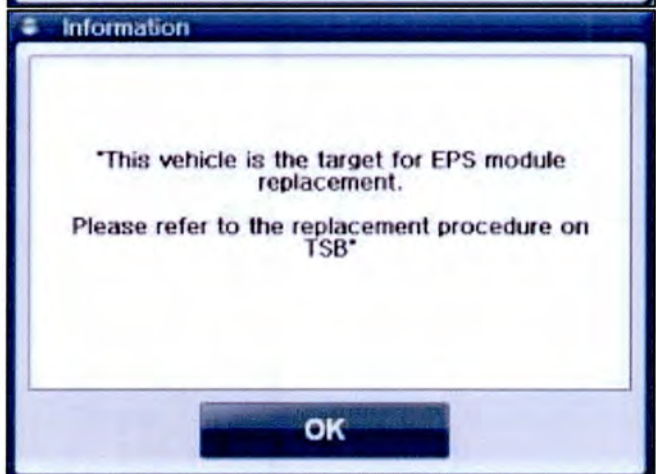
Message to replace the EPS unit. Proceed to the EPS Replacement procedure section on page 11 of this TSB.

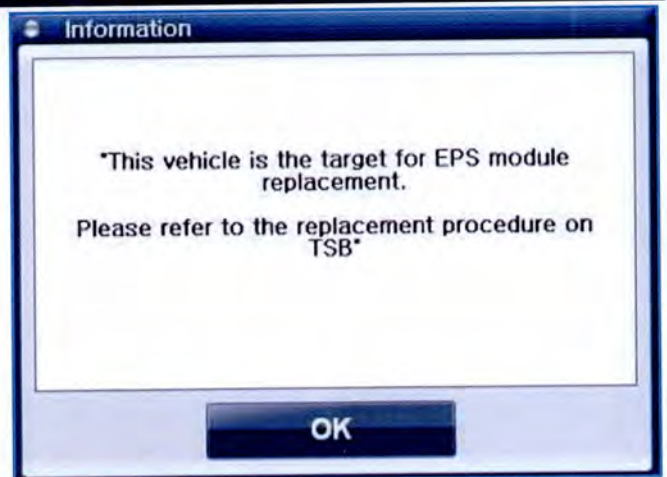
Replace the EPS unit only if the GDS displays the message on the right during the EPS S/W Version Check.
