SB-10058549-9447

TO: Mercedes-Benz Dealer Principals, General Managers, Sales Managers, Service Managers, Parts Managers	FROM: Thomas Brunner, Department Manager, Vehicle Compliance and Analysis, Engineering Services
RE: Service Campaign 2015050002 –Retrofit Headlamp Adjustment Screw Caps. Model 205 (C-Class Sedan) Model Year 2015	DATE: June 12, 2015

Campaign No. 2015050002, June 2015

SUBJECT: **Model 205 (C-Class), Model Year 2015**
Retrofit Headlamp Adjustment Screw Caps

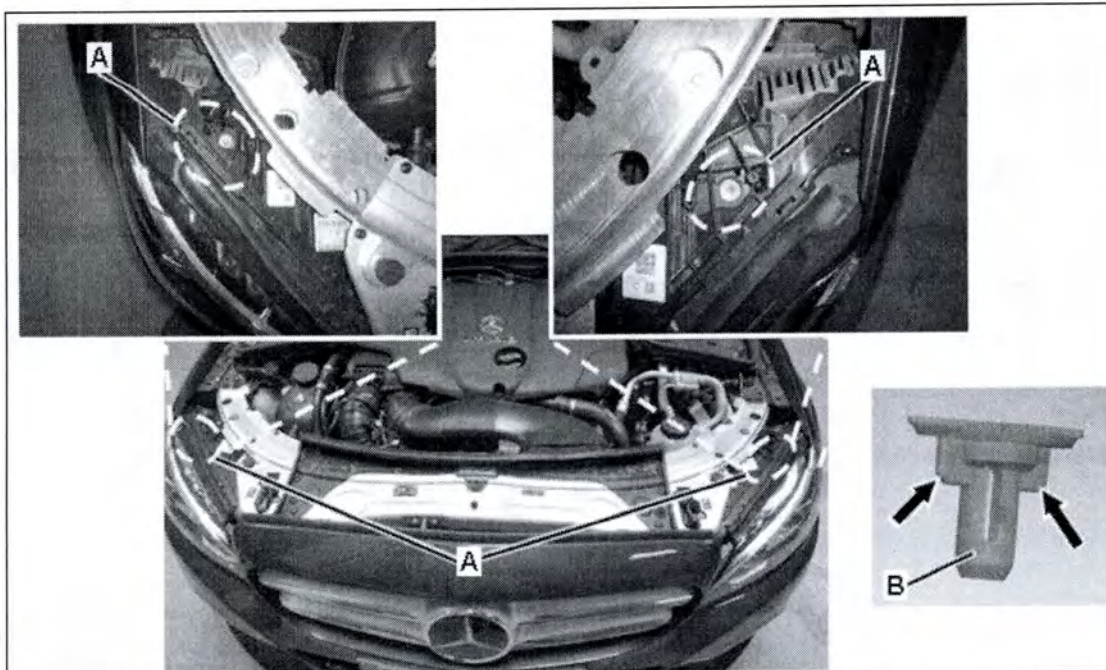
Figure 1

Daimler AG (DAG), the manufacturer of Mercedes-Benz vehicles, has determined that the headlamp horizontal adjustment sealing caps may not have been installed. To correct this condition an authorized Mercedes-Benz dealer will install the headlamp horizontal adjustment sealing caps at the next dealer visit.

1. Open hood.
2. Retrofit cap (B, Figure 1) for headlamp adjustment screws (A) at left and right:
 - Position cap (B, Figure 1) on headlamp adjuster (A) so that the tabs (arrows) on the cap (B) align with the grooves in the adjuster (A).
 - Press the cap (B) into adjuster (A) by hand until it locks into position.

An audible click will be heard when the cap (B) is properly seated into the adjuster (A).
