Technical Service Bulletin

01 Coolant loss from coolant valve, engine warning light on, "Limp Home" mode active, cabin heating is insufficient

01 15 31 2033806/7 July 21, 2015. Supersedes Technical Service Bulletin Group 80 number 14-07 dated August 11, 2014 for reasons listed below.

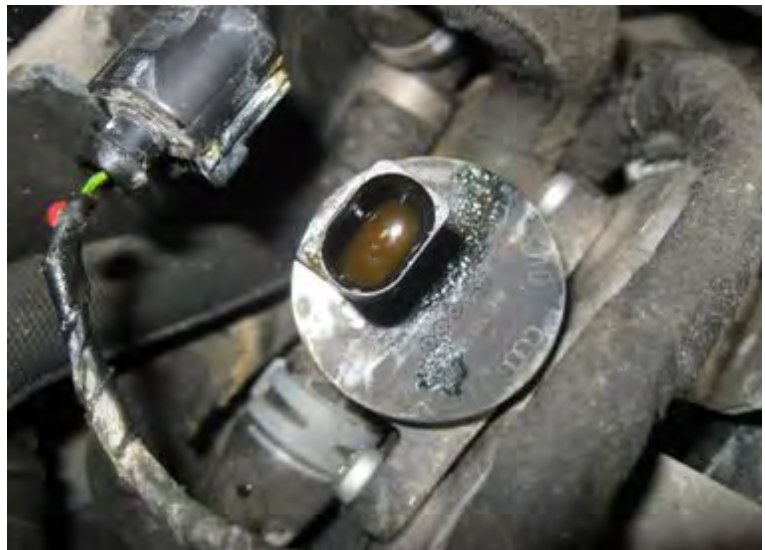
Climate system heating performance is insufficient due to coolant loss as a result of coolant migration in the electrical harness, faults in 08-Heating and Air Conditioning Electronics that result from coolant migration in the electrical harness, or a faulty N82 control valve.

Inspection of the coolant control valves N82, N509, or N488 reveals the presence of coolant inside the electrical connector as shown in the illustration (Figure 1).

Figure 1. Coolant residue in the connector housing of the coolant regulating valve.

1. Diagnose the defective coolant valve (N82, N509, or N488) using Guided Fault Finding (GFF) where stored DTCs are found.
2. Replace the defective coolant valve.

Tip: Check the connectors, wiring harness, and connected control units for coolant damage. Perform repairs as necessary.

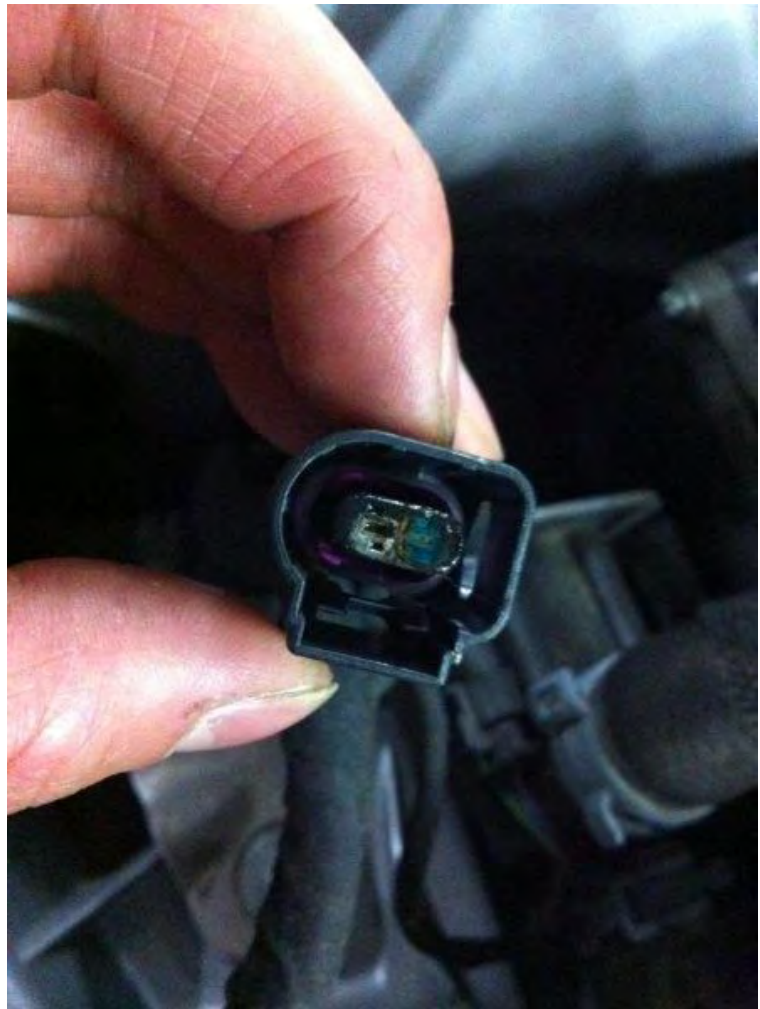
The connectors, wiring harness, and/or connected control units may have been damaged from exposure to coolant (Figure 2).

Figure 2. Corrosion formation on the connector pins.
