Technical Service Bulletin

97 Multiple warning lights illuminated; communication error DTCs

97 15 47 2034945/3 May 6, 2015. Supersedes Technical Service Bulletin Group 97 number 13-40 dated November 26, 2013 for reasons listed below.

Model(s)	Year	VIN Range	Vehicle-Specific Equipment
Q7	2010 - 2015	All	Not Applicable

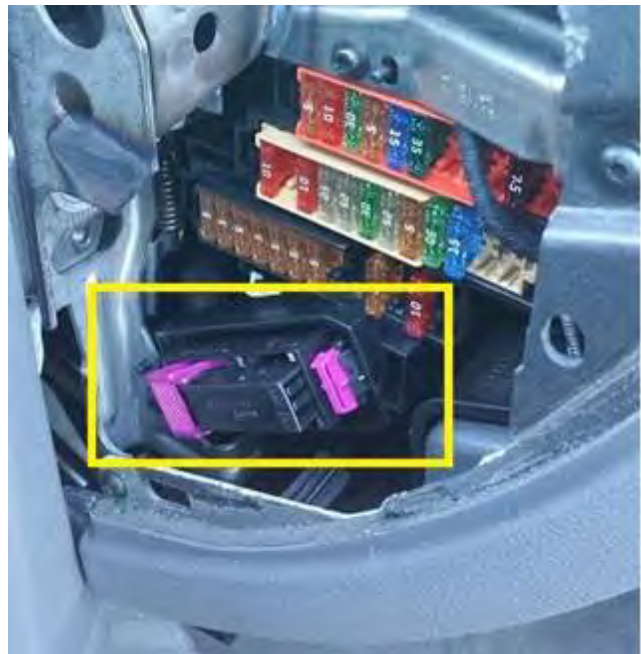
There is sporadic data disruption on the CAN bus wiring behind the dashboard, between the left (T46a) and right (T46b) 46-pin CAN disconnect plugs.

Figure 1. T46a CAN disconnect plug, left dashboard.

1. Upload GFF paperless log showing communication DTCs as described in the complaint.
2. Overlay new CAN twisted pair wiring behind the dashboard, between the two 46-pin CAN disconnect plugs (T46a/1H <-> T46b/1H and T46a/1L <-> T46b/1L) (Figure 1 and Figure 2).

3. Replace the terminals with the VAS1978B repair kit.

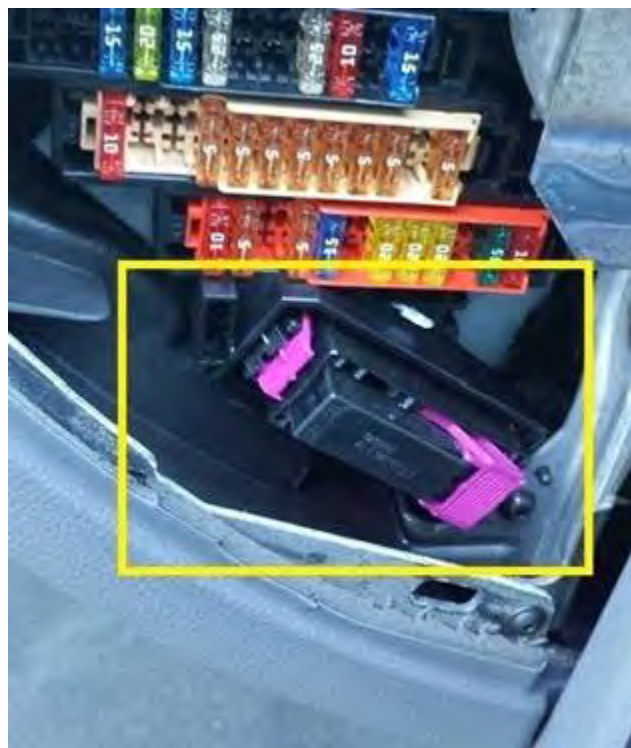
Figure 2. T46b CAN disconnect plug, right dashboard.
