Service Bulletin

SB-10058745-3593

SUBJECT: Special Coverage Adjustment – Cracked Fuel Tank Inlet Control Valve

MODELS: 2006-2008 Chevrolet Cobalt
2006 Pontiac Pursuit, G4
2007-2008 Pontiac G5
2006-2007 Saturn ION

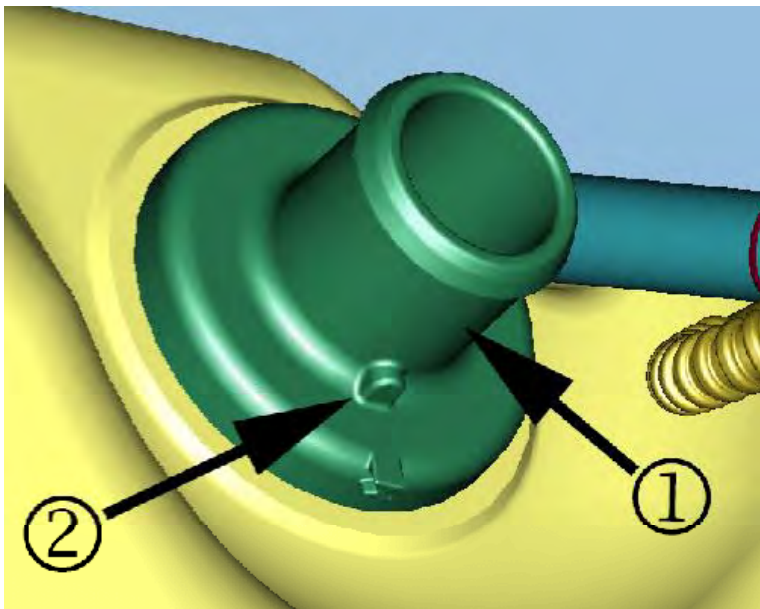
4093630

Identifying the 20870462 or 25947828 fuel tank.

The fuel tank hose connection (1) will have an index feature (2) at the bottom 6 o'clock position where the hose joins the tank. Older style tanks have this feature on top at the 12 o'clock position. The fuel tank may also have an identifying tag displaying the part number.

- If the part number is 20870462 or 25947828, and has the bottom index, stop, this bulletin does not apply.

- If the part number *is not* 20870462 or 25947828, and has the top index, proceed to Steps 3 and 4.
3. Replace the fuel tank with p/n 20870462 or 25947828 as applicable. Refer to *Fuel Tank Replacement in SI*.
 4. Replace the filler pipe.
 - a. **Cobalt, G4, G5, Pursuit ONLY:** Use p/n 20757861 fill pipe assembly. Refer to *Filler Tube Replacement in SI*.
 - b. **ION ONLY: Trim new hose p/n 20757866 to match existing fuel fill hose.**
 1. Remove **fuel fill hose** from vehicle mounted fill pipe.
