SB-10059159-6535

GROUP	NUMBER		
		CAMPAIGN	15-01-023		
Technical Service Bulletin		DATE	MODEL(S)		
		MAY 2015	VELOSTER (FS)		
SUBJECT:	FUEL FEED TUBE REPLACEMENT				
(SERVICE CAMPAIGN 937)

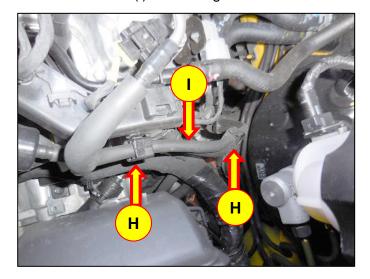
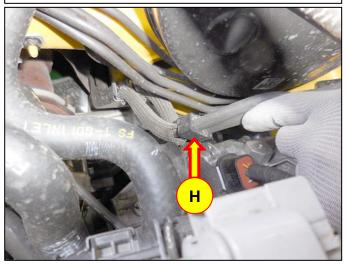
The red arrow on the right picture shows the location of the fuel feed tube holder (H) from the engine side (I) to the fuel tank side (K).

8. Release the fuel feed tube holder (H) to separate the fuel feed tube (I) on the engine room side.
