Field campaign

Topic	Adaptive cruise control radar sensor cover (SC13/04)
Market area	Worldwide Bentley (1WBE)
Brand	Bentley
Transaction No.	2033245/1
Campaign number	E780
Note	
Type	
US code

New Continental GT and GTC - V8T Engine derivative only

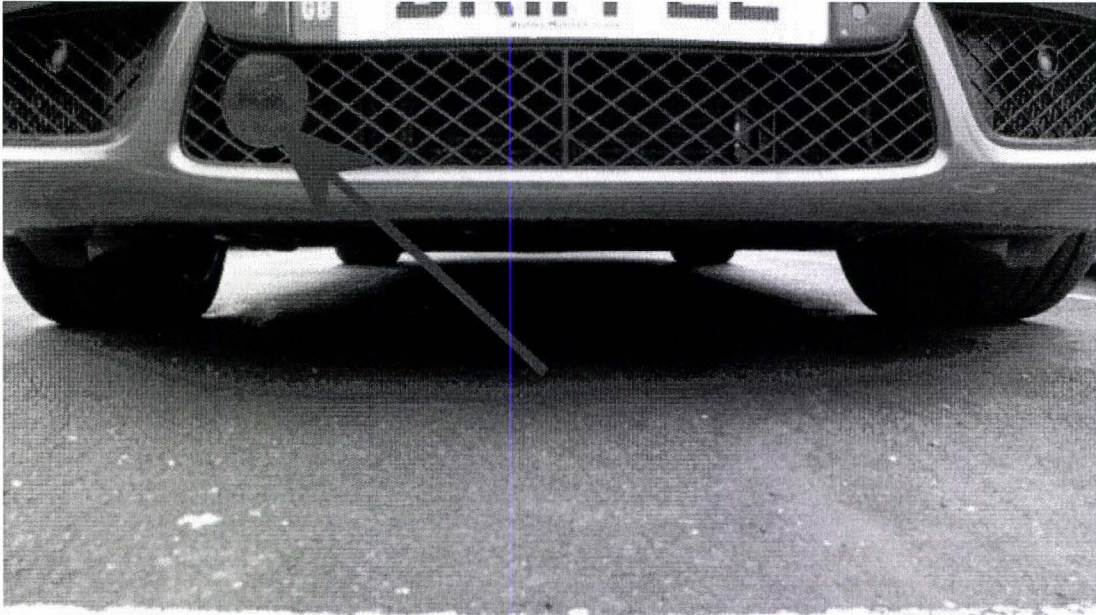
Figure 1

The New Continental GT and GTC with the V8T engine can be specified with Adaptive Cruise Control (ACC), all V8T cars specified with ACC have a cover fitted within the centre grille (Figure 1) the cover protects the ACC radar sensor assembly

A small number of centre grille ACC covers at the time of production were found to have labels fixed to the inner face of the ACC sensor cover.

This Campaign details the process which must be carried out to check and confirm that no labels are evident on the inner face of the cover.

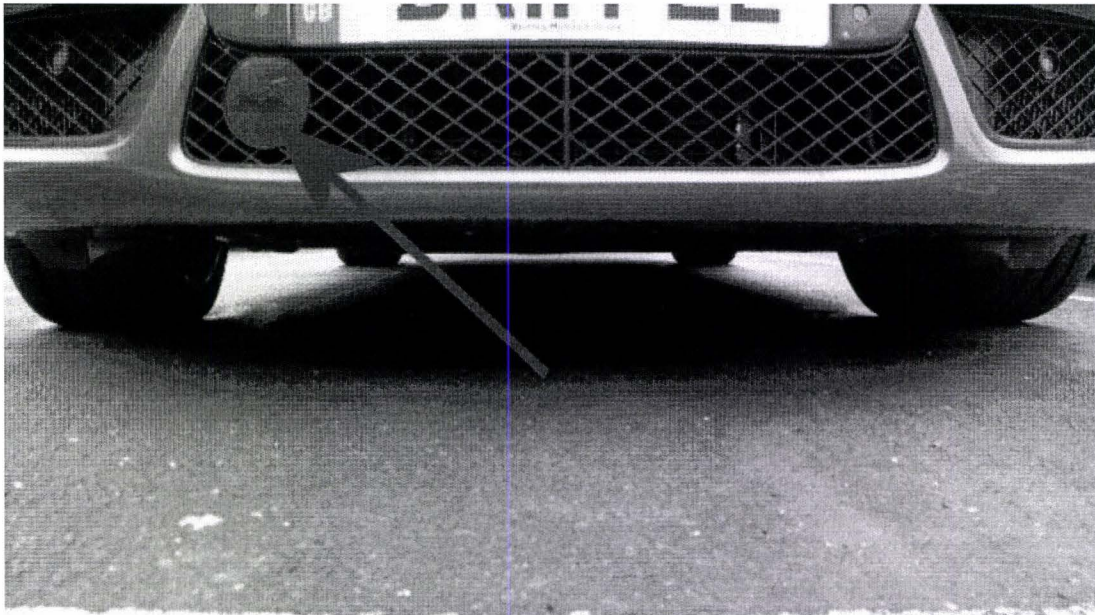
Figure 1

The New Continental GT and GTC with the V8T engine can be specified with Adaptive Cruise Control (ACC), all V8T cars specified with ACC have a cover fitted within the centre grille (Figure 1) the cover protects the ACC radar sensor assembly

A small number of centre grille ACC covers at the time of production were found to have labels fixed to the inner face of the ACC sensor cover.

This Campaign details the process which must be carried out to check and confirm that no labels are evident on the inner face of the cover.

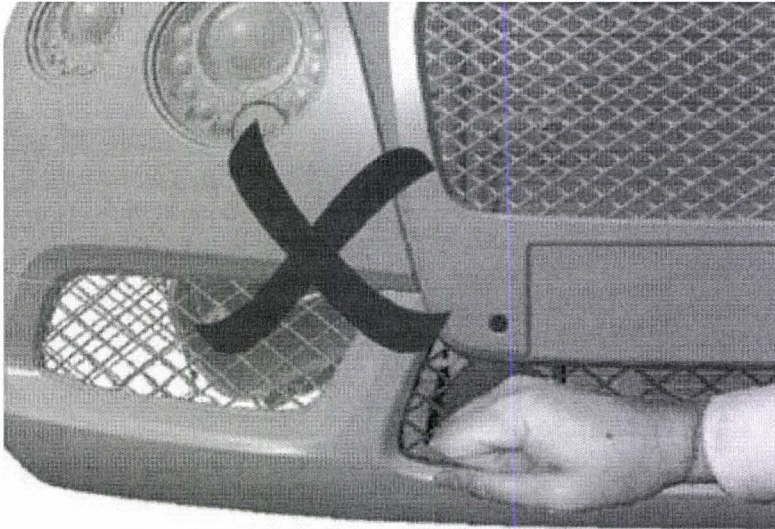
Important! Do not hit! This could cause radar misalignment

Do not hit the grille when refitting as this could cause radar misalignment

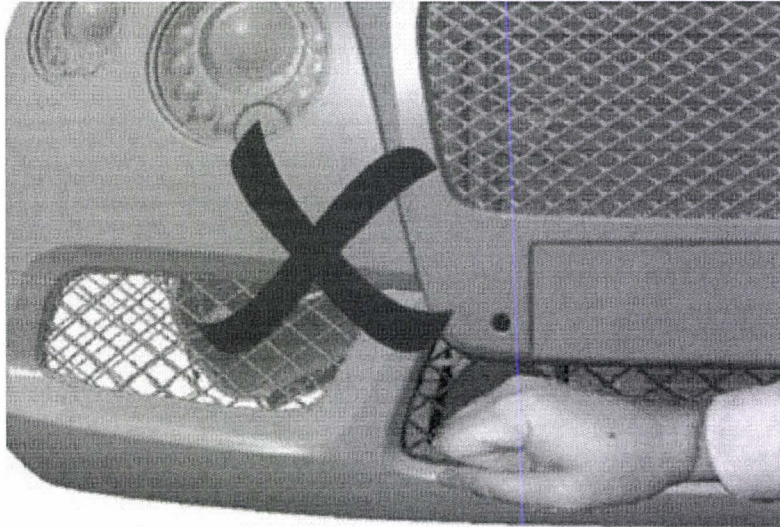
Important! Do not hit! This could cause radar misalignment

Do not hit the grille when refitting as this could cause radar misalignment

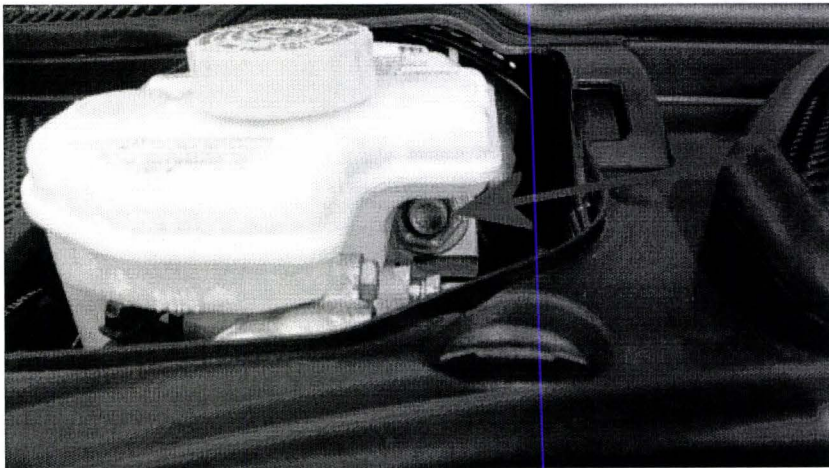
Figure 4

Blue confirmation mark on the left hand brake master cylinder bolt (Figure 4)

- Ensure that the grilles are fully clipped in around the outside aperture
- Place a Blue confirmation mark on the left hand brake master cylinder bolt (Figure 4)
