Service Bulletin

CREAK / SQUEAK NOISE FROM REAR WHEN DRIVING OVER BUMPS

Bulletin No: 02-002/14

2011-2014 Mazda2

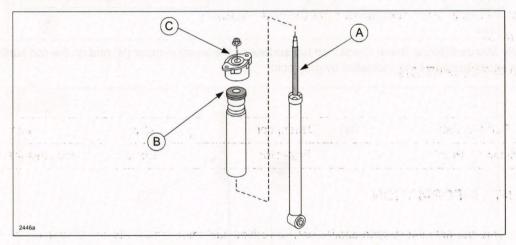
Some vehicles may exhibit a creak/squeak type noise coming from the rear of the vehicle when driving over bumps. Noise may be caused by the rear shock absorber rod surface (A) sticking to the bump stopper (B) and/ or the bump stopper sticking to the mounting base (C).

Customers having this concern should have their vehicle repaired using the following repair procedure.
