Technical Service Bulletin

NUMBER
14-BD-002

MODEL(S)
GENESIS SEDAN (BH)

SUBJECT: INTERMITTENT DOOR LOCK OPERATION

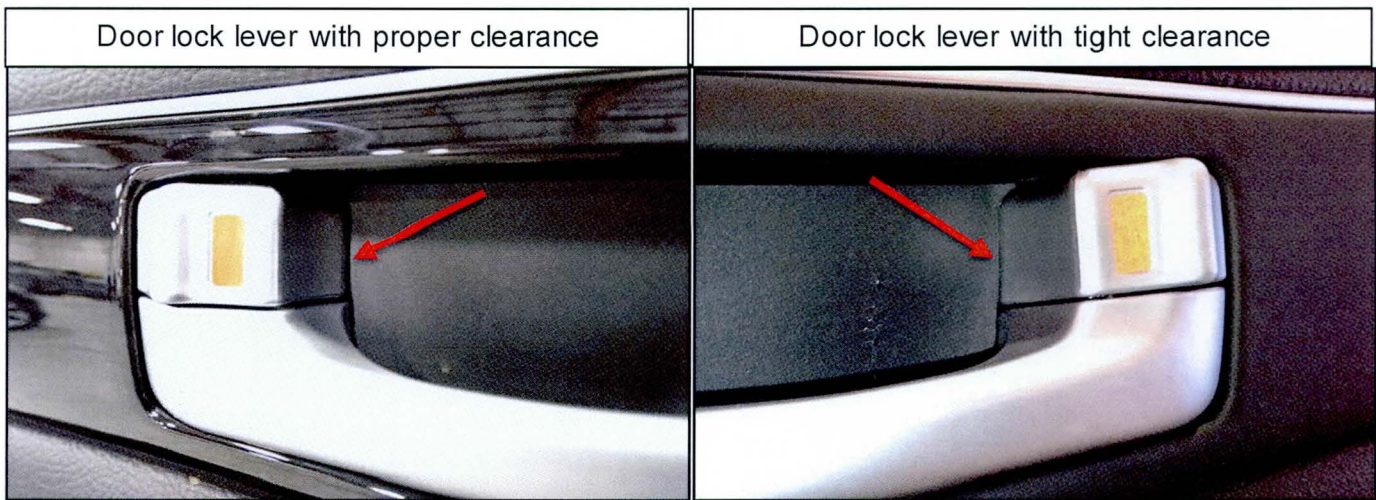
Visually inspect the clearance between the door lock lever and the cap cover.

If the door lock lever has little or no clearance, or is jamming against the cap cover, proceed to the repair procedure described below.
