05-010/14 - 2010-2015 CX-9 - DIFFICULT TO MOVE SELECTOR LEVER OUT OF "P" RANGE

Subject: DIFFICULT TO MOVE SELECTOR LEVER OUT OF "P" RANGE	Bulletin No: 05-010/14
	Last Issued: 10/03/2014

2010-2015 CX-9

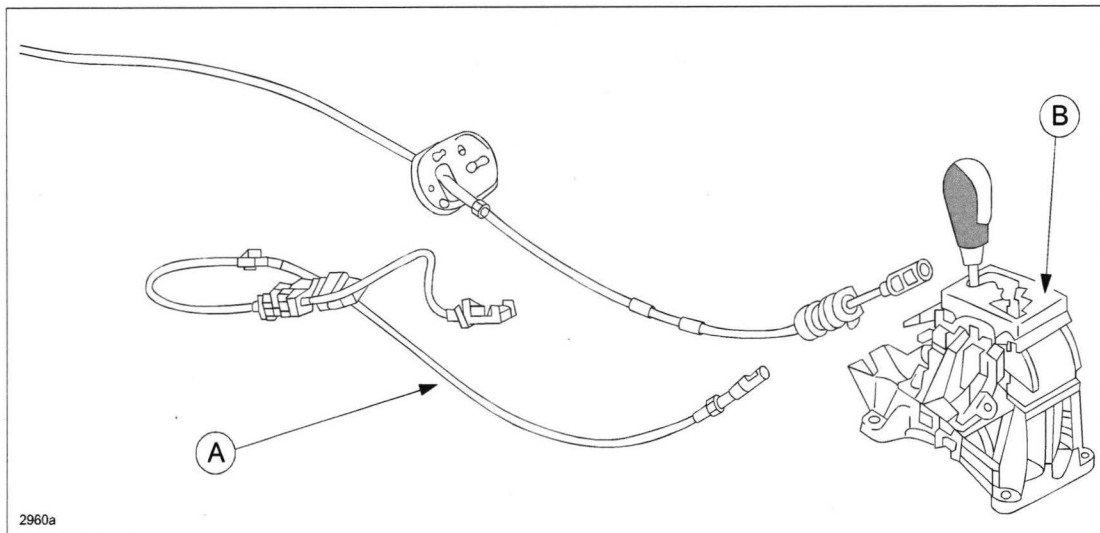
Some customers may experience difficulty moving the selector lever out of "P" range after the vehicle has been parked overnight in extremely cold temperatures (i.e. below freezing). The selector lever movement may return to normal after running the climate control system at maximum hot for short period of time.

This concern may be caused accidentally by the customer spilling a drink around the selector lever. When the spilled liquid reaches the interlock cable and freezes overnight, it causes the customer to have difficulty moving the selector lever out of "P" range the next morning.

1. Verify the customer concern.
2. Replace the interlock cable (A) according to the instructions on MS3 online or the Workshop Manual (section 05-18 AUTOMATIC TRANSAXLE SHIFT MECHANISM REMOVAL/INSTALLATION).

NOTE: Advise the customer to take the necessary precautions to avoid spilling liquids around the selector lever (B) area.
