TO: Mercedes-Benz Dealer Principals, General Managers, Sales Managers, Service Managers, Parts Managers	FROM: Thomas Brunner, Department Manager, Vehicle Compliance and Analysis, Engineering Services
RE: : Recall Campaign 2012100001 - Replace Refrigerant R1234yf with R134a, Model 231 (SL), Model Year 2013	DATE: October 26, 2012

Campaign No. 2012100001, October 2012

SUBJECT: **Model 231, Model Year 2013**
Replace Refrigerant R1234yf with Refrigerant R134a

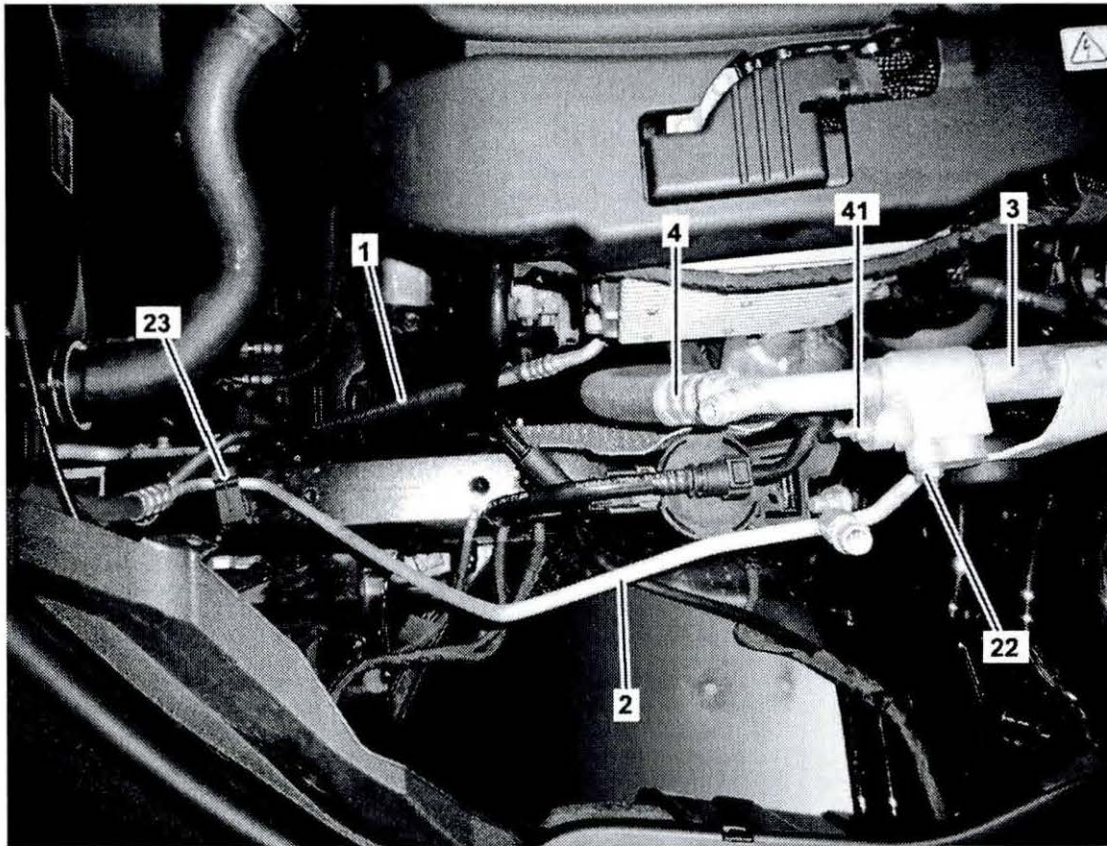
Figure 1

1	High pressure refrigerant line	22	Nut
2	Condenser refrigerant line	23	Condenser refrigerant line mounting clip
3	Low pressure refrigerant line (to evaporator).	41	Nut
4	Low pressure refrigerant line (to compressor).

1. Remove nut (41, Figure 1).
 - Torque nut (41) to 8 Nm when installing.
2. Disconnect refrigerant line (4, Figure 1) from refrigerant line (3).
3. Remove nut (22, Figure 1).
 - Torque nut (22) to 8 Nm when installing
4. Disconnect condenser refrigerant line (2, Figure 1) from mounting clip (23).
5. Disconnect condenser refrigerant line (2, Figure 1) from refrigerant line (3).

17. Assemble in reverse order.
18. Recharge air conditioning **with R134a** refrigerant **ONLY** and include 40 cc of refrigerant oil. Refer to WIS: AR83.30-P-1760NKB.
19. Replace information label for R-1234yf air conditioning filling capacity on radiator cross-member with **new R-134a** label (H, Figure 3).
20. Install new caps on A/C service valves of new refrigerant lines (2, 4, Figure 1).

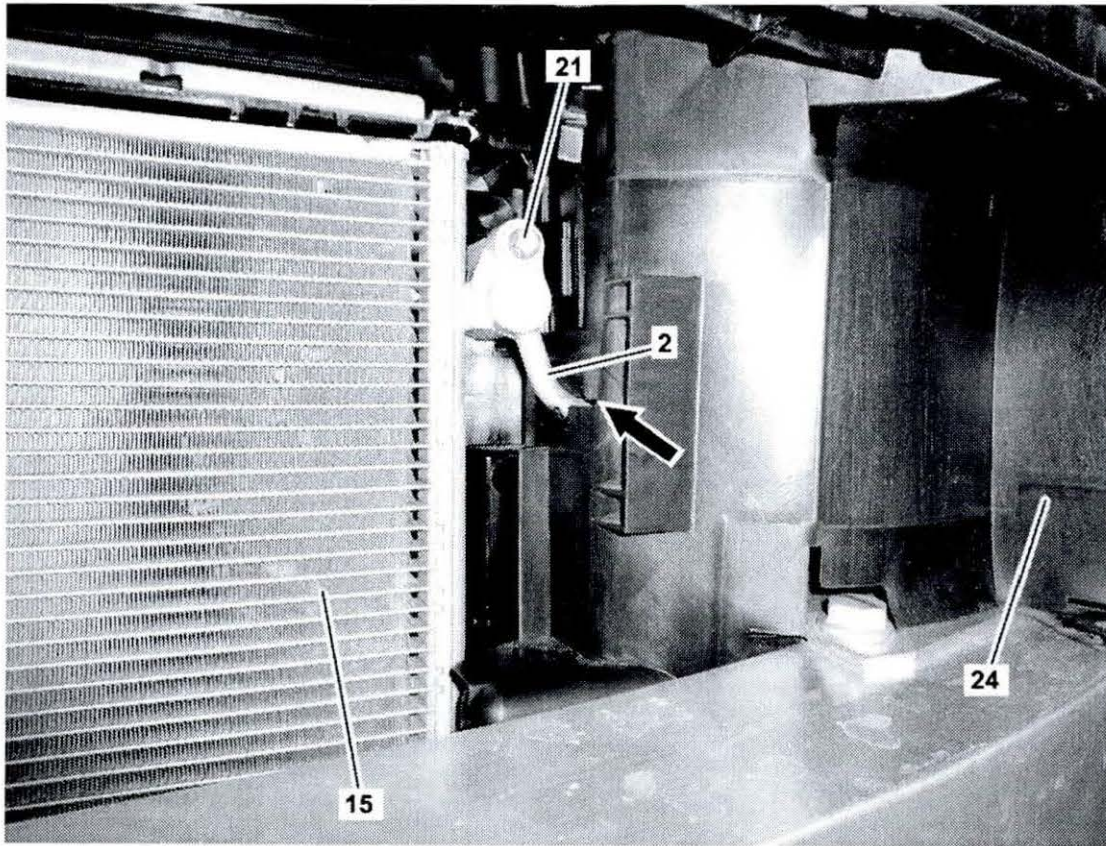
Figure 7 (shown from front of vehicle, behind radiator grill)

- 2 Condenser refrigerant line
 - 15 Condenser
 - 21 Condenser refrigerant line bolt
 - 24 Radiator side shroud
- Arrow: Opening for refrigerant line

14. Carefully pull radiator assembly (A, Figure 6) in direction of arrows (Figure 6) then remove condenser refrigerant line bolt (B)
15. Route condenser refrigerant line (C, Figure 6) out through opening (arrow, Figure 7) in radiator side shroud (24, Figure 7) and remove from engine compartment.
