Service Bulletin

Bulletin No.: 06-03-09-004E

Subject: Squeak Noise from Rear of Vehicle (Lubricate Rear Leaf Springs)

Models: 1999-2007 Chevrolet Silverado (Classic)
2007-2012 Chevrolet Colorado
2007-2013 Chevrolet Silverado
1999-2007 GMC Sierra (Classic)
2007-2012 GMC Canyon
2007-2013 GMC Sierra
2007-2010 HUMMER H3, H3T

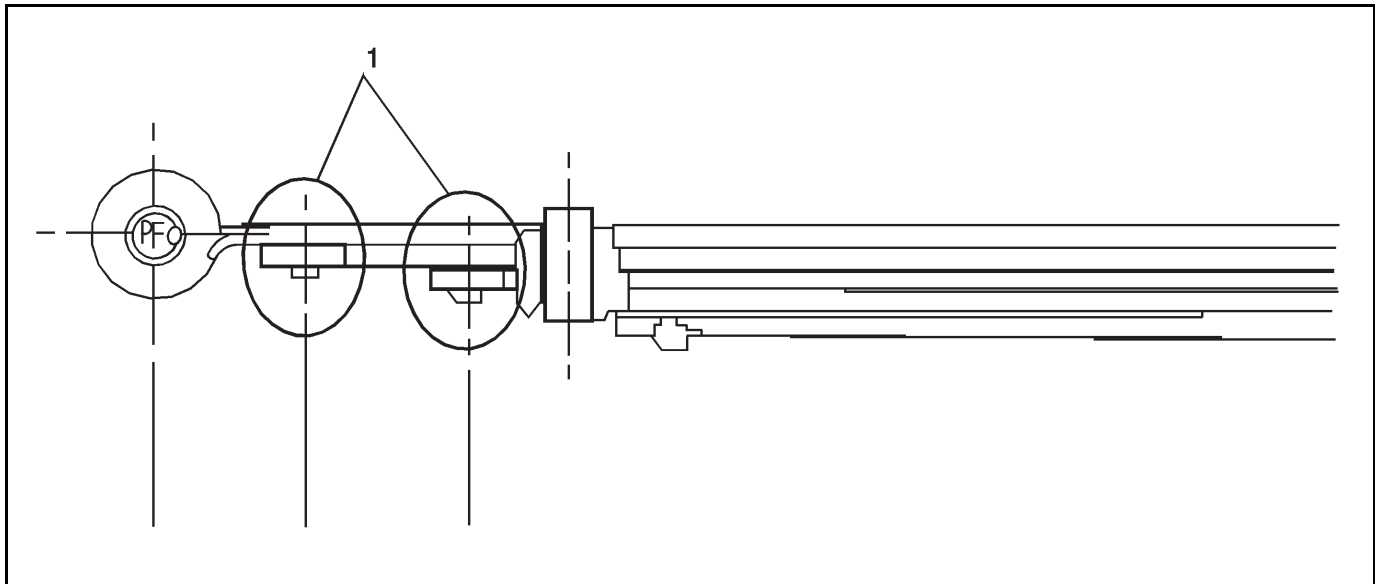
1826776

Some customers may comment about a squeak noise coming from the rear of the vehicle. During normal operation, certain vehicles may exhibit a squeaking noise that may be traced to the rear leaf springs. While this noise is an operating characteristic of leaf springs, the frequency and severity of this noise will be affected by the roads that the vehicle is driven on.

This condition may be due to debris getting between the leaf springs.

Note: Ensure any tool used to gently pry the tip inserts or spring leaves is protected to prevent damage to the spring leaves.

5. Apply a liberal amount of grease, P/N 12345996 (in Canada, use P/N 10953501), both underneath and on top of the front and rear tip inserts for the #2 and #3 leaves, as indicated below. A screwdriver can be used to gently pry up the tip insert; however, a rag around the screwdriver must be used to prevent damage to the spring. Use a flat-bladed tool, such as a gasket scraper to properly distribute the grease.
6. Lower the vehicle to the ground and test drive to verify the repair.
