MODEL  
2014MY  
Soul (PS)

NUMBER  
PS300

**SUBJECT:** INCORRECTLY ROUTED HIGH PRESSURE A/C LINE

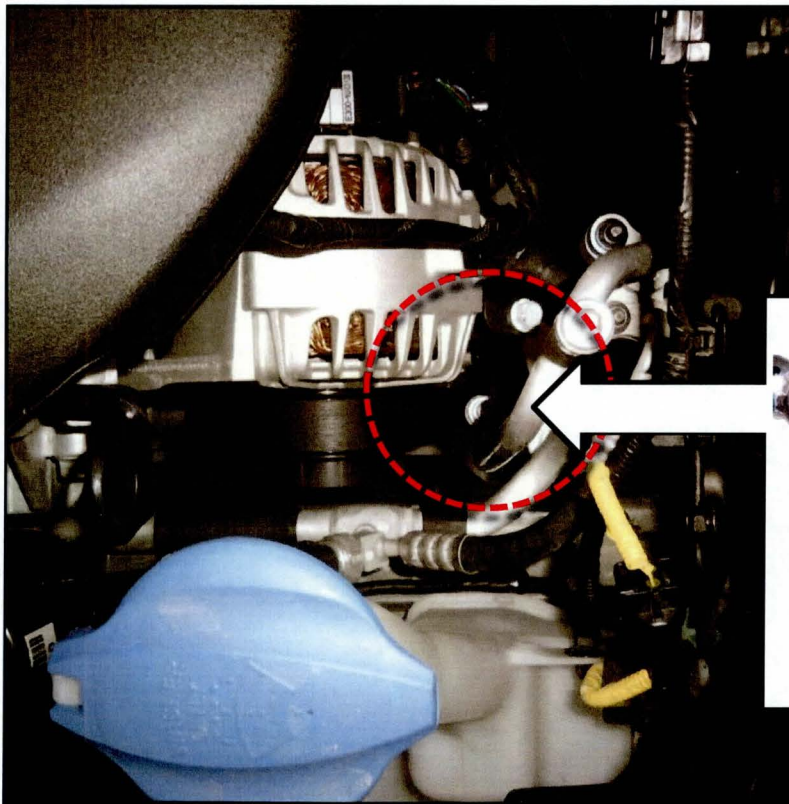
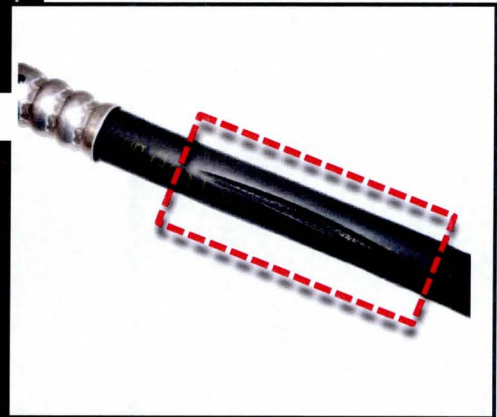
Some 2014 Soul (PS) produced prior to February 7, 2014, may exhibit a concern related to poor performance from the A/C system, accompanied by low refrigerant. In such cases, check the routing for the A/C high pressure line to make sure it is not coming into contact with the accessory drive belt (see image). If the line has come into contact with the belt and has sustained damage, replace the line and recharge the system to resolve the concern.
