GROUP
Engine

MODEL
Sorento (BL)
2003~2006MY

NUMBER
PS233

SUBJECT: UNUSUAL FUEL TRIM VALUES AND/OR MISFIRE CODES
AFTER INCORRECT ENGINE REPAIR

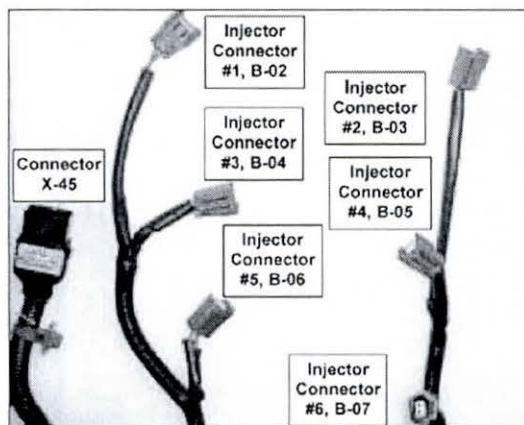
Injector connector B-06 (fuel injector #5, right bank) is closest to X-45: Use it for identification purposes. Route the harness connectors to the proper location and retest. Refer to the sample screenshots on page 2 to verify the condition. Note that these screenshots are from Hi Scan Pro (GDS screens will show similar information).

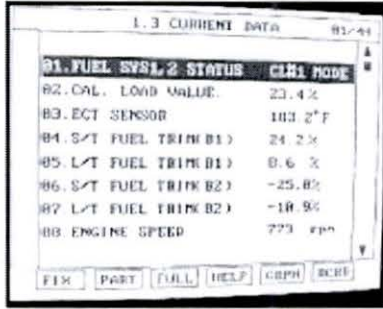
Current Data
(INCORRECT)

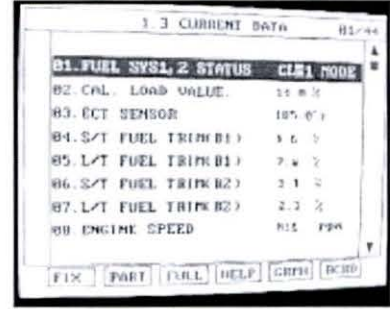
Current Data
(CORRECT)

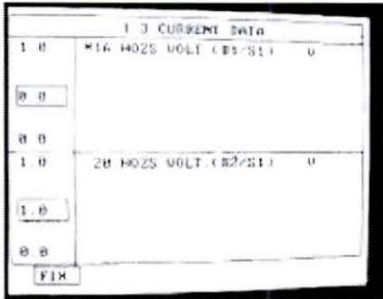
Output Voltage
From HO2s
(INCORRECT)

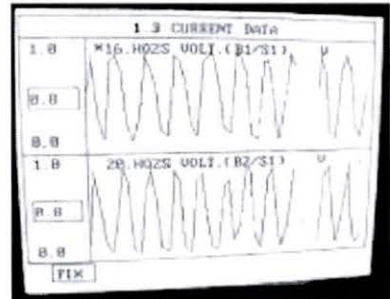
Output Voltage
From HO2s
(CORRECT)

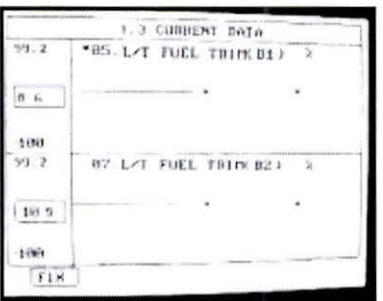
Fuel Trim Data
(INCORRECT)

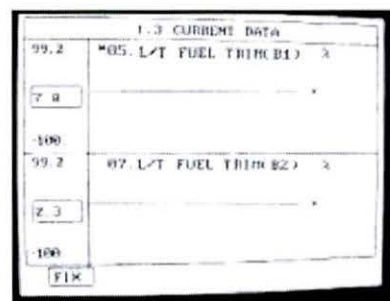
Fuel Trim Data
(CORRECT)
