GROUP  
Engine

MODEL  
2010-2013MY  
Forte (TD)

NUMBER  
PS267

**SUBJECT:** THERMOSTAT RE-INSTALLATION PROCEDURE – REPEAT REPAIR (DTC P0128)

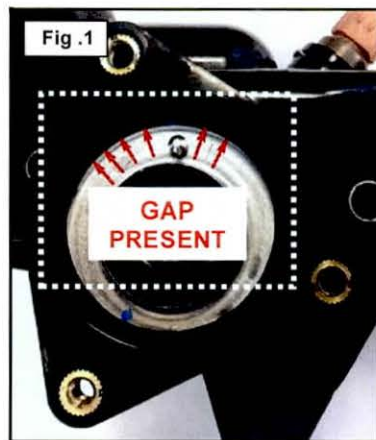
When diagnosing a Forte returning with a repeat DTC P0128 after replacement of the thermostat, remove the thermostat housing to verify if the thermostat was installed incorrectly during the previous repair. Incorrect installation may be difficult to determine due to the sideways orientation of the thermostat housing, however, pay close attention when the housing is removed for coolant flowing out and displacing the thermostat as soon as the housing is separated. In some cases if the housing is closely inspected, witness marks on the housing or gasket outside of the thermostat outer edge may be visible; if so, the thermostat was installed incorrectly (Fig. 1).

Improper Installation

To prevent any further repeat repairs, follow the procedure outlined on KGIS and remove all necessary components to gain proper access, **including the air box assembly**. Correctly position the thermostat in the housing by aligning the tab on the thermostat housing (Fig. 3) with the tab on the thermostat body (Fig. 4). Try rotating the thermostat to validate if it is properly indexed and seated. No movement should be possible, if properly installed. Make sure the thermostat does not move during installation of the housing as this could cause repeat repairs.

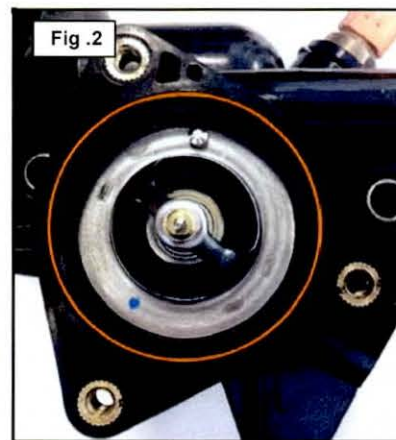
Proper Installation

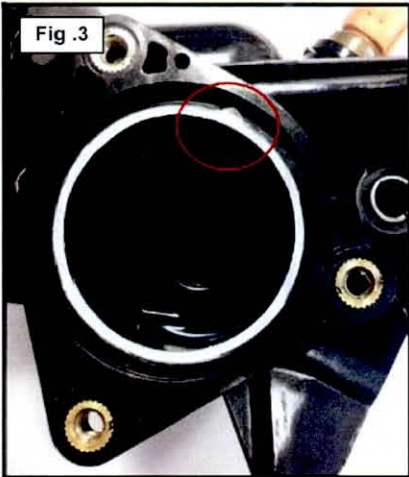
Alignment Tab on  
Thermostat Housing

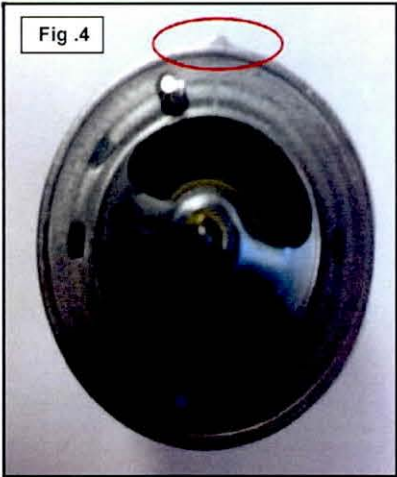
Alignment Tab on  
Thermostat
