GROUP BODY	MODEL 2011-2012MY Optima (TF)
	NUMBER 097	DATE June 2013
<b>TECHNICAL SERVICE BULLETIN</b>		
SUBJECT: COMBINED TSB/SERVICE ACTION: FUEL FILLER DOOR INSPECTION AND UPGRADE PROCEDURE (SA145)

**SUBJECT: OPTIMA RIGHT HAND FENDER SPLIT REPAIR PROCEDURE**

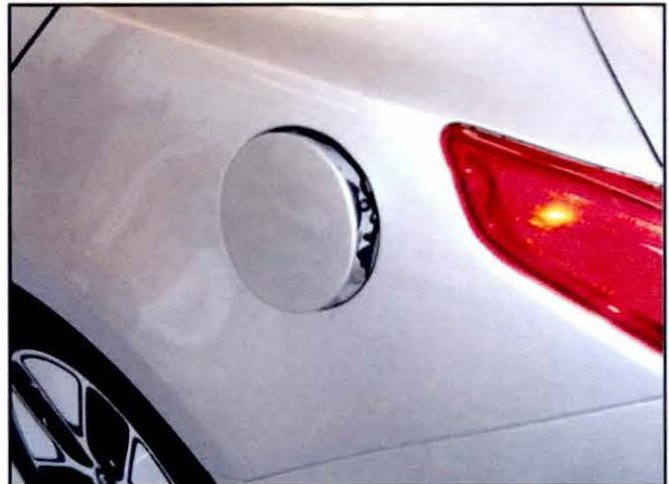
1. Open the fuel filler door and verify any clearance issues preventing the door from opening or closing correctly.
  - If the door operation is normal, no further steps will be necessary.
  - If there is evidence of abnormal operation due to clearance concerns, proceed to the Service Procedure below.

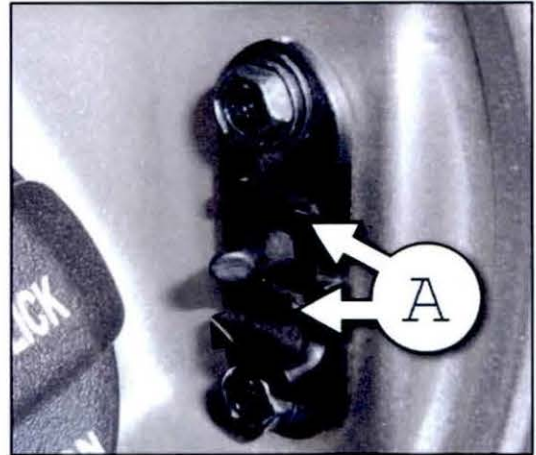
- Note the location of the upper and lower alignment guides (A) protruding from the body of the fuel filler door latch.

These guides need to be filed down as noted below:

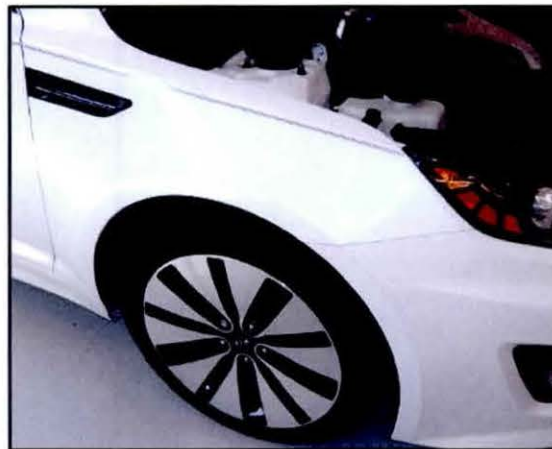
RH Fender Assembly

This bulletin provides information related to some 2013MY Optima (QF) vehicles, produced from May 17, 2013 to May 18, 2013, which may exhibit a split in the metal on the inner portion of the right hand side fender. This condition is only present on the right side fender. Follow the procedure outlined in this bulletin to repair the concern, without replacing the fender.
