MODEL
2012-2013MY
Optima (QF)

NUMBER
103

TECHNICAL SERVICE BULLETIN

SUBJECT: PANORAMA SUNROOF & SUNSHADE MOTOR REPLACEMENT

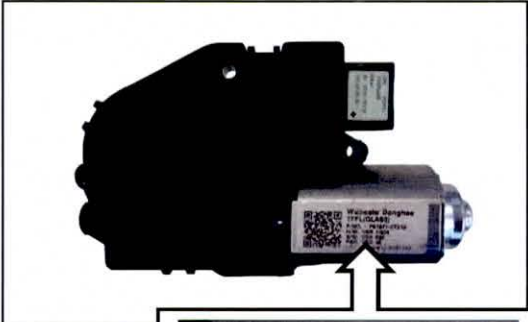
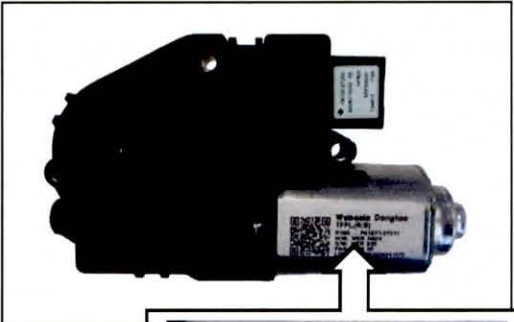
Sunroof Motor P/N 81671 2T210	Sunshade Motor P/N 81671 2T211
