Subject: STAINS FOUND ON PAINT DURING PDI	Bulletin No: 09-004/14
	Last Issued: 01/14/2014

2013-2014 MX-5
2013-2014 Mazda2
2013-2014 Mazda3
2013-2014 Mazda5
2013-2015 Mazda6
2013-2015 CX-5
2013-2014 CX-9

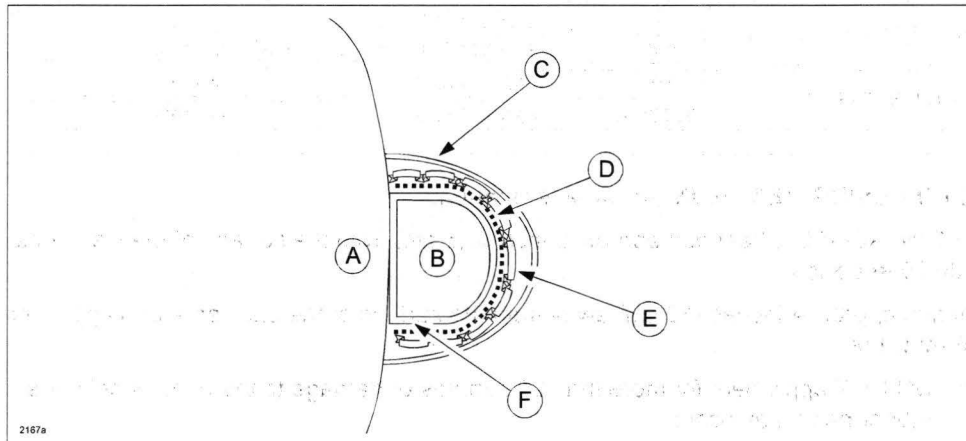
- Since this repair procedure requires the use of heat from a heat gun or infrared drier, be sure to insulate all rubber or plastic parts which are easily affected by heat from near the affected stain area.
- Use extreme care to ensure the top coat surface temperature stays below 284°F (140°C).
- To protect materials inside the cabin area (i.e. carpet, seats, etc.), also place insulation over the glass as necessary.

1. Visually inspect the top coat surface for stains.
 - If stains are found, use a heat gun (for smaller stains) or an infrared drier (for larger stains) to heat the affected area and remove the stains.
2. Insulate all plastic and rubber parts (as shown below) using heat insulation materials (C ~ F) prior to beginning the application of heat.
 - A - Body Panel
 - B - Molding
 - C - Aluminum foil covering all area
 - D - Wet towel
 - E - Folded aluminum foil
 - F - Aluminum foil tape

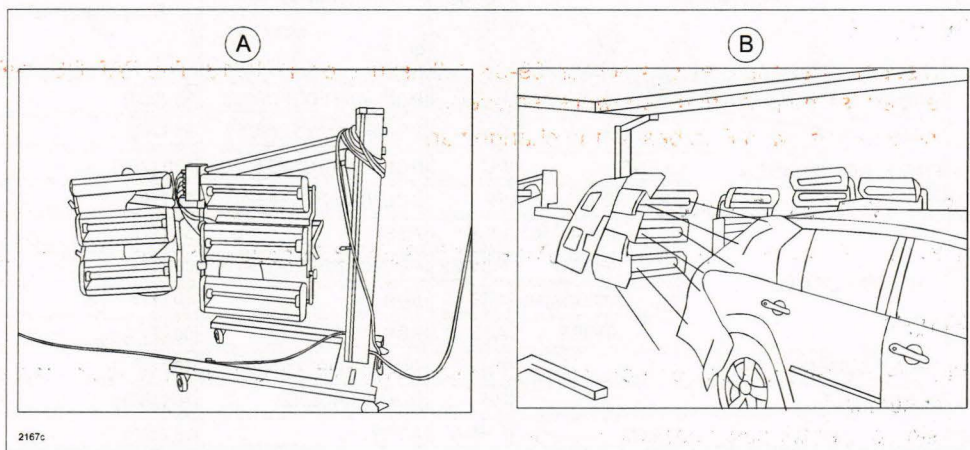
CAUTION: DO NOT apply heat for more than 60 minutes or damage to the body panel surface, plastic or rubber parts may occur.

1. Mount an infrared drier (A) approx. 31.5 inches (80 cm) away from the surface (B) of the stain area.
2. Set the temperature of the infrared drier to 140~158° F (60~70° C) and apply heat for a maximum of **60 minutes**.
