09-029/14 - 2010-2013 MAZDA6 - SEAT CUSHION TRIM COMING APART AT SEAMS - (CLOTH SEATS ONLY)

<b>Subject:</b> SEAT CUSHION TRIM COMING APART AT SEAMS - (CLOTH SEATS ONLY)	<b>Bulletin No:</b> 09-029/14
	<b>Last Issued:</b> 07/03/2014

2010-2013 Mazda6 vehicles equipped with cloth seats

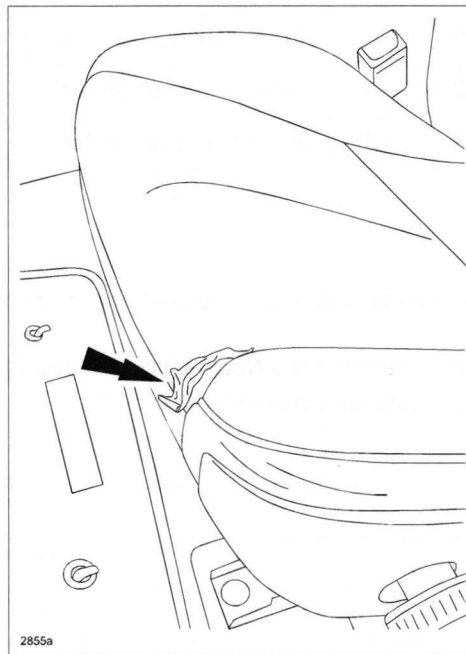
Some vehicles may exhibit a condition where the front and/or rear seat cushion trim is coming apart at the seams.

Seat cushion trim(s) with increased strength are available to eliminate this concern.

1. Verify the customer concern.
2. Replace **only the affected** seat cushion trim(s) with a new one according to the instructions on MS3 online or the Workshop Manual (section 09-13 FRONT SEAT CUSHION TRIM REMOVAL/INSTALLATION) and/or (section 09-13 REAR SEAT CUSHION TRIM REMOVAL/INSTALLATION).
3. Verify the repair.
