14-01-031-1

August 2014

**Santa Fe (NC), Elantra (MD)
and Tucson (LM)****SUBJECT: AVN GEN 3 REBOOT LOGIC IMPROVEMENT
(SERVICE CAMPAIGN TT8)****THIS TSB SUPERSEDES TSB 14-01-031 TO CORRECT THE SANTA FE VERSION SCREEN IMAGE.***** IMPORTANT******* Dealer Stock and Retail Vehicles *****

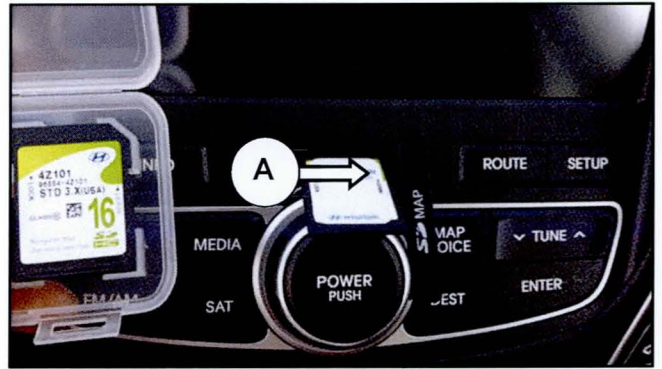
1. With the vehicle ignition OFF and the Navigation system off, remove the Navigation SD Map card then insert the Update SD Card (A).

You may temporarily store the Navigation Map SD card in the SD Card holder supplied with the Update SD Card as shown in the illustration.

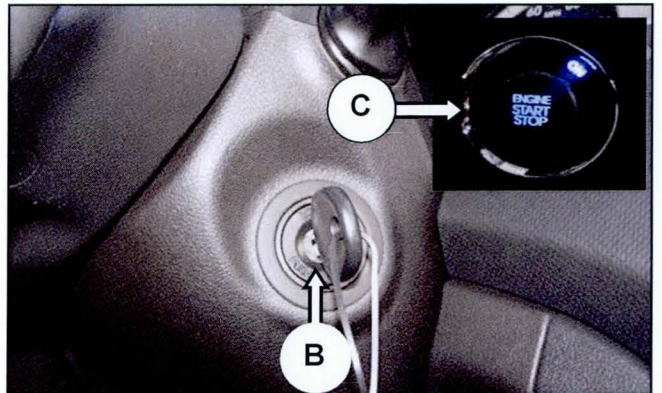
2. Start the vehicle by using the key (B), or with the Start Stop Button (C).

To start the vehicle using the Start/Stop Button (C) depress the brake and push the Start/Stop Button once.

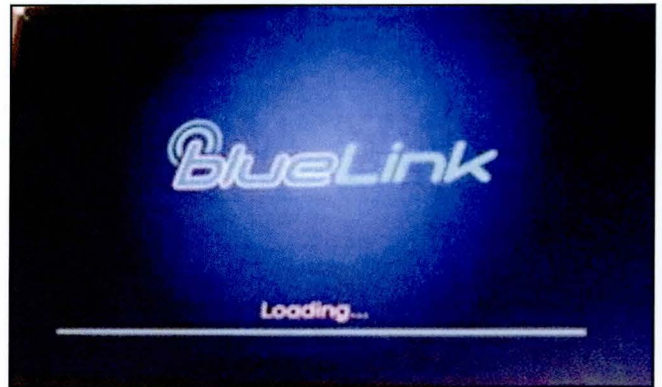
3. The update will begin automatically.

If the update does not start automatically, go to procedure (5) to conduct the manual software update. Update takes roughly 2-4 minutes.

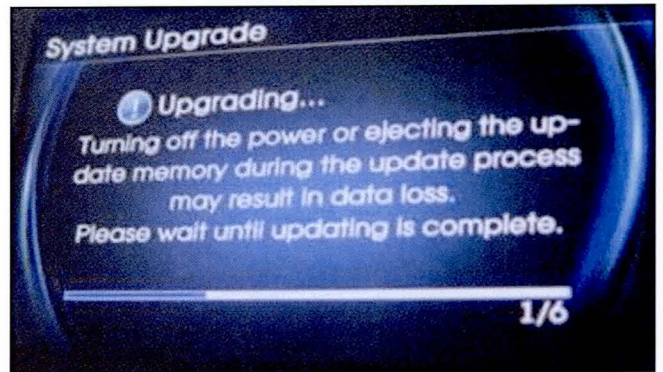
4. The Navigation Operating System software will continue to update until complete.

Do not turn off the vehicle, cycle the ignition or remove the SD Card during the update process.

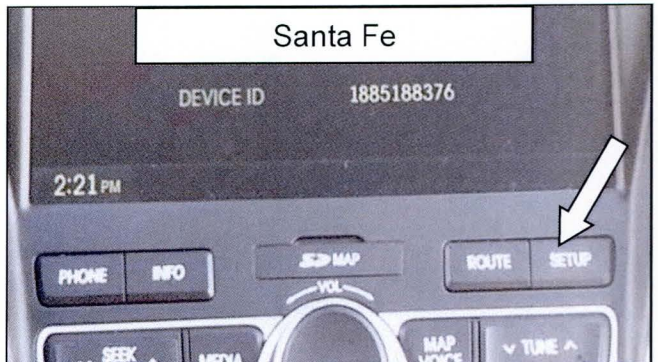
5. With the Update SD Card already inserted and the vehicle started; illustrated in procedures (1) and (2) above.

Press the **"SETUP"** button to begin the Manual Update.

Display screen will transition to procedure (7) below.

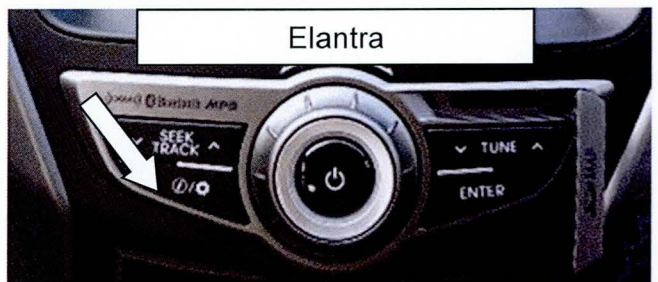
- 5b. The Elantra will transition to an Info/Setup screen, procedure (6) below.

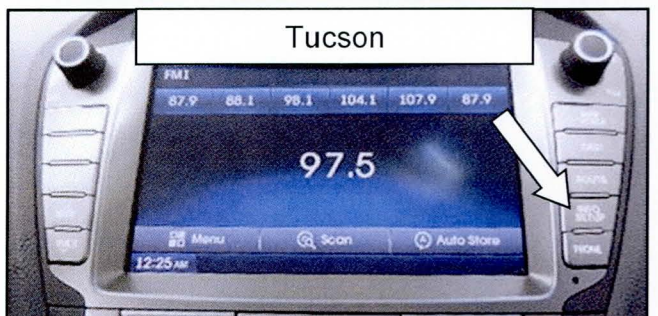
- 5c. The Tucson will transition to an Info/Setup menu, procedure (6) below.

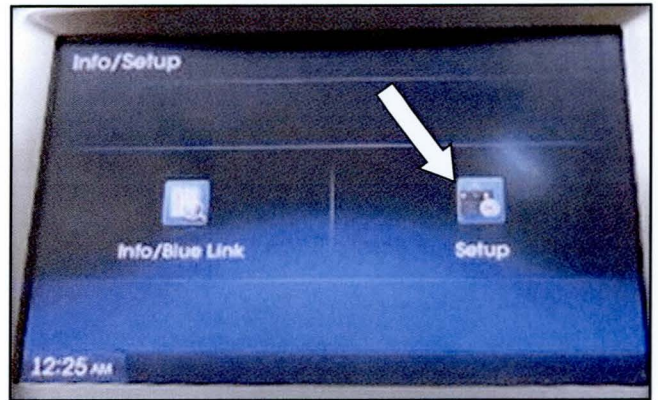
6. Press Setup to transition to the Info/Setup menu shown in procedure (7) below.

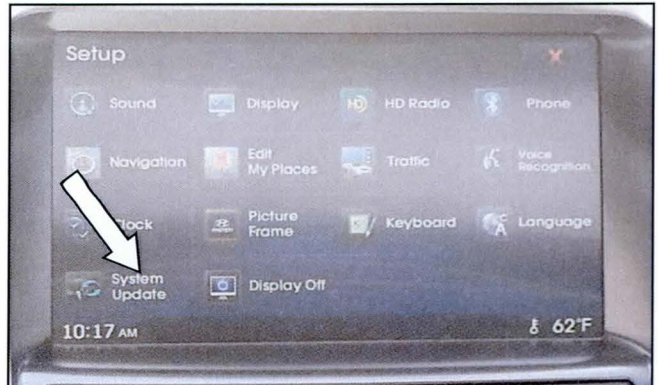
7. From the Setup menu, press "System Update" on the display.

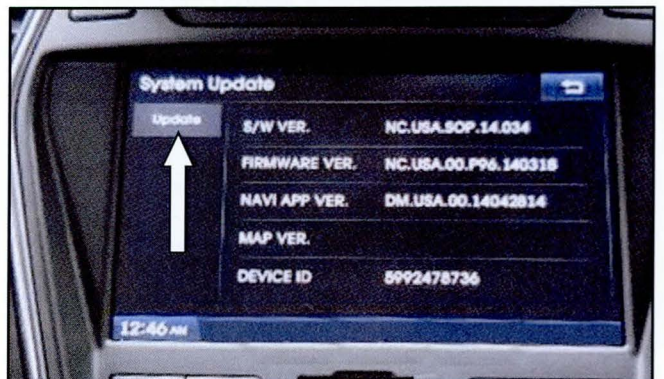
8. From the System Update menu press "Update" on the display.

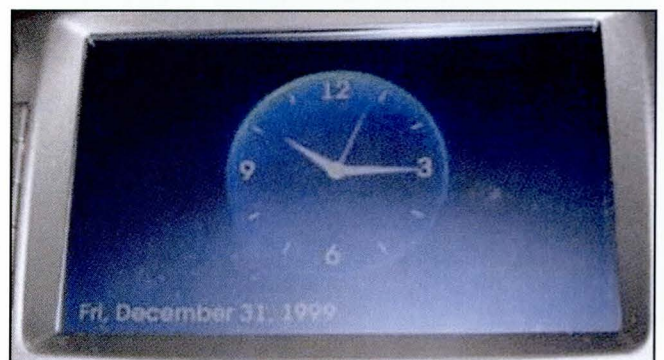
9. After the update is complete the radio will restart and display the previously chosen "Display Off" selection on the screen.

Default "Display Off" is set to clock as shown in the image to the right, this could be a blank screen or a user saved image.

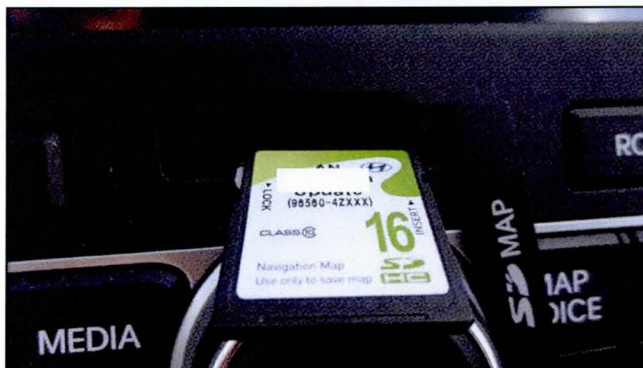
- Remove the Update SD Card and insert the SD Card supplied with the vehicle.

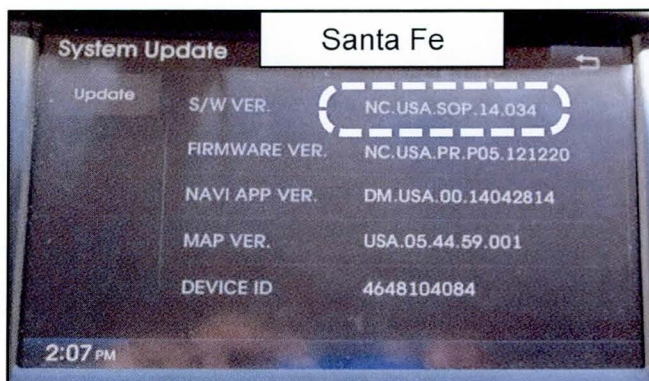
- Santa Fe:**
Follow procedure (5) through (8) to enter the "System Update menu to compare the S/W VER with the after update version outlined on the picture to the right.

NC.USA.SOP.14.034

If the software version information shown in the image to the right does not match, conduct the update again.

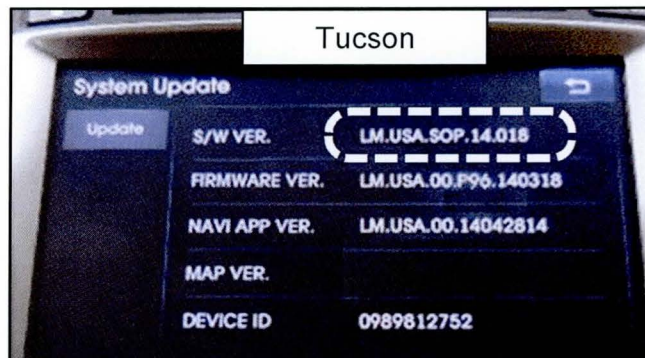
- Tucson:**
Follow procedure (5) through (8) to enter the "System Update menu to compare the S/W VER with the after update version outlined on the picture to the right.

LM.USA.SOP.14.018

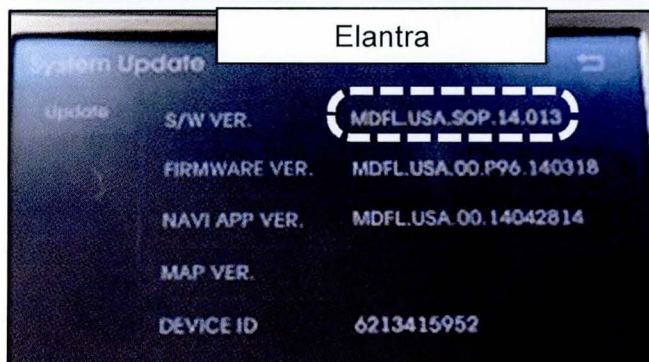
- Elantra:**
Follow procedure (5) through (8) to enter the "System Update menu to compare the S/W VER with the after update version outlined on the picture to the right.

MDFL.USA.SOP.14.013
