Second Row Seat Squeak

Service
Category Vehicle Interior

YEAR(S)	MODEL(S)	ADDITIONAL INFORMATION
2010 – 2013	GX460

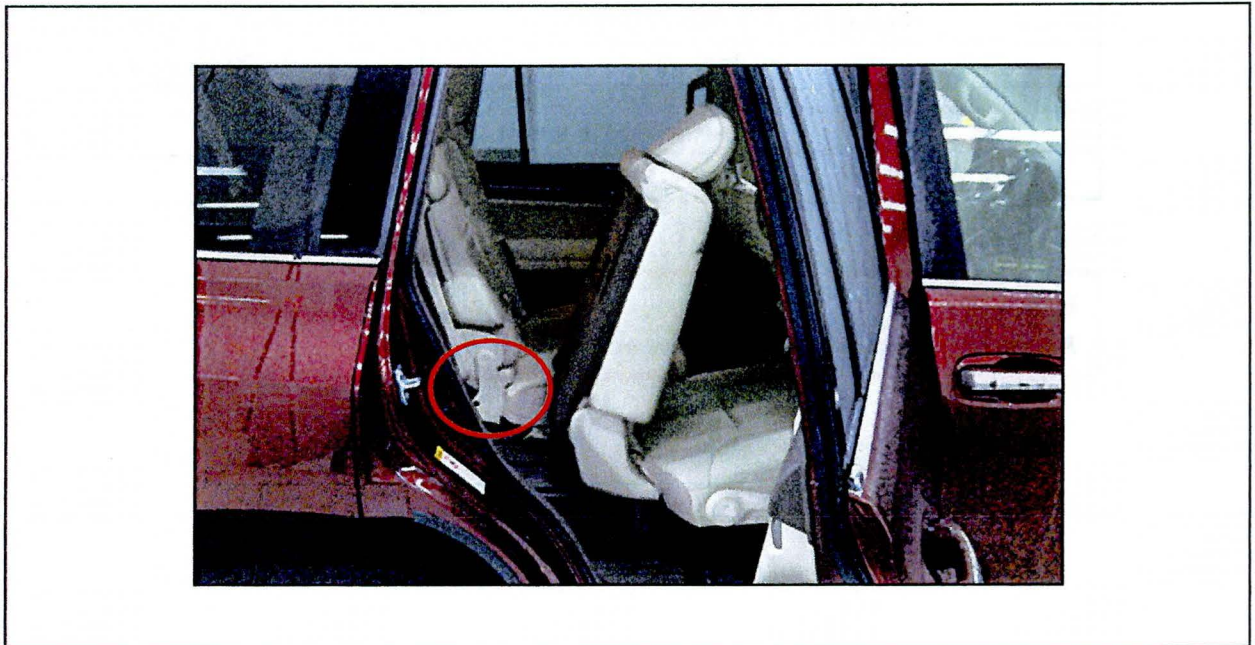
Some 2010 – 2013 model year GX 460 vehicles may exhibit a squeak noise coming from the second row seats when driving over uneven terrain.

The bracket for the inside hinge of the 60% second row seat may rub the seat frame. Follow the procedure outlined below to address this condition.

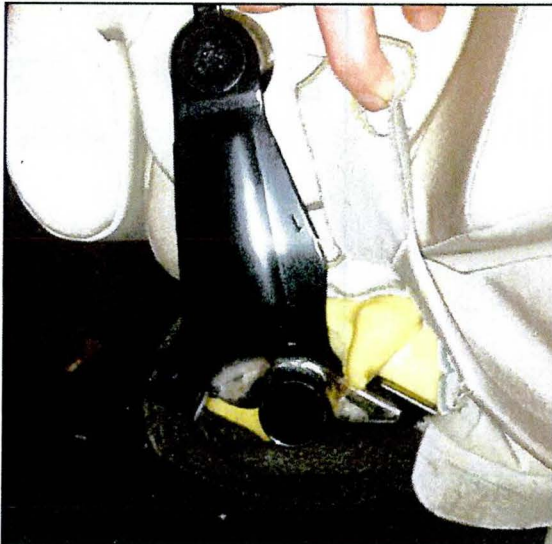
Figure 2. Approximate Vantage Point (Reposition Foam to Access View)

3. Confirm that a noise is being generated by two surfaces rubbing, as shown below.
