# Spark Knock Noise

YEAR(S)	MODEL(S)	ADDITIONAL INFORMATION
2012 – 2014	Tacoma

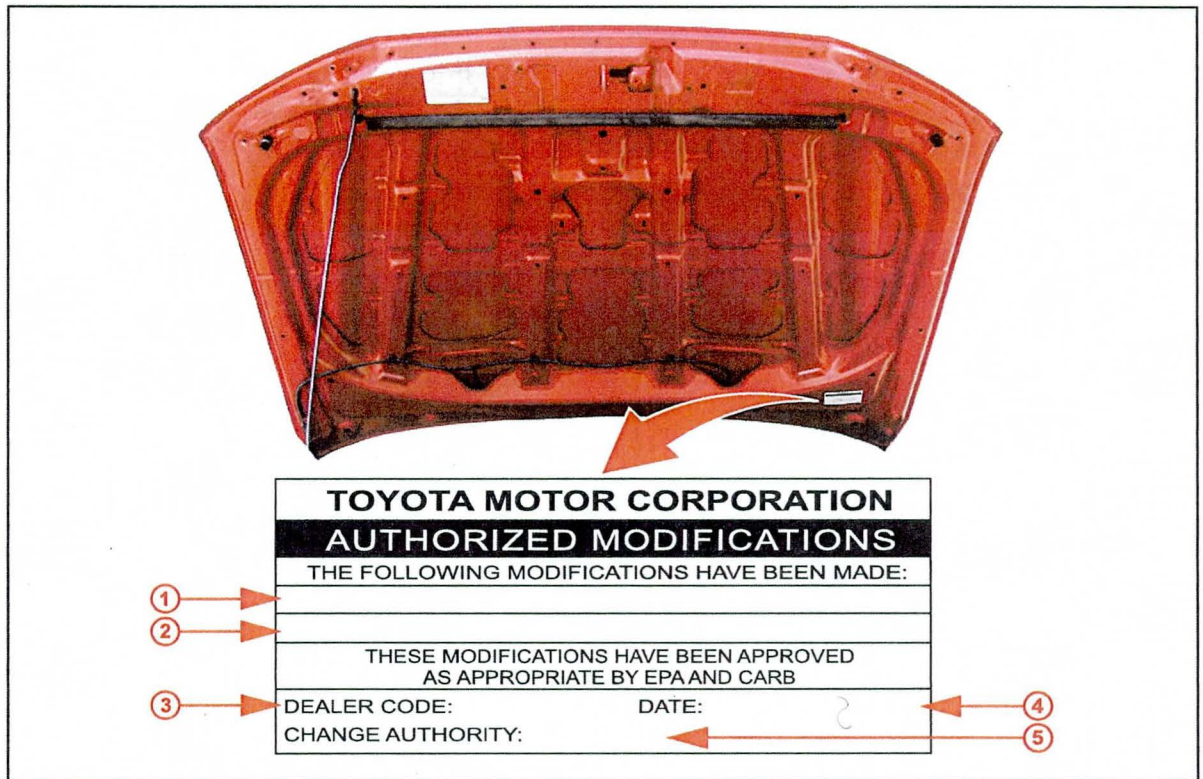
**Figure 1. Location of Authorized Modifications Label on 2012 – 2014 Tacoma**

2. Check for the Authorized Modifications Label affixed to the vehicle in the location shown in Figure 1. Confirm if the ECM (PCM) calibration has been updated. If the calibration ID listed is NOT the latest ECM (PCM) calibration — go to step 3. If the calibration ID is the latest, go to step 5.

- Install the Authorized Modifications Label.
  - Using a permanent marker, enter the following information on the label:
    - ECM part number [Refer to the **Parts Information** section for the **NEW PART NUMBER**]
    - Calibration ID(s) [Refer to the **Calibration Information** section for the **NEW CALIBRATION ID**]
    - Dealer Code
    - Repair Date
    - Change Authority [**This bulletin number**]
  - Affix the Authorized Modifications Label to the vehicle at the location shown in Figure 1. The Authorized Modifications Label is available through the MDC, P/N 00451-00001-LBL.
- Test drive to confirm the repair.
