Window Freezing, Losing Initialization

Service Category Vehicle Exterior

Section Window/Glass

YEAR(S)	MODEL(S)	ADDITIONAL INFORMATION
2013	FR-S

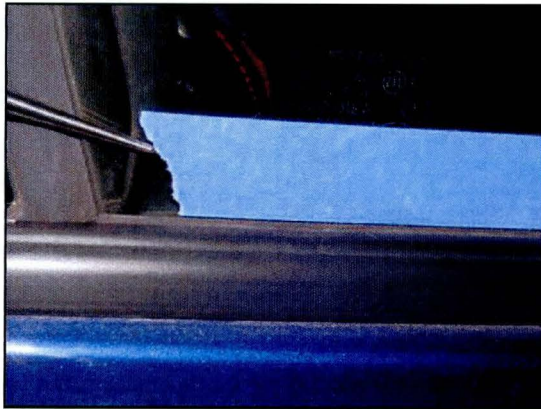
Figure 3. Example of Tape Applied to Front of Outer Door Weatherstrip

- Apply tape horizontally to about 1 inch (15 mm) from the rear edge of the passenger and driver side windows and about 1 inch (15 mm) from the front outer Door Weatherstrip, as shown.
- Apply the tape parallel to the outer Door Weatherstrip as shown in Figures 2 – 6.

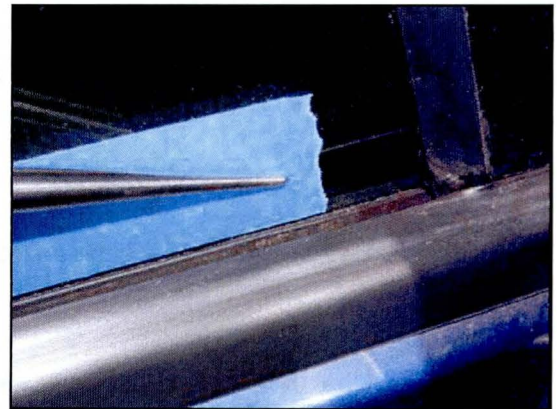
Figure 4. Example of Tape Applied to Rear of Outer Door Weatherstrip

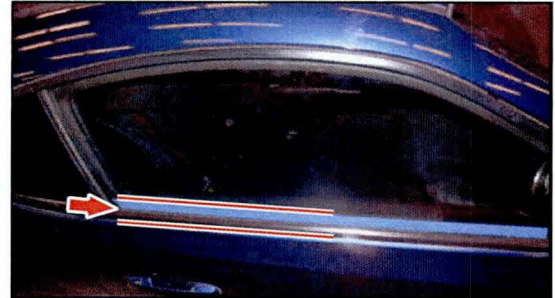
Figure 5. No Gap Between Tape and Outer Door Weatherstrip

- There should be no gap between the outer Door Weatherstrip and tape.
- If the window was not properly aligned prior to this repair, the procedure will not be successful.

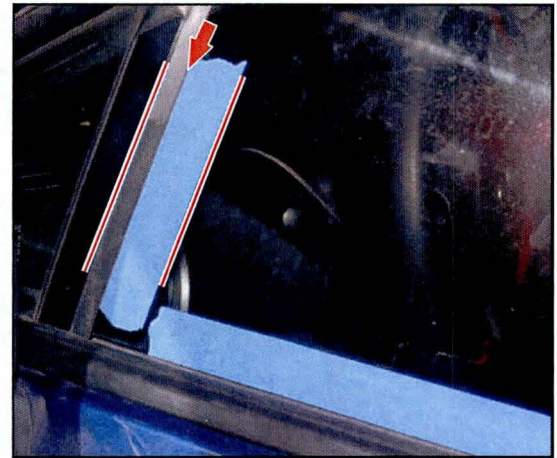
Figure 6. No Gap Between Tape and Outer Door Weatherstrip

- D. Apply a strip of 3M™ ScotchBlue™ Painter's Tape (or equivalent) vertically on the glass, parallel and adjacent to the front weatherstrip. There should be no gap between the weatherstrip and tape.

The tape should extend within 2 inches (or closer) to the top and bottom of the glass. This will aid in aligning the window during installation.

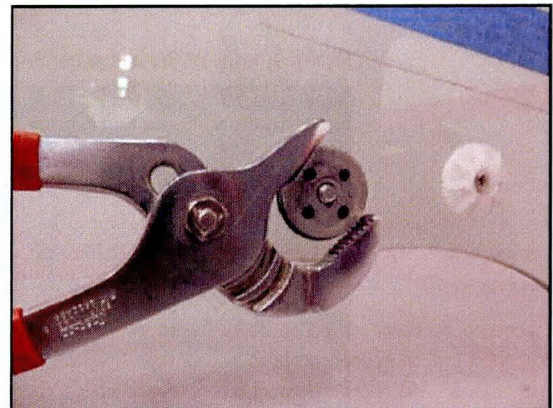
2. When removing the front door glass sub-assembly, the nuts and studs may turn freely in the window glass. If this happens, follow the steps below. **Figure 7.**

- Use a tool like slip-joint pliers to carefully hold the round stud in the back side of the window close to the door skin. This will prevent the 2 nuts from turning during removal.
- Wrap the jaws of the pliers in tape to prevent damage to the glass (see Figure 7 for an example of the stud in the back of the window).

In Figure 7, tape has been removed from pliers to show clarity. Be careful NOT to touch the pliers against the glass.

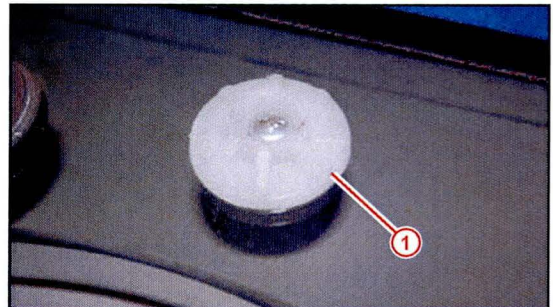
Figure 8.

1	Glass Lifter
---	--------------

3. After the glass assemblies have been removed, carefully remove the 2 (white) door glass window lifters from the driver and passenger side glass.

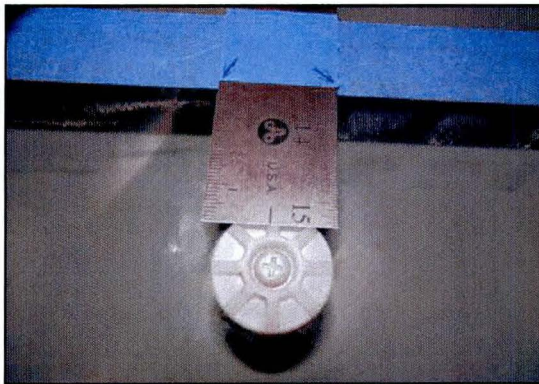
Figure 9. Edge of Ruler Against Flat Side of Glass Lifter

- Using a ruler as a guide, install the NEW Glass Lifters. Ensure the flat edge at the top of the Glass Lifter is facing the top of the glass and is parallel to the masking tape on the glass as shown below.

- Be sure the flat edge on the Glass Lifter is parallel to the tape applied in earlier steps. If necessary, loosen and realign the Glass Lifter to ensure it is parallel to the tape.
- If new nuts are not available to install the window to the regulator, use Toyota Genuine Adhesive 1344, Three Bond 1344, Loctite® 242, or equivalent, to reinstall the nuts.

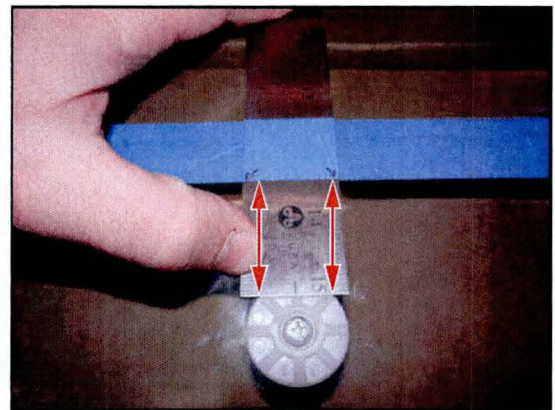
Figure 10. Edge of Ruler Parallel to Tape

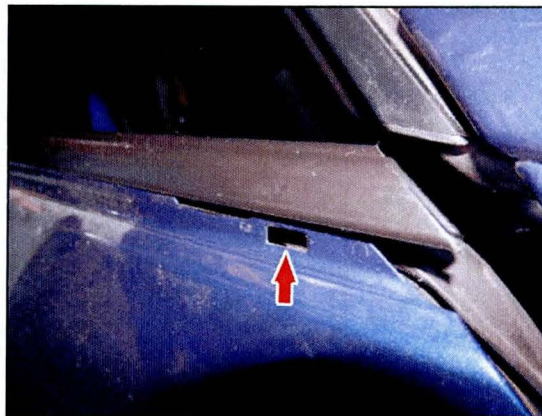
Figure 11. Hole for Clip in Outer Door Weatherstrip at Front of Door

1. Ensure the bolt holding the outer Door Weatherstrip is removed.
2. Disengage the clip holding the weatherstrip.
 - A. At the front of the door is a hole where the clip is engaged. Use a plastic pry tool to gently pry out and up on the weatherstrip in this location at the front of the door. This will allow the clip in the weatherstrip to disengage.
 - B. After disengaging the clip, lift up on the outer Door Weatherstrip starting where the bolt is.
