S-SB-0002-13 Rev1 January 16, 2013

Moisture in Rear Combination Light / Water Intrusion Into Vehicle

YEAR(S)	MODEL(S)	ADDITIONAL INFORMATION
2013	FR-S

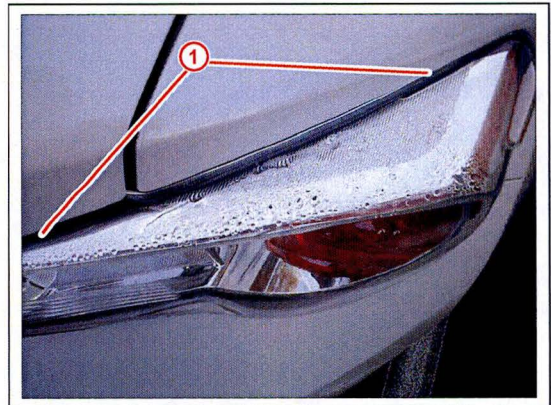
Figure 1.

1. Prior to making any repairs or replacing parts, locate the source of water entry.
2. See Figure 1 for an example of moisture inside the Rear Combination Light.

1 Interior Moisture

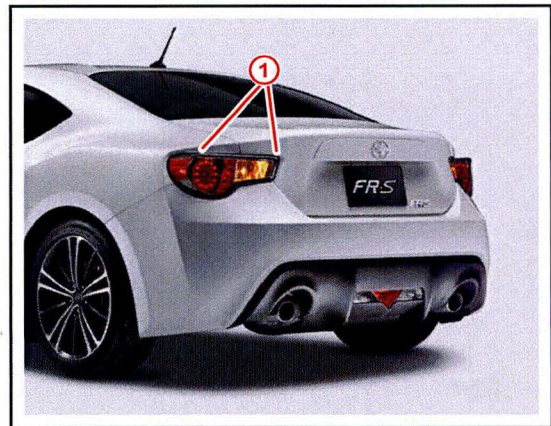
Figure 2.

4. Spray water on the vehicle, especially around the perimeter of the light housing.

1 Spray Location

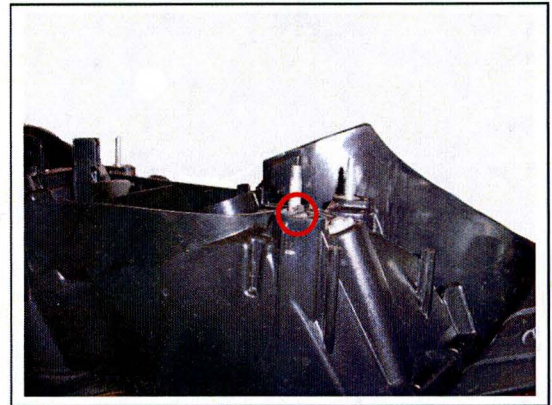
Figure 3.

6. Remove one or both lights that show evidence of moisture intrusion.
7. Inspect the back side of the combination lights for evidence of plastic cracking around the mounting studs. If cracking is present, replace the housing, gasket, and nuts.

- The sealing gasket is a “ONE USE ONLY” type gasket and **MUST** be replaced every time a combination light housing is removed from the vehicle.
- If servicing a rear combination light or gasket, be sure to replace the hardware with the **NEW** service parts (SU003-04650).

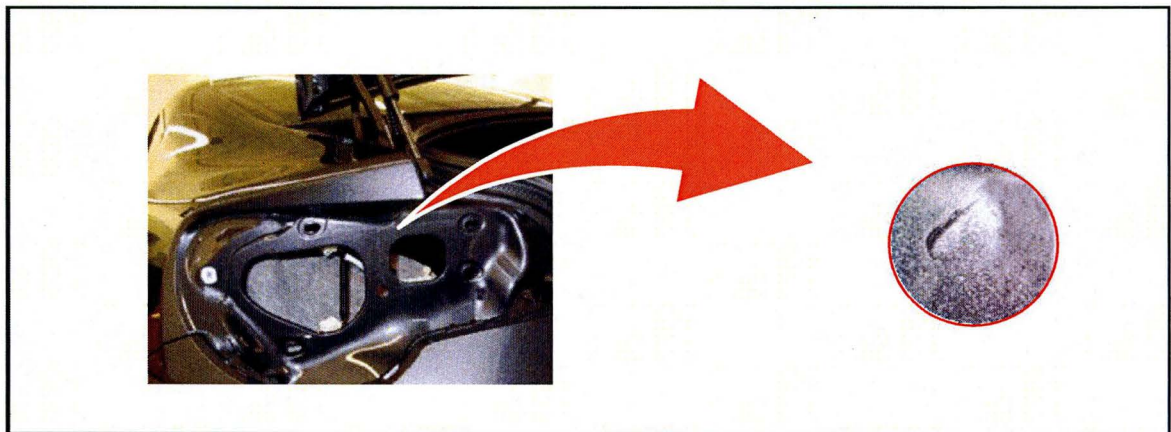
Figure 4.

1. Inspect the sheet metal body panel adjacent to the back side of the light housing for evidence of misplaced body seam sealer.

Remove any misplaced seam sealer with the sharp end of the plastic pry tool (SST# 00002-06002-01) being careful **NOT** to damage the painted body surface. If bare metal should appear during the sealer removal process, use touch-up paint to cover any bare metal areas before proceeding.

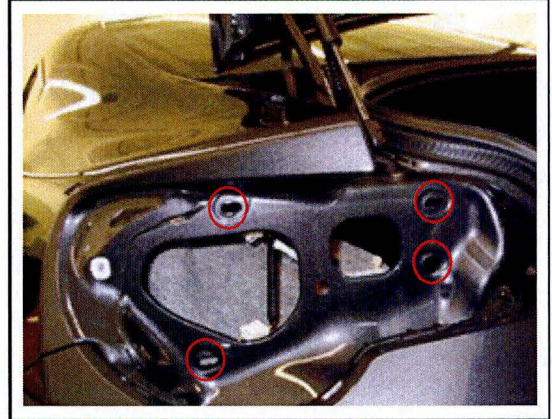
Figure 5.

2. Inspect the body sheet metal for evidence of deformed (cone shape) sheet metal around the 4 through-holes in the body.

Use a Body Hammer and Body Dolly to flatten the sheet metal around the 4 through-holes in the body (see circled areas for through-hole locations). Use touch-up paint on any bare metal areas.

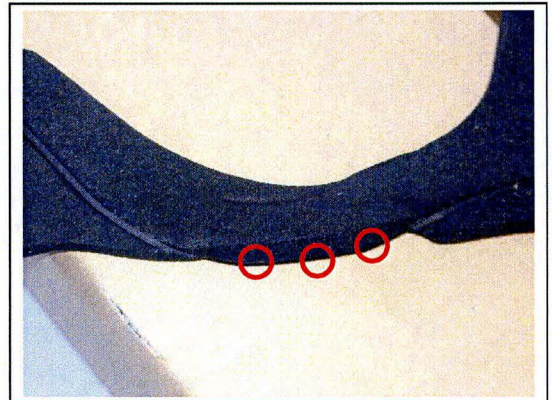
Figure 6.

3. Inspect the rear combination light sealing gasket for evidence of misplacement.

A misplaced gasket may allow water to enter the combination light housing or possibly the interior of the vehicle.
