**HYUNDAI**NEW THINKING.
NEW POSSIBILITIES.**Technical Service Bulletin**

GROUP	NUMBER
AUTOMATIC TRANSMISSION	13-AT-014
DATE	MODEL
JULY 2013	Tucson (LM), Santa Fe (CM/AN/NC), Sonata (YF), Elantra (UD/MD/GD/JK), Accent (RB), Azera (TG/HG), Veloster Turbo (FS)

SUBJECT:	ATM INPUT AND OUTPUT SPEED SENSOR DTC P0717, P0721 AND P0722
-----------------	---

*This TSB supersedes bulletin 12-AT-009-4 to include 2013 models***Description:** Do not replace the transmission for the DTC listed below. Instead, follow the repair procedure and replace the related part.

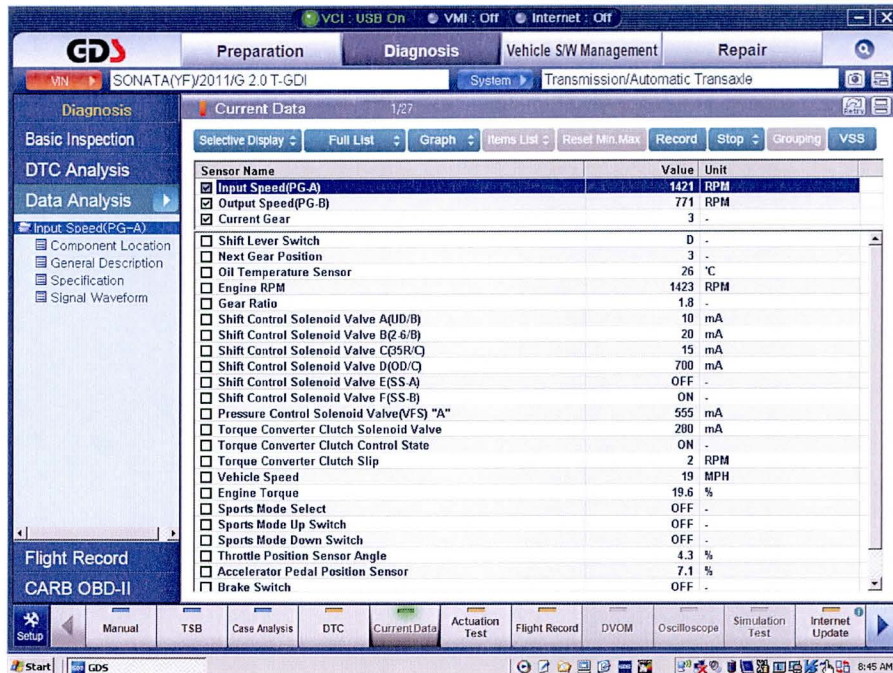
- Using a GDS, check for DTC in the “Automatic Transaxle” menu. **Record the DTC and description.** Delete the DTC.
- From the GDS, select the following parameters. Drive the vehicle and monitor the sensors.
 - Vehicle and A/T menu.
 - “Current Data”
 - Input speed and output speed sensors.

- If the sensors show:
 - Continuous and changing output with changes in vehicle speed, the wiring **currently** has no open/short circuits. Go to Step 5.
 - No continuous and changing output, go to Step 4.
- Visually check the wiring harness between the PCM and transmission for a damaged wire or short circuit to ground. Check for a damaged pin or pin not fully inserted into the connector.
 - If damage exists, repair or replace the ECM control harness and drive the vehicle to confirm the repair.
 - If no damage, go to Step 5.
- Refer to the DTC recorded in Step 1 and follow the repair procedure shown below:
