SERVICE BULLETIN RELEASE - 04/03/2014

Subject: UNUSUAL NOISE FROM EXHAUST PIPE SEAL RING	Bulletin No: 01-007/14
	Last Issued: 04/03/2014

2009-2013 Mazda6 2.5L with automatic transmission

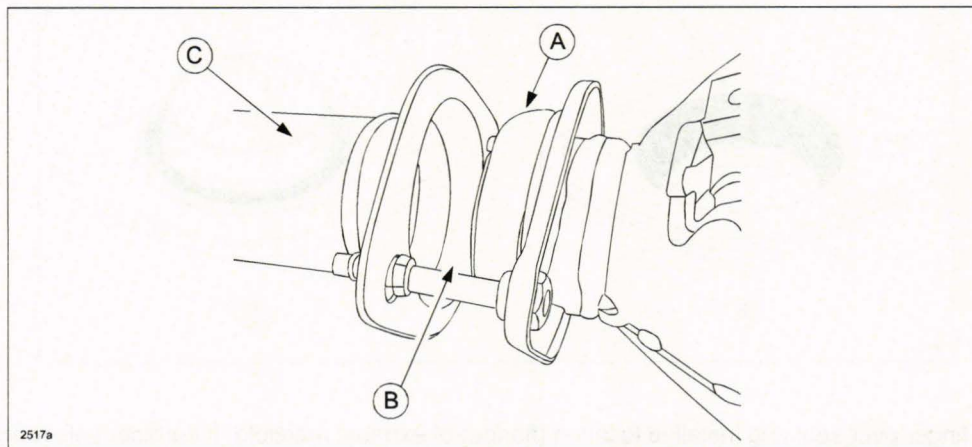
Some vehicles may exhibit an unusual squeak noise when the engine is idling, or just at the moment when the engine is shut off. The noise may be audible from inside the vehicle if one or more windows are open, or if any passenger is opening a door to exit the vehicle.

Due to engine vibration and a lack of seal ring lubrication, the mesh in the seal ring (A) rides in the flared portion (B) of the catalytic converter (C) resulting in a slight noise from the exhaust system while the engine is running. **The friction between the exhaust system parts and the resulting slight noise are normal.** This friction does not cause breakage, gas leakage, or other functional problems with the vehicle's exhaust system.

During normal vehicle aging, the noise level may change as the surface of the metal flange deteriorates. Usually this noise cannot be heard when the engine is running, however the noise may be heard in a quiet environment when the customer is outside the vehicle or when a door or window is open.

Customers having this concern should have their vehicle repaired using the following repair procedure.

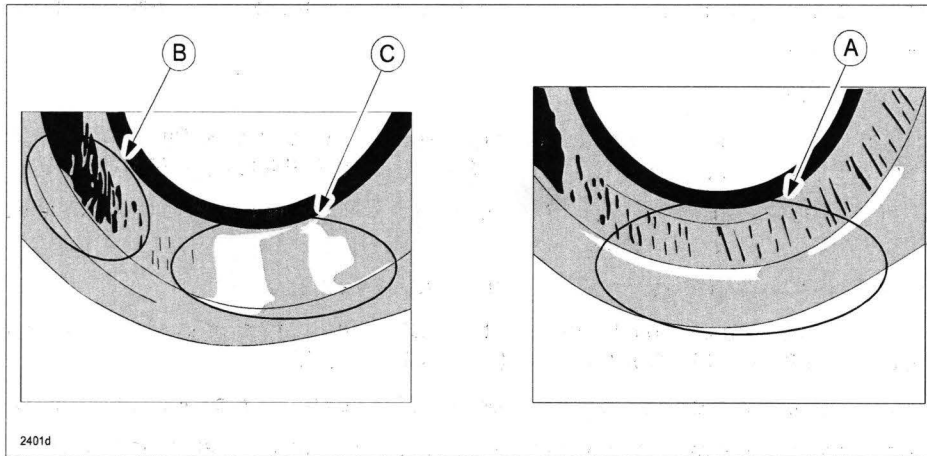
NOTE: If the catalytic converter is replaced and a black coating (B) remains on the round surface of the flared flange, the white coating of the seal ring will stick to the black coating, which may cause noise. Be sure to sufficiently polish the flange (C).

12. If severe damage appears on round surface of catalytic converter-side flared flange (A), replace catalytic converter.

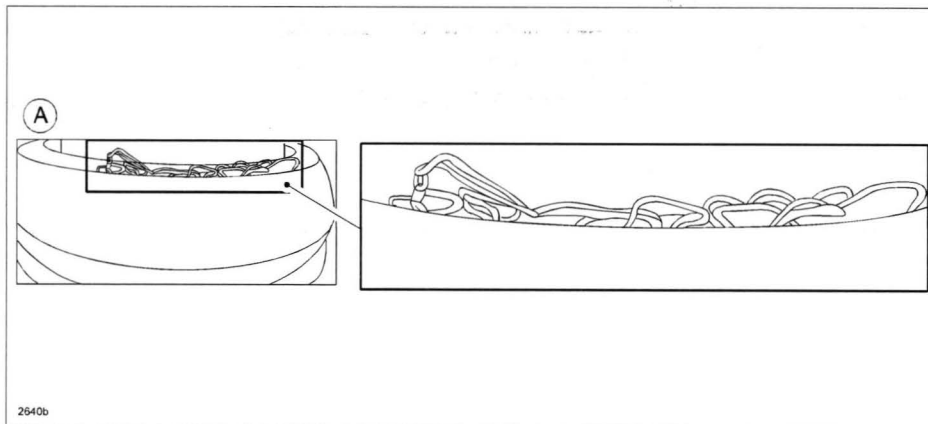
19. If the seal ring is NOT installed straight, mesh wire (A) will come out from the seal ring which will then contact the exhaust pipe flange.
