01-007/14 – 2009-2013 MAZDA6 2.5L (A/T) – UNUSUAL NOISE FROM EXHAUST PIPE SEAL RING

Subject: UNUSUAL NOISE FROM EXHAUST PIPE SEAL RING	Bulletin No: 01-007/14
	Last Issued: 03/17/2014

2009-2013 Mazda6 2.5L with automatic transmission

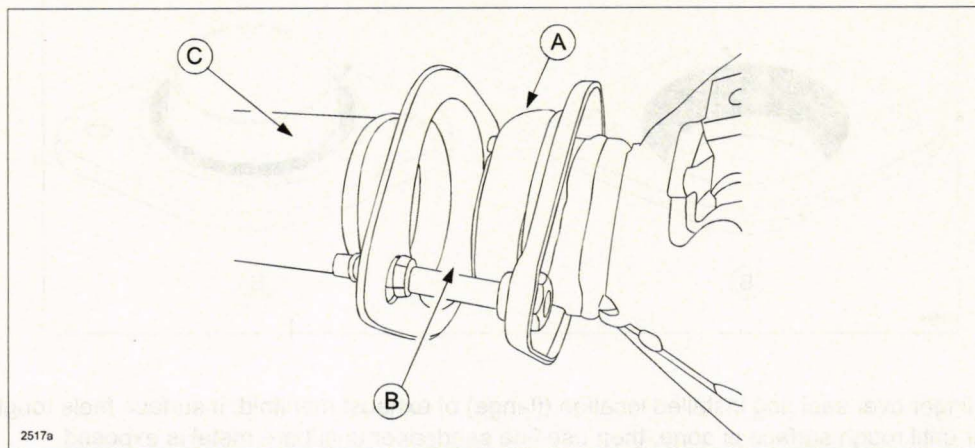
Some vehicles may exhibit an unusual squeak noise when the engine is idling, or just at the moment when the engine is shut off. The noise may be audible from inside the vehicle if one or more windows are open, or if any passenger is opening a door to exit the vehicle.

Due to engine vibration and a lack of seal ring lubrication, the mesh in the seal ring (A) rides in the flared portion (B) of the catalytic converter (C) resulting in a slight noise from the exhaust system while the engine is running. **The friction between the exhaust system parts and the resulting slight noise are normal.** This friction does not cause breakage, gas leakage, or other functional problems with the vehicle's exhaust system.

During normal vehicle aging, the noise level may change as the surface of the metal flange deteriorates. Usually this noise cannot be heard when the engine is running, however the noise may be heard in a quiet environment when the customer is outside the vehicle or when a door or window is open.

Customers having this concern should have their vehicle repaired using the following repair procedure.

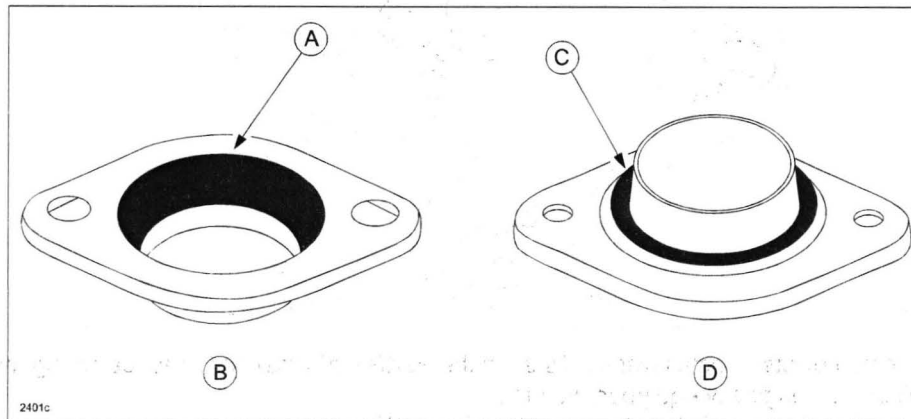
NOTE: Make sure the polished surface is free from seal ring residue, debris, or wear marks.

4. Remove the exhaust studs and washers (if any) and discard them.
5. Remove seal ring from exhaust manifold. Refer to the MS3 online instructions or Workshop Manual (section 01-15A EXHAUST SYSTEM REMOVAL/INSTALLATION [MZR 2.5]).
6. Stuff a cloth into exhaust manifold and catalytic converter to prevent dust or debris from entering.
7. Polish the flared portion (A) of catalytic converter-side (B) using a nylon brush or sandpaper (#60) for twenty (20) minutes, then use (#600) for three (3) minutes until bare metal is exposed.
8. Degrease (A) using ethanol for thirty (30) seconds.
9. Remove stains from the seal ring installed location (C) in exhaust manifold (D).
10. Degrease (C) using ethanol for thirty (30) seconds.

11. Run your finger over seal ring installed location (flange) of exhaust manifold. If surface feels rough, use #80 sandpaper until rough surface is gone, then use fine sandpaper until bare metal is exposed.

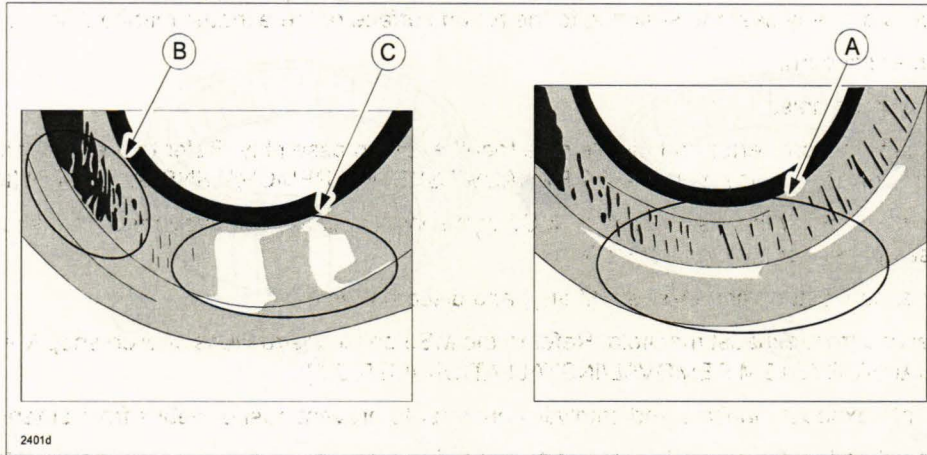
12. If severe damage appears on round surface of catalytic converter-side flared flange (A), replace catalytic converter.

NOTE: If the catalytic converter is replaced and a black coating (B) remains on the round surface of the flared flange, the white coating of the seal ring will stick to the black coating, which may cause noise. Be sure to sufficiently polish the flange (C).

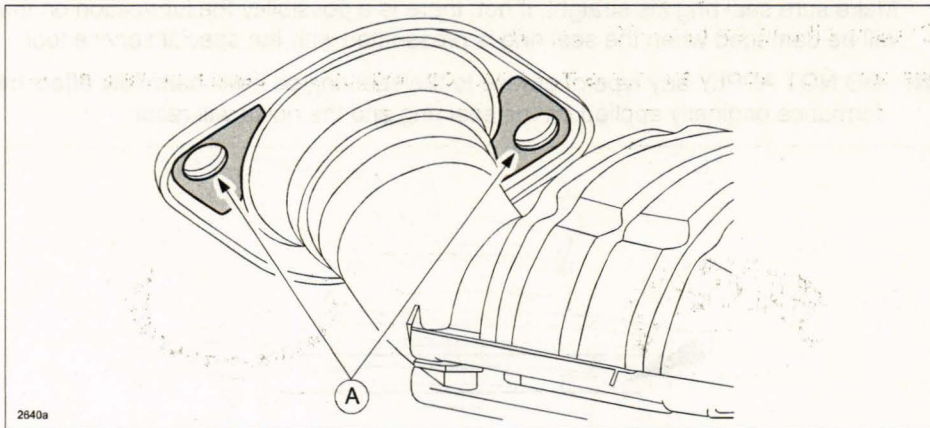
- In case where catalytic converter is NOT replaced:
 - a. Install a new exhaust stud.
 - b. Confirm if patch (A) exists behind the catalytic converter flange.

If YES (patch exists) - Install washer listed in the Part(s) Information to reduce spring tension.
NEVER use an originally equipped washer.

If NO (patch does not exist) - Washer installation is NOT necessary.

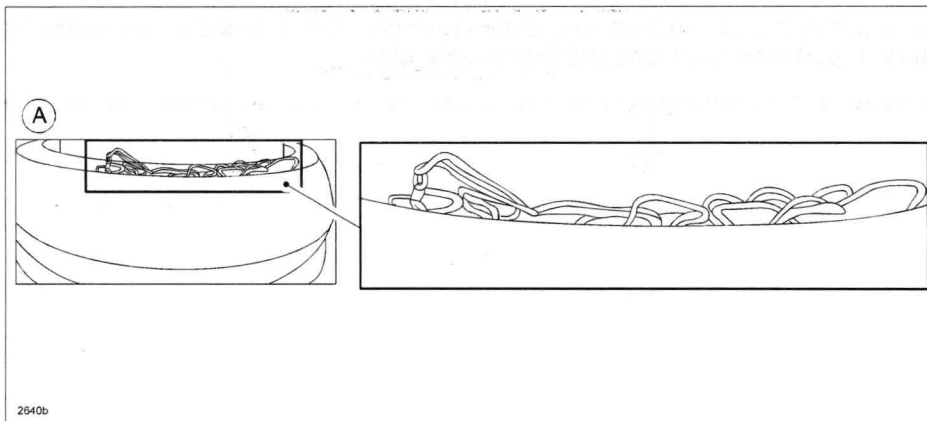
19. If the seal ring is NOT installed straight, mesh wire (A) will come out from the seal ring which will then contact the exhaust pipe flange.

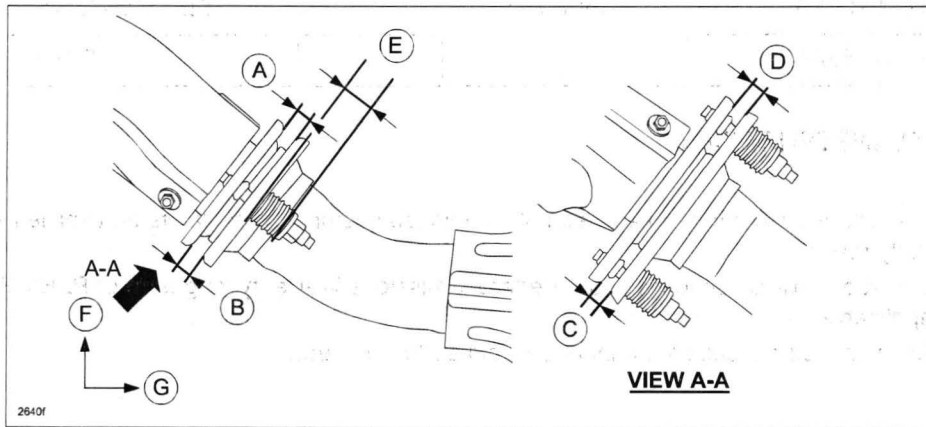
23. Measure the length and clearance between the flanges of the exhaust manifold and U/F catalytic converter. Verify that they are within the specification shown.

A	Upper	9-12 mm
B	Lower	7-10 mm
C	Right	6-9 mm
D	Left	6-9 mm
E	Spring length (end-to-end)	29-31 mm
F	Vehicle upper	
G	Vehicle lower

NOTE: If the clearance or spring length is out of range, verify the cause and repair.
