<b>Subject:</b>  CHECK ENGINE LIGHT ON WITH DTC P0456	<b>Bulletin No:</b> 01-014/14
	<b>Last Issued:</b> 06/10/2014

## APPLICABLE MODEL(S)/VINS

2011-2013 Mazda3

2007-2014 CX-9

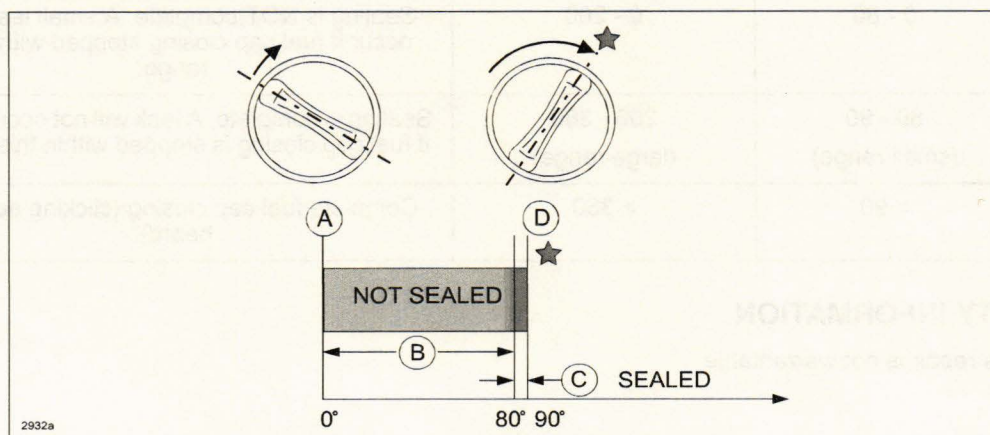
### 2011-13 MAZDA3, 2007-14 CX-9:

- **DO NOT** replace any parts without detecting a leak using MS3 / Workshop Manual diagnostics.
- **Explain to the customer that the fuel cap must be turned at least 80 degrees (C) or until two (2) or more click sounds are heard (D) to be properly sealed.**
- If the fuel cap is not completely closed, it may stay in the B range, (because the C range is so small) and will likely leak.

1. Verify the customer concern (and that DTC P0456 is stored in the PCM memory).
2. Perform the workshop manual diagnosis procedures for DTC P0456.
  - If a leak is detected, repair it according to the instructions on MS3 online or the Workshop Manual.
  - If no leak is detected, the most probable cause is the fuel cap was not completely sealed (B).

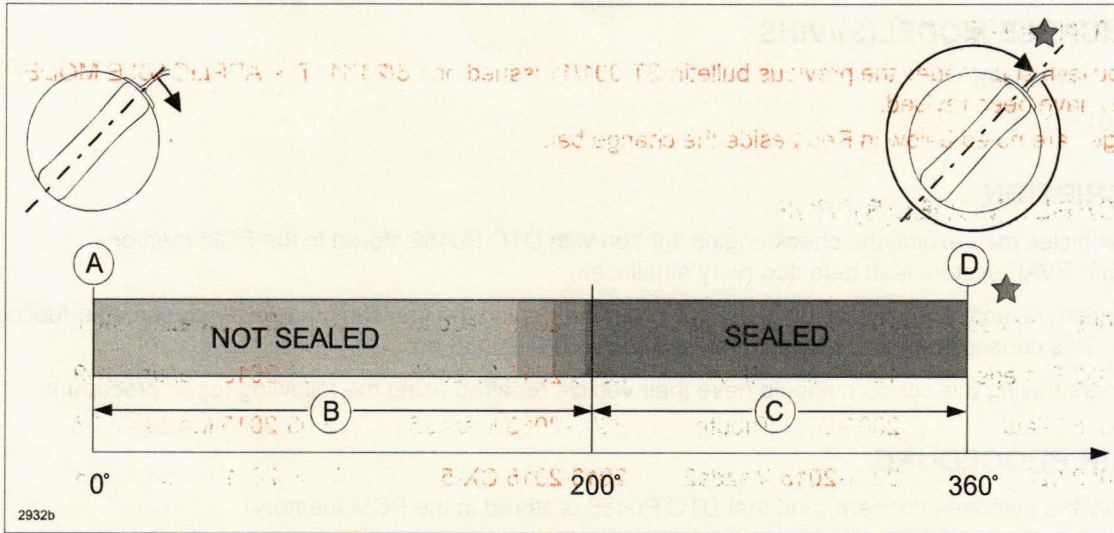
**2014-15 MAZDA3, 2013-15 CX-5, 2014-15 MAZDA6:**

- If the fuel cap is turned less than 200 degrees (B), it is not sealed.
- If the fuel cap is turned between 200 ~ 360 degrees (C), it is sealed.
- If the fuel cap is turned 360 degrees or more, it is sealed and a clicking noise (D) is also heard.

**NOTE:** The fuel cap may stay within the (C) range, since it is a large range. A leak is unlikely to occur, even if the fuel cap was not closed completely (until clicking sound is heard (D)).
