NUMBER: 02-002-13 GROUP: Front Suspension DATE: April 04, 2013

Cold Weather Noise From Front End Over Bumps

2012-2013 (FF) Fiat 500

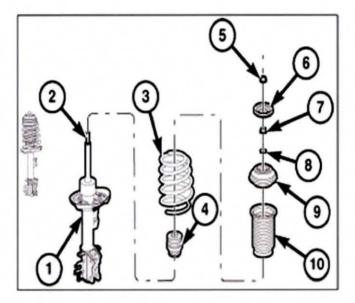
Fig. 1 Strut Disassembly

The customer may experience a noise from the front of the vehicle while going over bumps which may be more noticeable in colder temperatures.

- Remove and disassemble the left and right front strut assemblies. Refer to the detailed removal procedures available in DealerConnect>TechCONNECT> under: Service Info> 02 - Front Suspension> Front> STRUT, Suspension, Assembly> Removal/Disassembly.
- 2. Replace both left and right front jounce bumpers (4) (Fig. 1).
