Service Bulletin

Bulletin No.: 08-08-44-015C

Subject: Information on Inappropriate Warranty Claims Submitted for Damaged Radios and Instrument Panel Clusters (IPCs)

Models: 2013 and Prior GM Passenger Cars and Light Duty Trucks

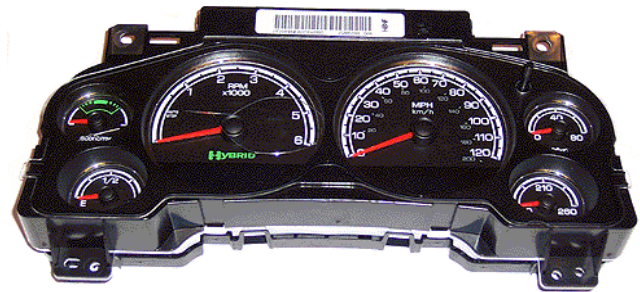
2127807

- The illustration above shows an IPC with a cracked lens.

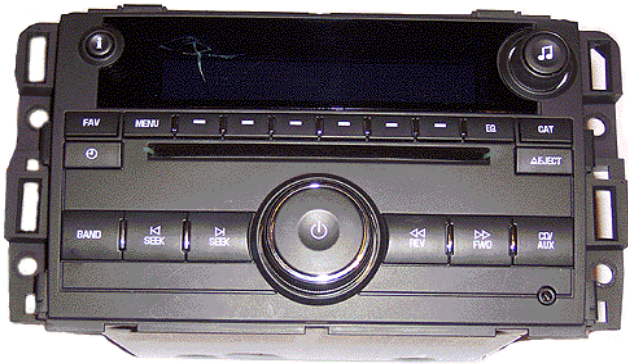
2127814

- The illustration above shows a radio with a cracked display window.

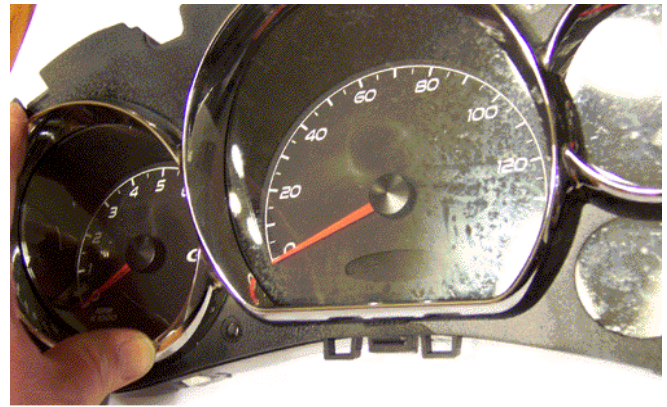
2127838

- The illustration above shows an IPC with chemical damage to the lens.

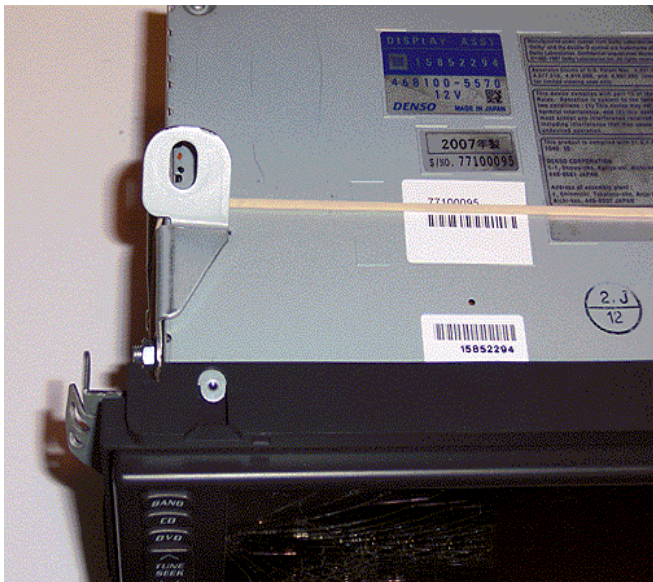
2127829

- The illustration above shows a radio with damaged mounting tabs.

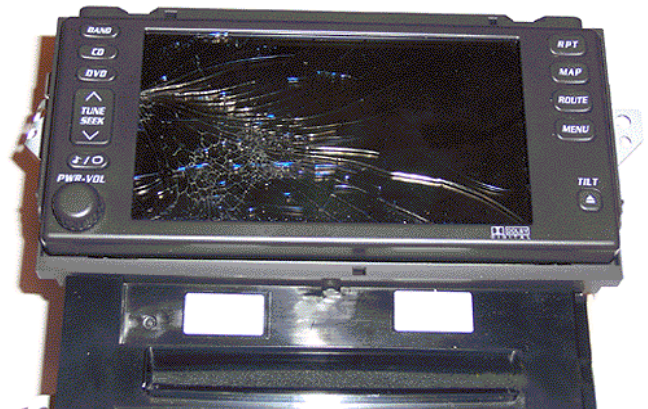
2127860

- The illustration above shows a navigation radio with a cracked display window.
