NUMBER: 08-066-14

Flash: RE9 Radio Enhancements

This bulletin involves updating the radio and navigation software, if required.

2013-2014 (JC) Journey (China only)

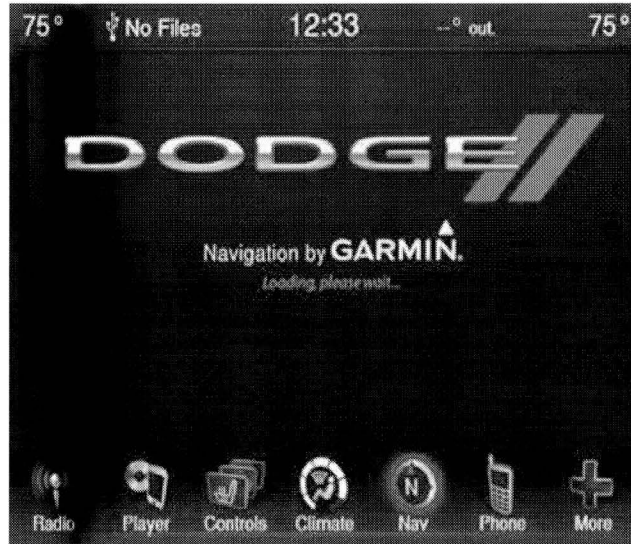
Fig. 1 System Loading Screen

1. Start the vehicle, turn the radio ON and allow it to power up.
2. Press the navigation screen button and attempt to access the navigation main menu screen.
3. Is the radio stuck on the "Loading Please Wait" screen? See (Fig. 1)
 - a. Yes <<< The radio will have to be replaced. Replace the radio using current electronic exchange center stock following normal warranty repair procedures. Refer to published service information in Tech Connect Section 08 - Electrical/8E - Electronic Control Modules/MODULE, Telematics Gateway/Removal. No further action is required, the bulletin is now complete. The replacement radio will contain the latest software update. Please use LOP 18-60-02-CD to close out the RRT portion of this bulletin.
 - b. No <<< Proceed to Step #4 and perform the software update.

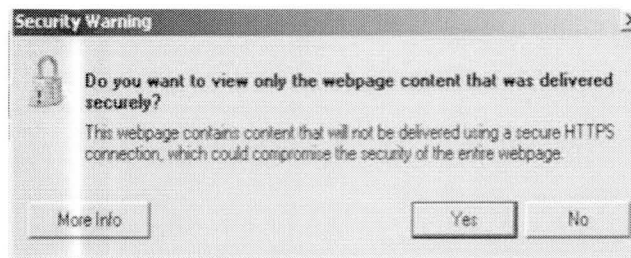
Fig. 2 Pop-up Security Message

4. Has a USB stick been created with the current software update?
 - a. Yes >>> Proceed to Step #10.
 - b. No >>> Proceed to Step #5.
5. Using Wi-tech, navigate to the Radio ECU details and record the ECU part number.
6. Go to DealerCONNECT>Service>UCONNECT Information & Utilities> Uconnect Dealer software downloads to download the files.
7. If a security message appears "Do you want to view only the webpage content that was delivered securely?" See (Fig. 2). Press **No** to continue.

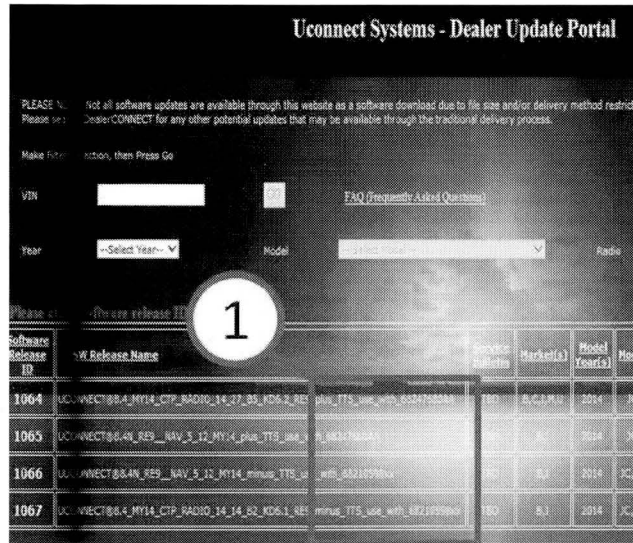
Fig. 3 Uconnect Main Portal Screen

- 8. If multiple files are available for the selected VIN, use the radio ECU part number recorded in Step #5 to select the correct software packages. See (Fig. 3) and (Fig. 4) for the location of the part number information.

1 - Radio Part Number Location

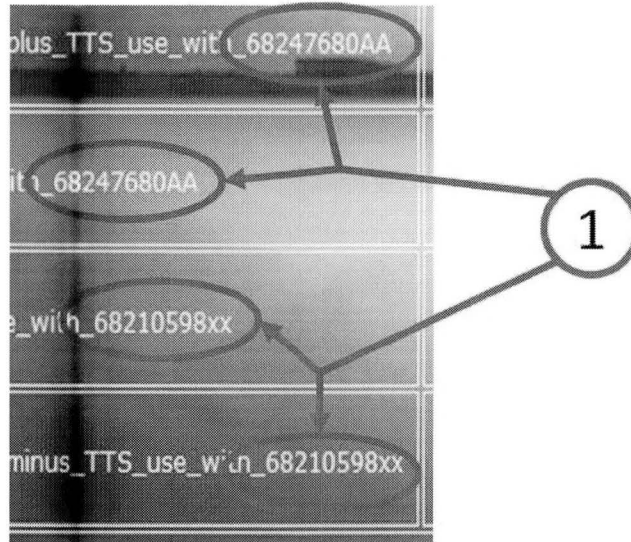
Fig. 4 Radio Software Selections

1 - Radio ECU Part Numbers

NOTE: Radio part numbers ending in XX indicate any letter combination AA through AH.

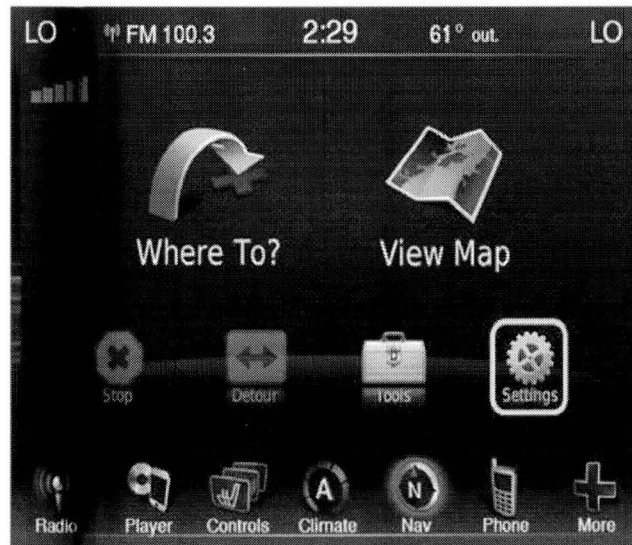
Fig. 5 Settings Icon

14. When the update is completed, the screen will read "Reflash Successful". Touch the screen and the radio will reboot.
15. The screen will now show the current and new software levels. Verify if the new and current software levels are now the same and press no on the screen.
16. Remove the USB stick from the USB port and proceed to Step #17
17. From the navigation main menu screen, press the Settings screen button. See (Fig. 5)

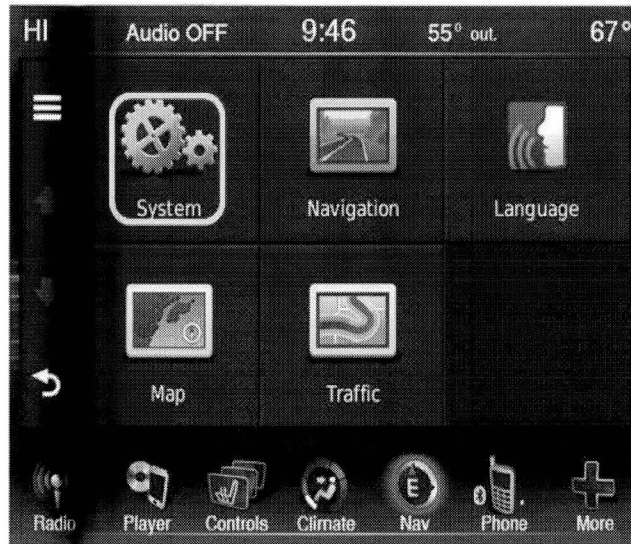
Fig. 6 System Icon

18. Press the System Icon. See (Fig. 6)

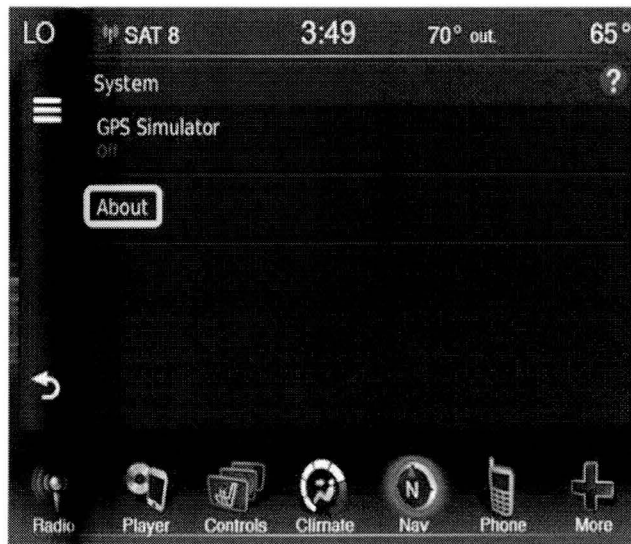
Fig. 7 About Icon

19. Press the About screen icon, see (Fig. 7), and record the software version.

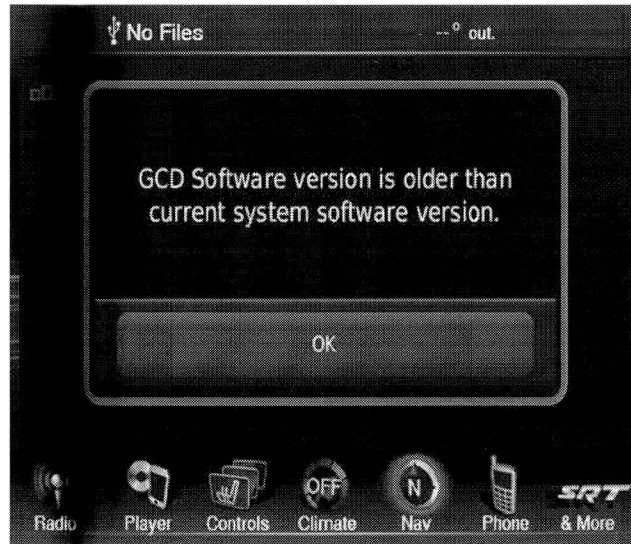
Fig. 8 Garmin Software Already Updated

24. Which screen does the radio currently display?
 - a. (Fig. 8) <<< The radio has the latest Garmin software installed. Press OK and proceed to Step #28.
 - b. (Fig. 9) <<< Press Yes to continue and proceed with the Garmin software update.
25. The first step in the update is "system recover". There will be a pop up that indicates this step along with a progress bar. This will only take a few minutes.
26. This next screen will be displayed when the update is being down loaded, see (Fig. 10)

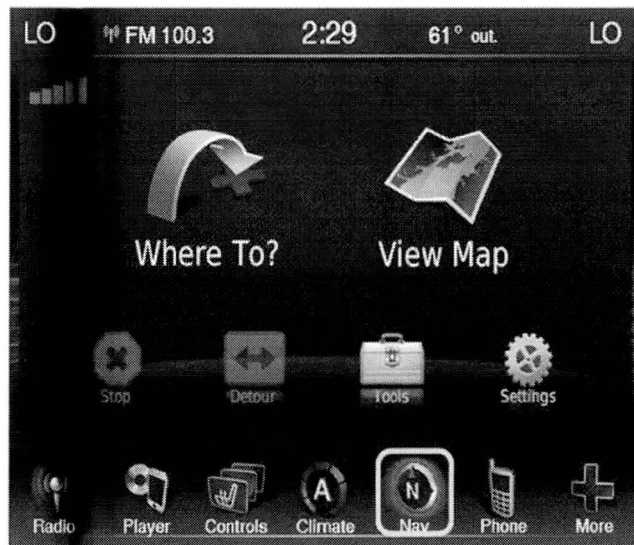
Fig. 11 Update Complete

27. When the software has completed down loading, the screen will change to the Garmin main screen, see (Fig. 11)
