NUMBER: 08-070-13 REV. B

GROUP: Electrical

RHR RHW Or RHP Radio Navigation Map Enhancements

This bulletin involves updating the RHR,RHP or RHW radios navigation map database software.

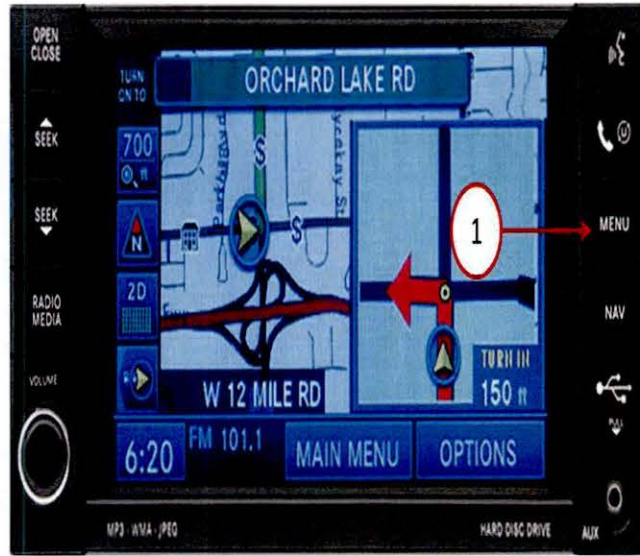
Fig. 1 Radio Face Plate

1 - MENU Key

1. Start the vehicle.
2. Turn the Radio on.
3. Press the MENU key (Fig. 1).

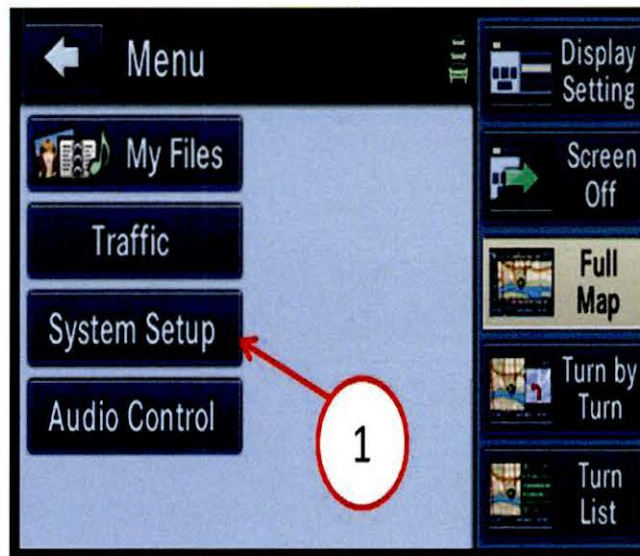
Fig. 2 Radio Face Plate

1 - System Setup

4. Press System Setup (Fig. 2).

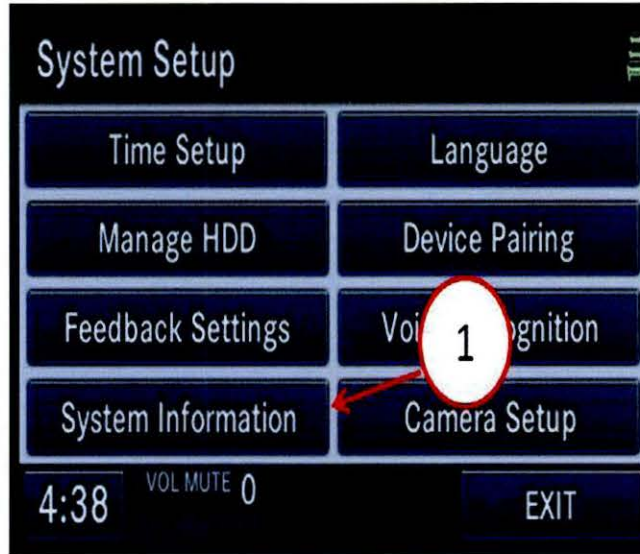
Fig. 3 Radio Face Plate

1 - System Information

5. Press System Information (Fig. 3).

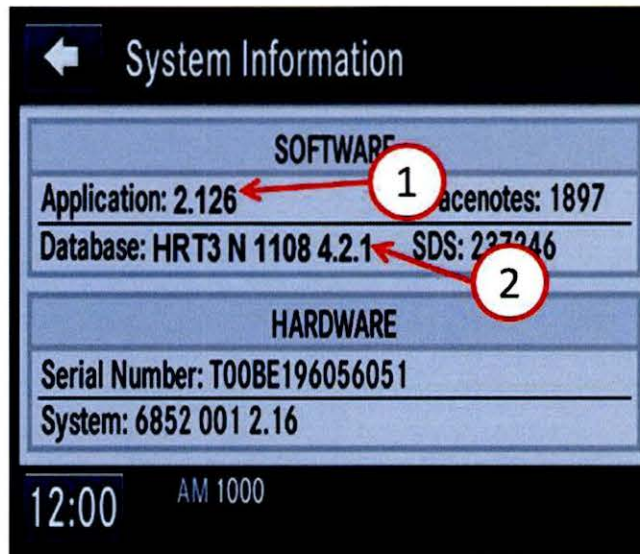
Fig. 4 Software Versions

1 - Application Version

2 - Database Software Version

-
6. Is the application software level at 2.184? (Fig. 4).
a. No >>> Perform service bulletin 08-066-13 first, before proceeding with this bulletin.
b. Yes >>> proceed to [Step #7](#).

7. Is the database software level at 4.3.1 or higher? (Fig. 4).
 - a. Yes >>> This service bulletin doesn't pertain, normal diagnostic should be performed.
 - b. No >>> Proceed to [Step #8](#).
8. An activation key is required and must be obtained by going to <http://www.navteq.com/freshmaps/chryslerdealers>. You must have the vehicle VIN before you can obtain a functional activation key.

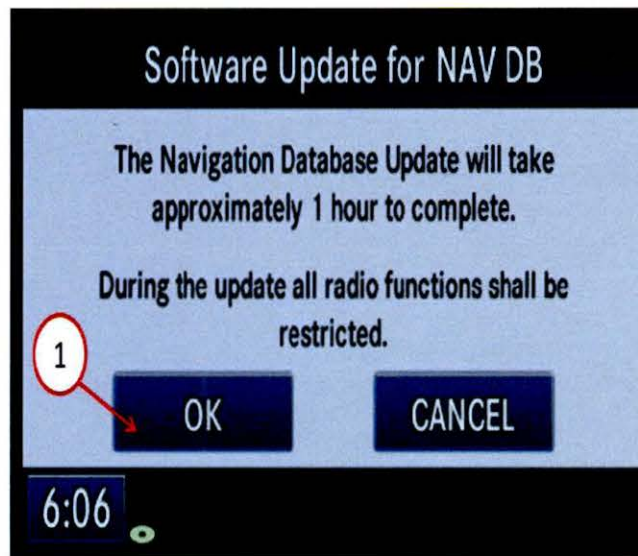
Fig. 5 Radio Face Plate

1 - Press OK

9. Insert the navigation map update disc into the radio by pressing OPEN/CLOSE and inserting the update disc.
10. The radio will read the contents of disc and will prompt the user to select "OK" or "CANCEL" as shown in the screen below. It may take approximately 2 minutes for this prompt to display (Fig. 5).

-
11. Press "OK"(Fig. 5).
 12. The next screen will display the current and new version of the navigation map database software (Fig. 6).
 13. Press YES to continue.

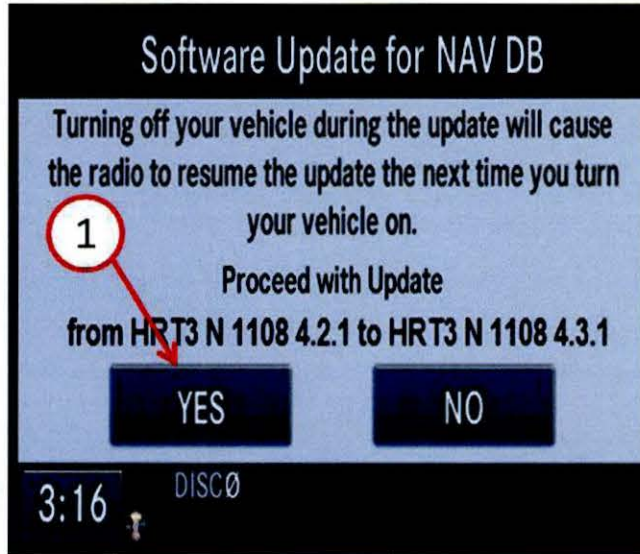
Fig. 6 Current and Update Software Level

1 - To Proceed Select "YES"

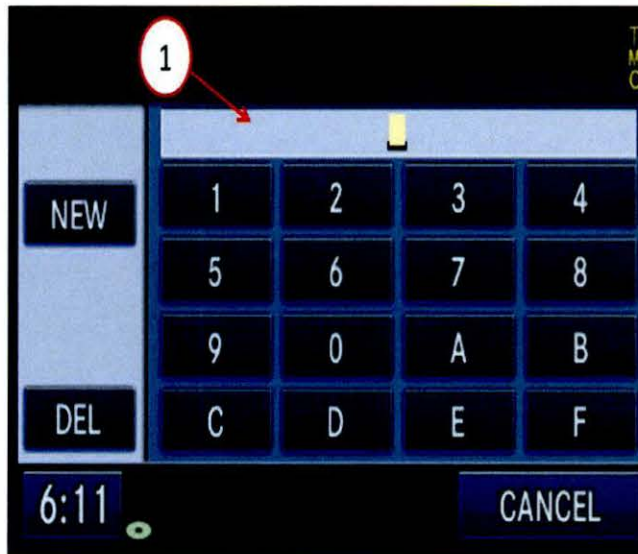
Fig. 7 Radio Face Plate

1 - Activation Key

14. When prompted by the radio enter the activation key obtained in [Step #8](#).

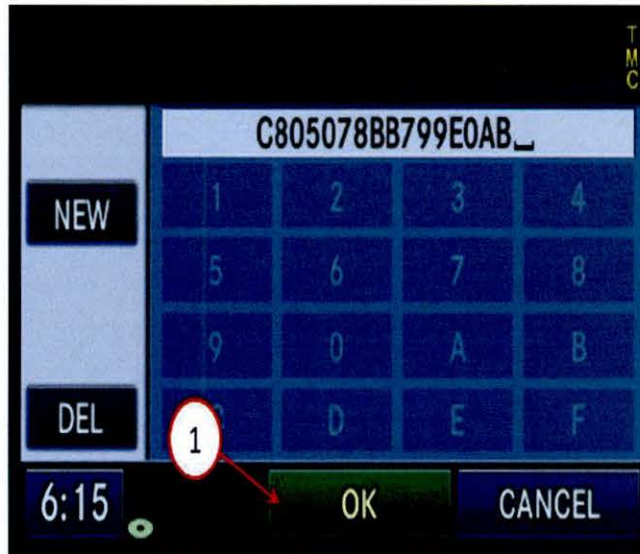
Fig. 8 Radio Face Plate

1 - Press OK

15. After successful entry of the activation key, the following screen will be displayed ([Fig. 8](#)).

- 16. Press "OK" and the update process will begin.
- 17. The following screen will be displayed (Fig. 9).

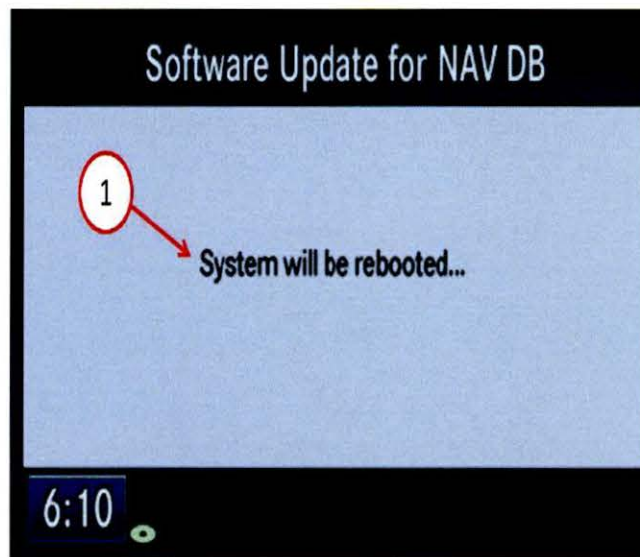
Fig. 9 Radio Face Plate

1 - System Reboot

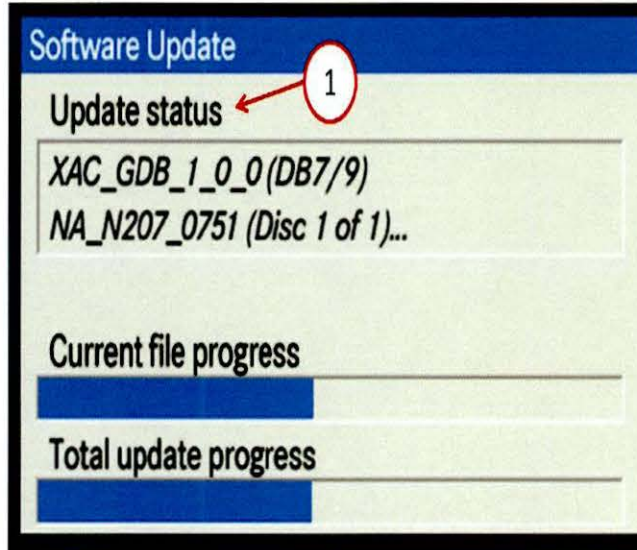
Fig. 10 Radio Face Plate

1 - Status

18. After the radio resets, the following screen will be displayed (Fig. 10)

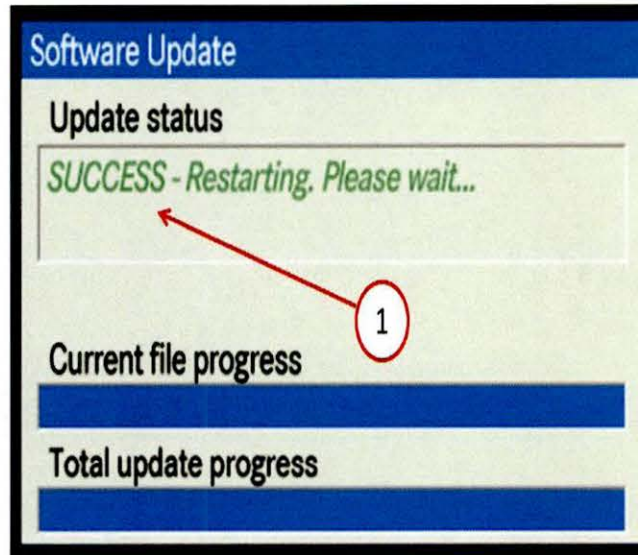
Fig. 11 Radio Face Plate

1 - Success

19. After successful update, the following screen will be displayed (Fig. 11)
