NUMBER: 08-070-13

RHR RHW Or RHP Radio Navigation Map Enhancements

This bulletin involves updating the RHR,**RHP or RHW** radios navigation map database software.

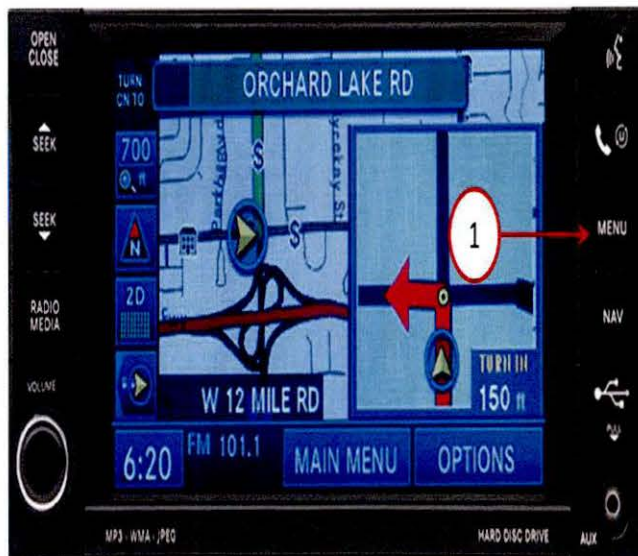
Fig. 1 Radio Face Plate

1 - MENU Key

1. Start the vehicle.
2. Turn the Radio on.
3. Press the MENU key (Fig. 1).

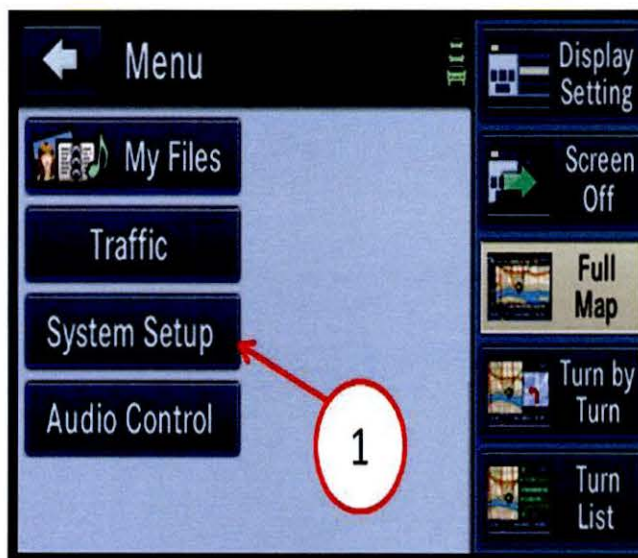
Fig. 2 Radio Face Plate

1 - System Setup

4. Press System Setup (Fig. 2).

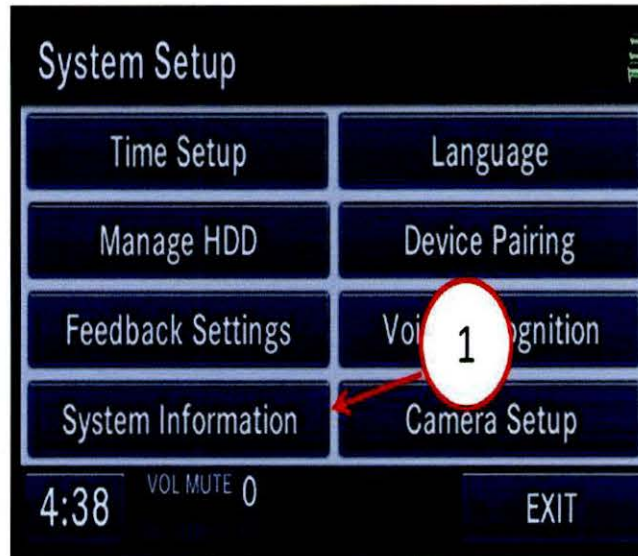
Fig. 3 Radio Face Plate

1 - System Information

5. Press System Information (Fig. 3).

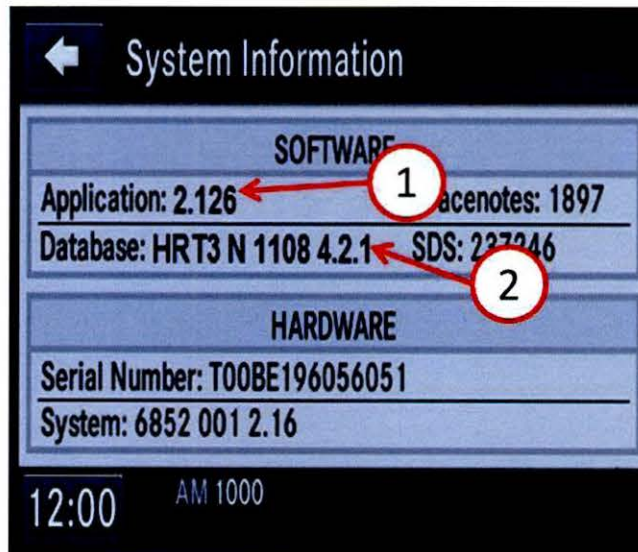
Fig. 4 Software Versions

1 - Application Version

2 - Database Software Version

-
6. Is the application software level at ****2.184****? (Fig. 4).
 a. No >>> Perform service bulletin ****08-066-13**** first, before proceeding with this bulletin.
 b. Yes >>> proceed to **Step #7**.

7. Is the Database software level at 4.3.1 or higher? (Fig. 4).
 - a. Yes >>> This service bulletin doesn't pertain, normal diagnostic should be performed.
 - b. No >>> Proceed to **Step #8**.
8. An Activation Key is required and must be obtained by going to <http://www.navteq.com/freshmaps/chryslerdealers>. You must have the vehicle VIN before you can obtain a functional activation key. If you need assistance generating an activation code please contact Navteq at 866-629-3212.

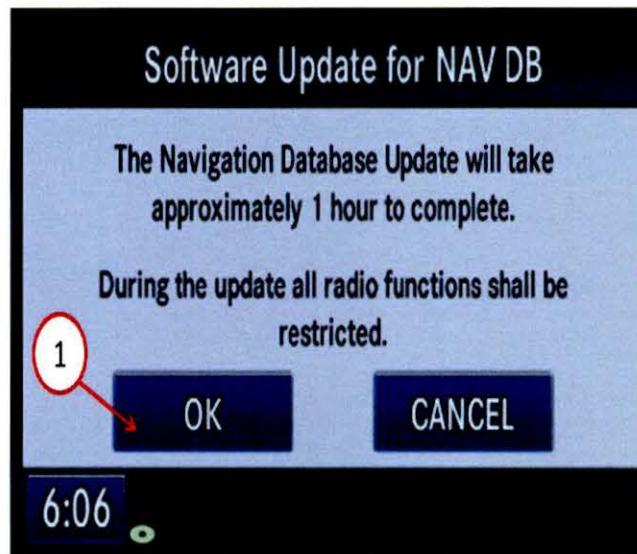
Fig. 5 Radio Face Plate

1 - Press OK

9. Insert the Navigation Map Update disc into the radio by pressing OPEN/CLOSE and inserting the update disc.
10. The radio will read the contents of disc and will prompt the user to select "OK" or "CANCEL" as shown in the screen below. It may take approximately 2 minutes for this prompt to display (Fig. 5).

- 11. Press "OK"(Fig. 5).
- 12. The next screen will display the current and new version of the Navigation Map database software (Fig. 6).
- 13. Press YES to continue.

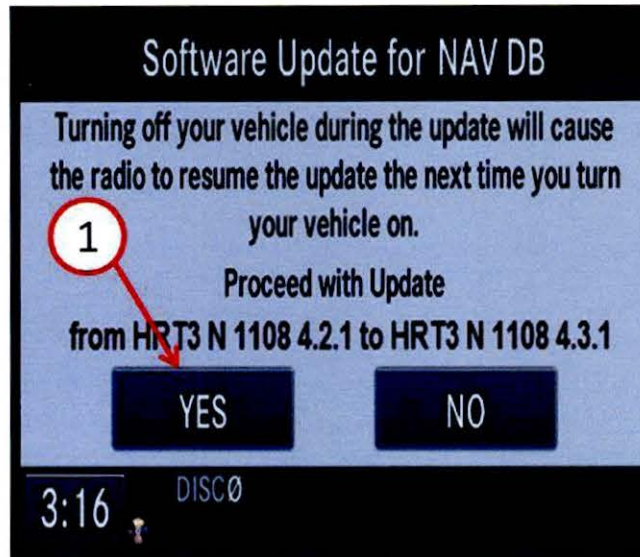
Fig. 6 Current and Update Software Level

1 - To Proceed Select "YES"

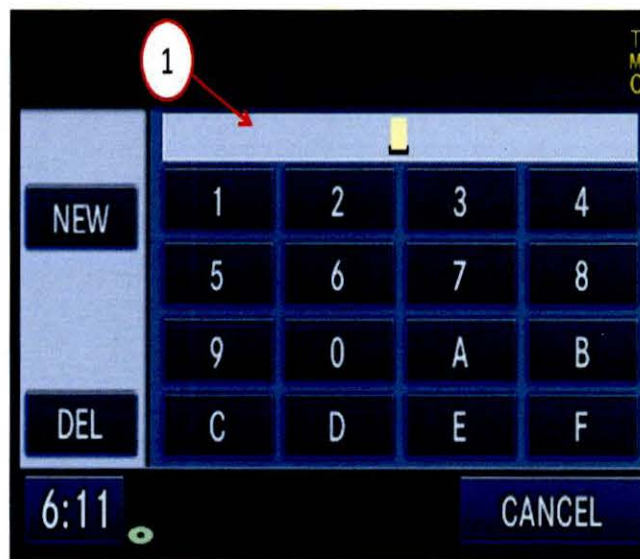
Fig. 7 Radio Face Plate

1 - Activation Key

-
- 14. When prompted by the radio enter the activation key obtained in [Step #8](#).

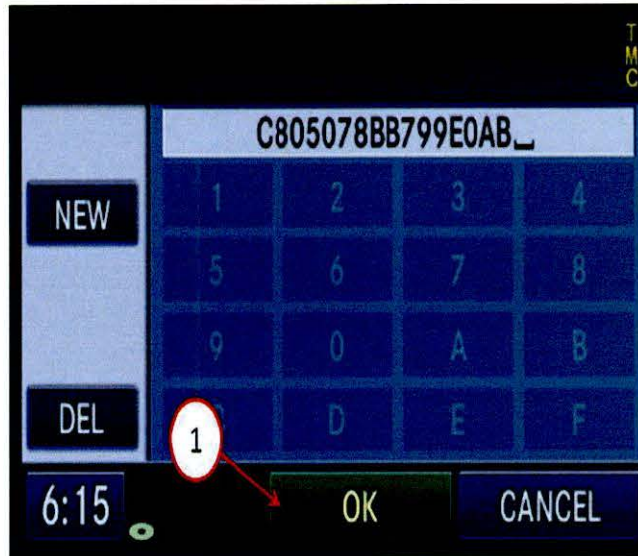
Fig. 8 Radio Face Plate

1 - Press OK

15. After successful entry of the activation key, the following screen will be displayed (Fig. 8).

16. Press "OK" and the update process will begin.
17. The following screen will be displayed (Fig. 9).

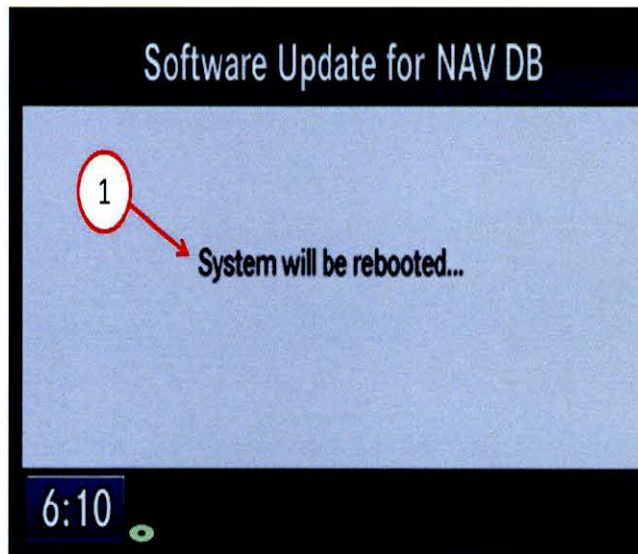
Fig. 9 Radio Face Plate

1 - System Reboot

NOTE: The update may take up to 1 hour to be completed. Once the update has been started no other action is needed from the technician. The tech can perform other duties while the navigation system is being updated.

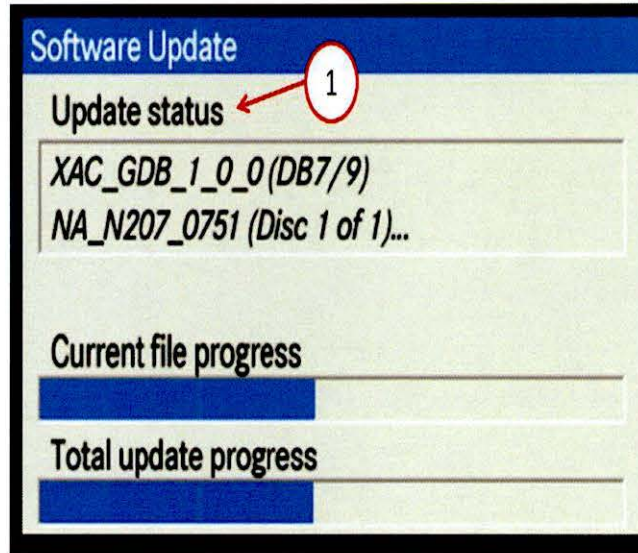
Fig. 10 Radio Face Plate

1 - Status

18. After the radio resets, the following screen will be displayed (Fig. 10)

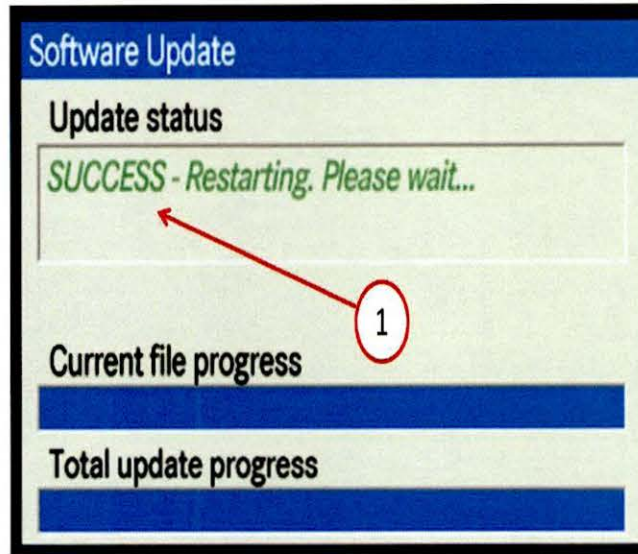
Fig. 11 Radio Face Plate

1 - Success

19. After successful update, the following screen will be displayed (Fig. 11)
