# Service Bulletin

Bulletin No.: PIT5171B

**Subject:** Service Stability Traction ABS Rear Wheel Speed DTC Or Chassis Expansion Bus Communication Fault

**Models:** 2010 - 2012 Chevrolet Equinox  
2010 - 2012 GMC Terrain  
With Any Combination of DTCs U0073 U0074 U0125 C0196 C0287 C0186 C056D C0045  
C0050 Symptom 00 06 3B 4A 4B 5A 39 42 54 71

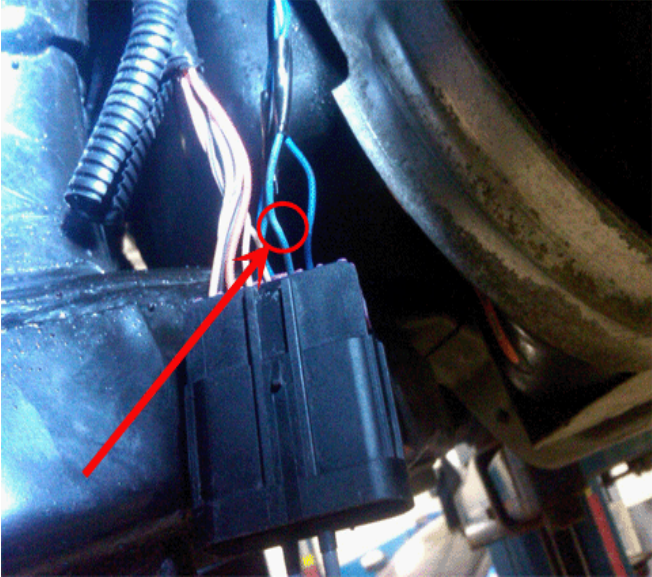
2893988

**Note:** Wire broken within the insulation has also been found high up in the harness X411. Reference the following photos:

Several conditions and symptoms have been found to be related to a wire harness at the left rear under vehicle. Inspect the wire harness insulation within 1 inch of the X411 before and after connector. It may be necessary to remove the tape and conduit from the wire harness for inspection upstream from the X411 connector. Some Issues have been found with circuits 6105 and 6106 for chassis bus wires and serial enable circuit 5986 and 120 ohm opens in 2500 and 2501 or 6106 and 6106. Other circuits 884, 885, 882, and 883 when related to rear wheel speed sensor codes C0045 or C0050. During inspection you may notice a discoloration in insulation in one spot of the wire. If you pull the wire near that area the insulation will break exposing the broken wire. Repair the circuit to complete the procedure.
