NUMBER: 17-002-13
GROUP: Rear Suspension
DATE: January 31, 2013

Squeak And/Or Creak Noise Coming From Rear Of Vehicle

2011-2013	(WK)	Grand Cherokee
2011-2013	(WD)	Durango

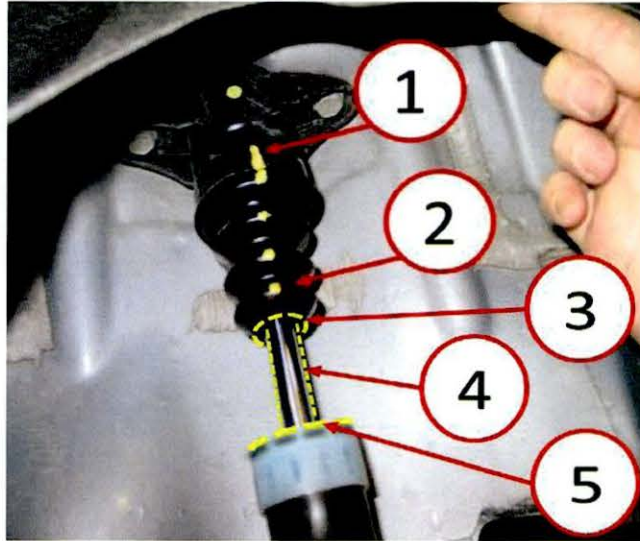
Fig. 6 Apply Nye Grease

NOTE: Ensure jounce bumper is correctly oriented into upper mount cup. Jounce bumper cut outs must line-up with upper mount cup formations. Incorrect installation will cause noise and/or harsh ride.

NOTE: Vehicles built after March 17,2011 have the jounce bumper fixed to the upper shock mount. Trying to pull the jounce bumper out of the mount can result in damage to the jounce bumper if built after this date.

12. Install the jounce bumper into the upper mount aligning the indicator marks of the upper shock mount and the jounce bumper (Fig. 6).

13. Apply Nye Grease, P/N 05019061AA to the bottom/small end face of the jounce bumper (3), shock shaft (4) and top of the shock striker cap (5) (Fig. 6).

NOTE: When applying grease to the bottom of the jounce bumper, the grease should be squeezed as best as possible up between the jounce bumper and the shock shaft. The goal is to get lubrication between the jounce bumper and shock shaft without removing the shock or pulling the jounce bumper down out of the mount.
