Program Bulletin

CUSTOMER SATISFACTION PROGRAM

SUBJECT: Transmission Dipstick Tube Fracture

MODELS: 2010-2011 Cadillac Escalade, Escalade ESV, Escalade EXT
2010-2011 Chevrolet Avalanche, Silverado, Suburban, Tahoe
2010-2011 GMC Sierra, Yukon, Yukon XL
Equipped with Active Fuel Management

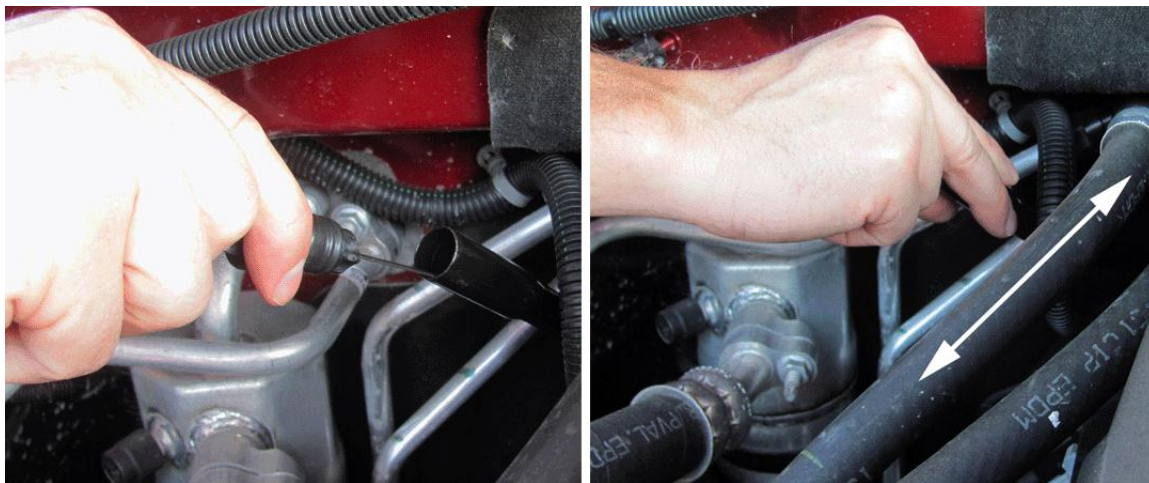
2906255

3. Grasp the transmission filler tube with your thumb and first two fingers of your right hand. Your thumb should be on the passenger side of the transmission filler tube and parallel to the filler tube.

4. Using only your thumb and the first two fingers of your right hand, force the transmission filler tube toward the driver's seating position and then back to the passenger's front wheel two times.

5. Determine if the transmission filler tube is damaged. An undamaged transmission filler tube will move less than two inches and spring back to its original position, while a damaged transmission filler tube will move greater than two inches and will not spring back to its original position. A damaged transmission filler tube will likely crack during this inspection.

- If the transmission filler tube is not damaged, proceed to Step 6.
 - If the transmission filler tube is damaged, replace the transmission filler tube. Refer to *Transmission Fluid Filler Tube and Seal Replacement* in SI.

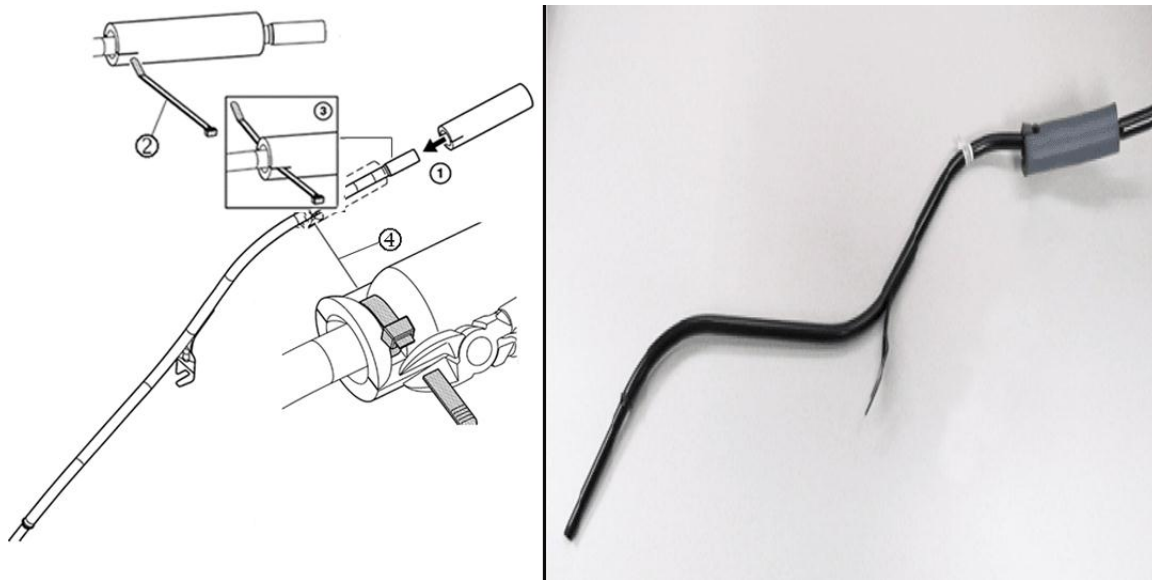
Note: The tie strap threads between the fill tube and half the foam damper using the slot in the sleeve. This is secured to the top half of the tube, leaving the lower half of the damper free.

7. Install a foam damper (sleeve) on the upper end of the transmission filler tube using a tie strap. Refer to illustration.
8. Install transmission dipstick.
9. Close hood.
