NUMBER: 18-051-13
GROUP: Vehicle Performance
DATE: October 22, 2013

Flash: MIL Illumination P2073 or P2074 MAP/TPS, or P0400 EGR System, or P2279 - Intake Air System

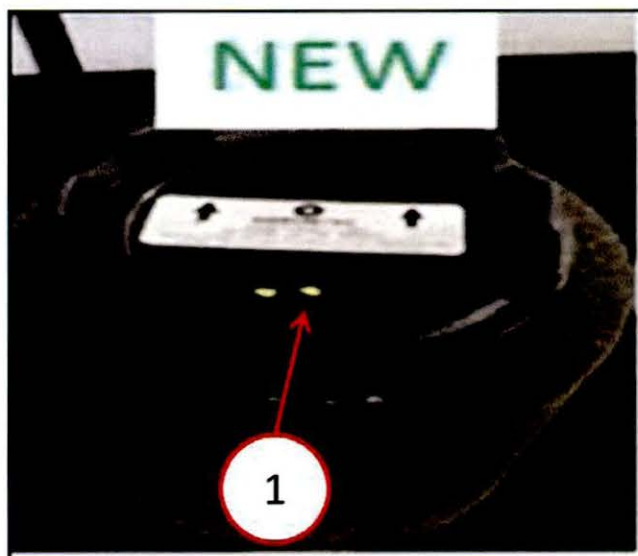
1- Two Certification Dots

1. Replace the Air Filter with the latest MOPAR Certified Filter which has two certification dots as shown below ().
