NUMBER: 23-003-13 REV. A

Left And/Or Right Rear Interior Speaker Bolster Is Raised At Quarter Panel Trim

2013 (RT) Caravan / Town and Country

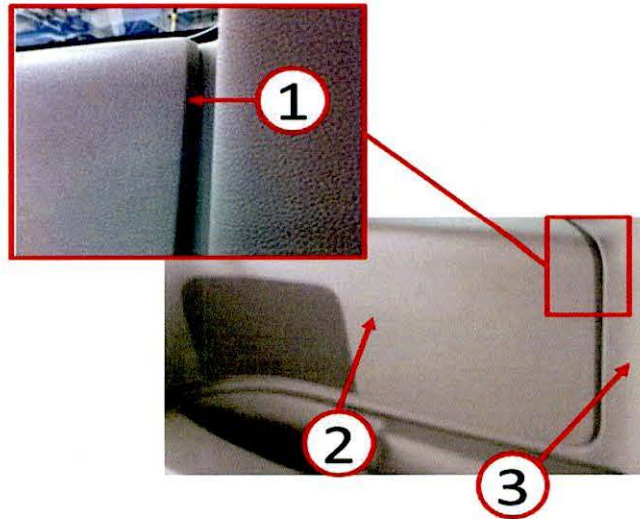
Fig. 1 Speaker Bolster Trim

1. Inspect the right and left rear speaker bolster at the area shown in (Fig. 1). Was the speaker bolster over flush and seated on the A-surface of the quarter panel trim?
 - a. Yes>>> Remove and replace the right and/or left rear speaker bolster. Refer to the detailed service procedures available in: DealerConnect> TechCONNECT under: Service Info> 23-Body> Interior> Panel, Quarter Trim, Bolster> Removal/Installation.
 - b. No>>> Proceed to [Step #2](#).

- 1 - Over flush and seated on the a-surface of the interior quarter panel trim
- 2 - Interior speaker bolster
- 3 - Interior quarter panel trim
