NUMBER: 23-005-14

Rattle, Tick, Or Squeak From The Instrument Panel Area

2012 - 2013 (RT) Caravan, Grand Voyager, Town And Country

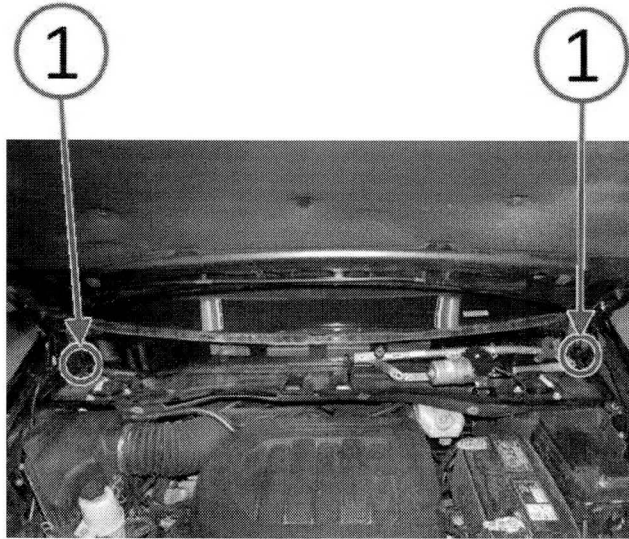
Fig. 1 Area Under The Cowl Panel Cover

1 - Lower Plenum Rear Corners

1. Verify the customer concern by driving the vehicle over a variety of road surfaces. If a rattle, tick, or squeak noise is heard and nothing can be touched inside the vehicle to eliminate the noise, continue with the repair procedure.
2. Remove the cowl panel cover to access the outboard end rear corners (1) of the lower plenum (Fig. 1). Refer to the detailed procedure in DealerCONNECT> TechCONNECT> Service> 23 - Body> Exterior> COVER, Cowl Panel> Removal.

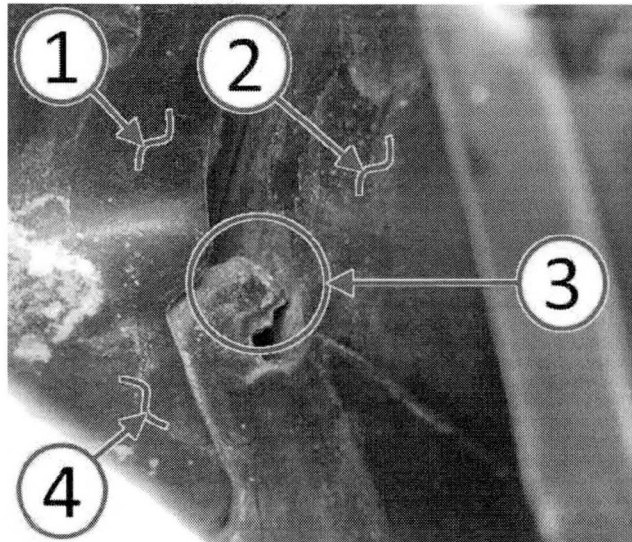
Fig. 2 Close Up Of Contact Area Under The Cowl Panel Cover

A sheet metal contact or touch condition under the cowl panel cover in either right or left corner of the plenum below the hood hinge may cause the rattle, tick, or squeak noise.

-
3. With a flashlight, look for a touch condition (metal to metal contact) of a sheet metal tab (3) contacting the body inner panel (2) at the outboard ends (rear corners) of the plenum (1, 4). The contact area will be under the hood hinge on the side of the vehicle where the noise was most noticeable (Fig. 2).

- 1 - Upper Plenum
- 2 - Body Inner Panel
- 3 - Metal Tab - Area Of Concern
- 4 - Lower Plenum
