NUMBER: 23-012-12 REV. A

GROUP: Body

DATE: October 04, 2012

Sliding Door Trim Contacting Vehicle Rear Quarter

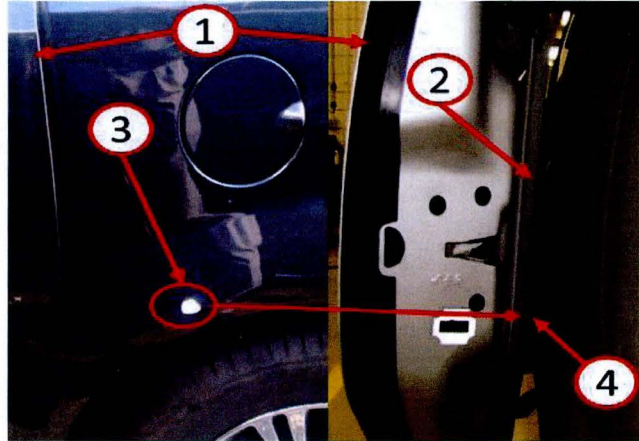
Fig. 1 Door Trim Contact

In some instances interior door panel to quarter panel contact has been noted on both left and right sides of the vehicle. Design clearances of the interior door panel are aggravated by heat which causes the door panel to relax and bow, which may contact the rear quarter panel (Fig. 1). In order to correct this condition and avoid costly paint repairs an additional retention point needs to be added to prevent the door panel bowing condition. If the customer describes the symptom, perform the Repair Procedure.

- 1 - Sliding Door
 - 2 - Interior Door Trim Panel
 - 3 - Quarter Panel Contact Point
 - 4 - Panel Clearance Area
-

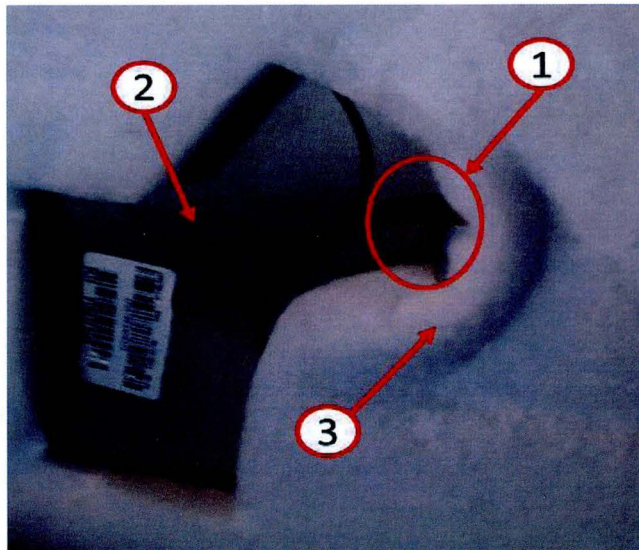
Fig. 2 Standoff Removal

- 1 - Standoff
 - 2 - Back Side of Door Panel
 - 3 - Sound Deadener
-

1. Remove both door trim panels. Refer to the detailed procedures available in DealerConnect>TechCONNECT> under: Service Info> 23-Body> Doors - Sliding> PANEL, Door Trim> Removal.
2. Remove the standoff from the back side of each door panel (Fig. 2).

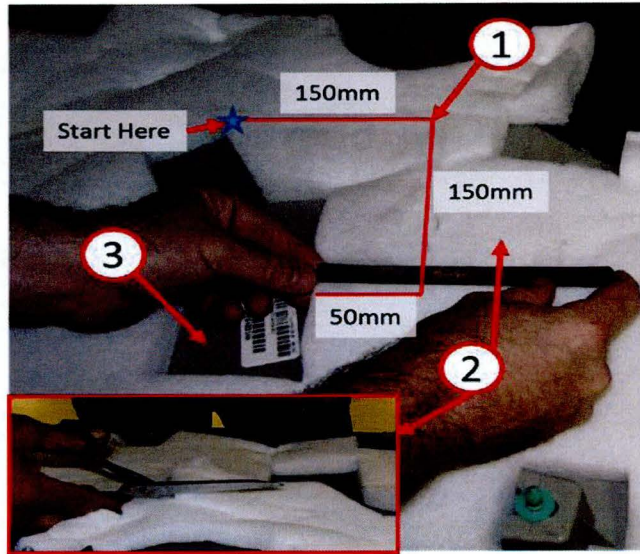
Fig. 3 Trim Sound Deadener

- 1 - Cut Line
 - 2 - Sound Deadener
 - 3 - Back Side of Door Panel
-

3. Cut the sound deadener on the back side of each door panel as shown in (Fig. 3).

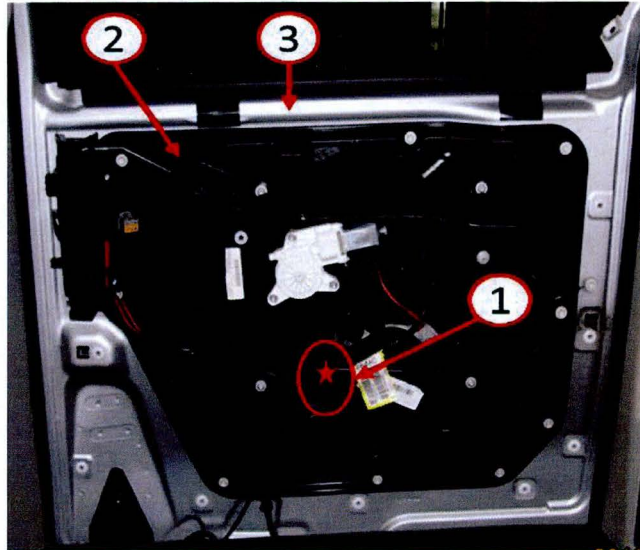
Fig. 4 Door Module Preparation

- 1 - Drill Location
 - 2 - Door Module
 - 3 - Sliding Door
-

- Carefully drill a 5/16"(8mm) hole through door module at the center of the formation/standoff (1) directly above the door module (if equipped) or just forward of the part number tag (Fig. 4).

NOTE: Make sure door window is in the full upward position before drilling hole in door module.

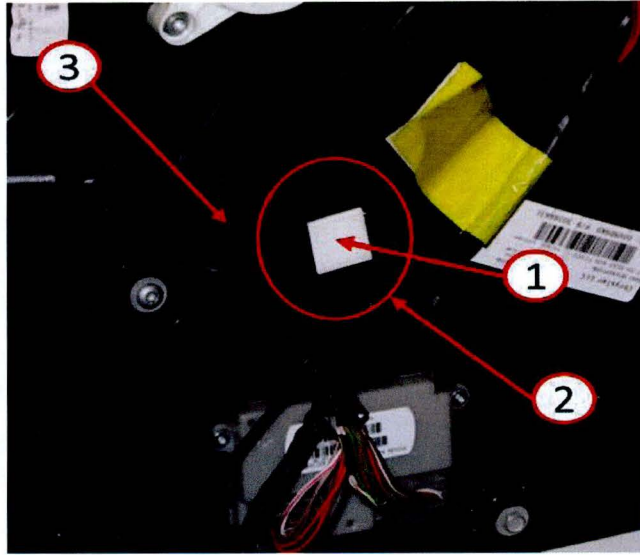
Fig. 5 Door Module Retainer Installation

- 1 - Dual Lock Push Clip
 - 2 - Drilled Hole Location
 - 3 - Door Module
-

5. Fully seat the white dual lock push clips (1) from repair kit into the 5/16" (8mm) hole in the door modules (Fig. 5).

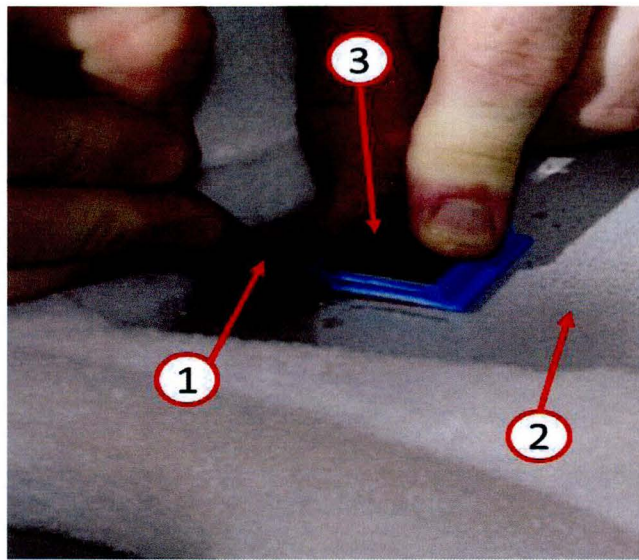
Fig. 6 Door Panel Preparation

- 1 - Scribe
 - 2 - Back Side of Door panel
 - 3 - Dual Lock Retaining Clip
-

6. Temporarily engage the dual lock halves in order to transfer the clip location from the module to the door panel using Kent Leak Trace Powder or equivalent and scribe the clip location on the back side of the door panel as shown in (Fig. 6).

NOTE: Door trim panel(s) will need to be rough set and pressurized to transfer the contact location. Leak trace powder should be applied to the approximate clip location on the back side of the door trim panel.

NOTE: Do not engage dual lock halves and remove peel-off backing to locate the door trim panel side of the clip as this could result in an improperly placed clip while reinstalling the door panel. Improperly placing the clip can possibly destroy it if removal or repositioning is required. Do not use grease to transfer clip location as this will leach into the plastic surface of the trim panel and affect clip adhesive retention.

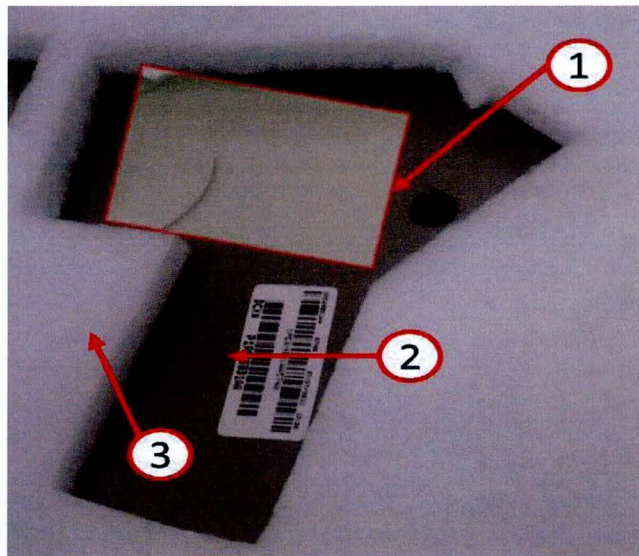
Fig. 7 Door Panel Preparation

- 1 - Clip Bonding Area
 - 2 - Back Side of Door Panel
 - 3 - Sound Deadener
-

7. Clean the surface area (1) of both door trim panels to be bonded with isopropyl alcohol (Fig. 7).
8. Once the alcohol has evaporated apply 3M 4298 adhesion promoter or equivalent to the surface area (1) where the dual lock adhesive backer will bond (Fig. 7).

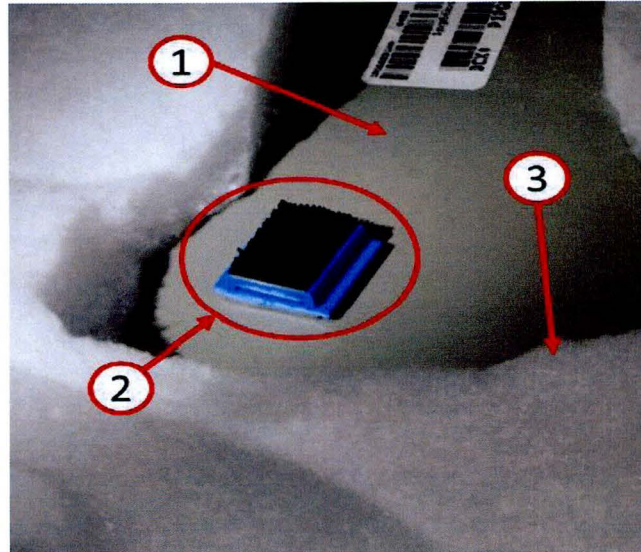
Fig. 8 Door Panel Retainer Installation

- 1 - Back Side of Door Panel
- 2 - Dual Lock Clip
- 3 - Sound Deadener

9. Firmly pressurize the blue dual lock clip at scribed location for 5 seconds after removing the protective backing off the adhesive side of the clip.

NOTE: Let the blue dual lock clip cure for 1 hour before reinstalling the door trim panels.

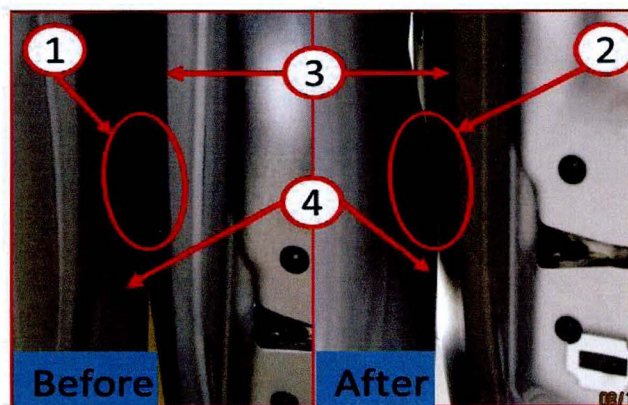
Fig. 9 Improved Panel Clearance

- 1 - Contact Point
- 2 - Panel Clearance
- 3 - Door Trim Panel
- 4 - Quarter Panel

12. Validate door trim panel clearance to rear quarter panel (Min Gap is 3/16" / 6mm) (Fig. 9).

NOTE: Gap can be checked by applying modeling clay to the suspect area of the quarter panel.
