NUMBER: 23-014-14

Sliding Door Trim Contacting Vehicle Rear Quarter

- 2008 - ****2014**** (RT) Dodge Caravan
- 2008 - ****2014**** (RT) Chrysler Town and Country

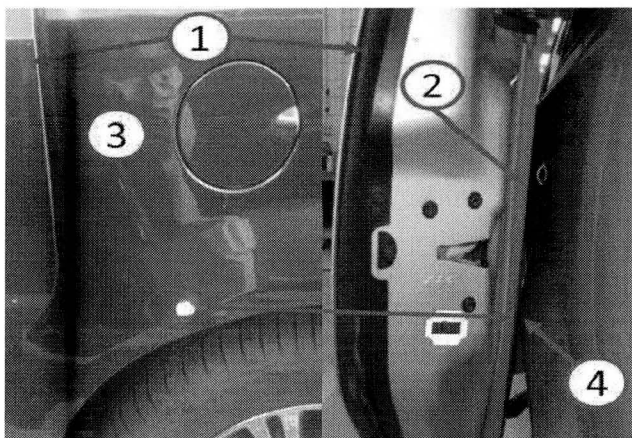
Fig. 1 Door Trim Contact

In some instances interior door panel to quarter panel contact has been noted on both left and right sides of the vehicle. Design clearances of the interior door panel are aggravated by heat which causes the door panel to relax and bow, which may contact the rear quarter panel (Fig. 1).

- 1 - Sliding Door
 - 2 - Interior Door Trim Panel
 - 3 - Quarter Panel Contact Point
 - 4 - Panel Clearance Area
-

In order to correct this condition and avoid costly paint repairs, depending on production date, an additional retention point needs to be either added or engaged to prevent the door panel bowing condition. If the customer describes the symptom, perform the Repair Procedure.

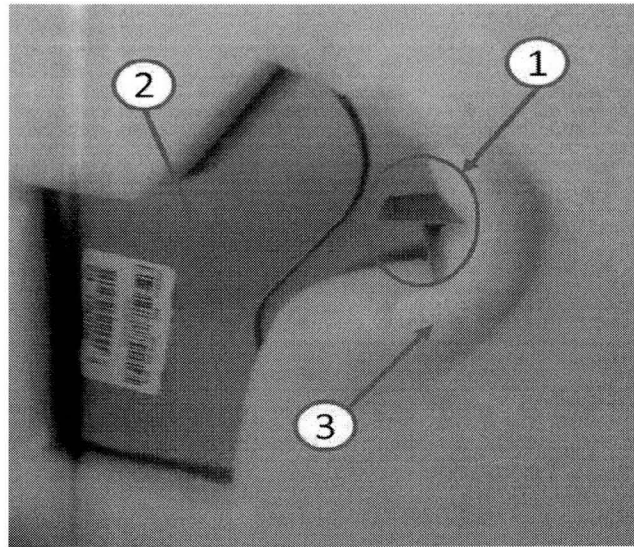
Fig. 2 Standoff Removal

- 1 - Standoff
 - 2 - Back Side of Door Panel
 - 3 - Sound Deadener
-

1. ****Was the vehicle built on or before February 11, 2012 (MDH 0211XX)?**
 - a. YES>>> Vehicle was built on or before February 11, 2012. Continue with Step #2.
 - b. NO>>> Vehicle was built on or after February 12, 2012 and on or before May 14, 2014. Proceed to Step #12.**
2. Remove both door trim panels. Refer to the detailed procedures available in DealerConnect>TechCONNECT> under: Service Info> 23-Body> Doors - Sliding> PANEL, Door Trim> Removal.
3. Remove the standoff from the back side of each door panel (Fig. 2).

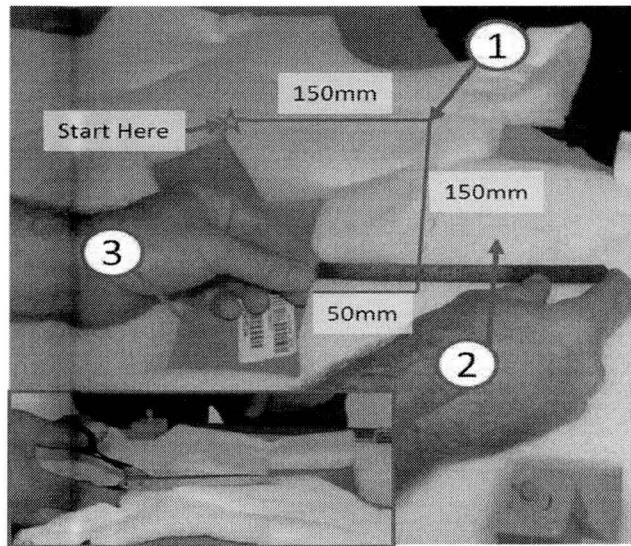
Fig. 3 Trim Sound Deadener

- 1 - Cut Line
 - 2 - Sound Deadener
 - 3 - Back Side of Door Panel
-

4. Cut the sound deadener on the back side of each door panel as shown in (Fig. 3).

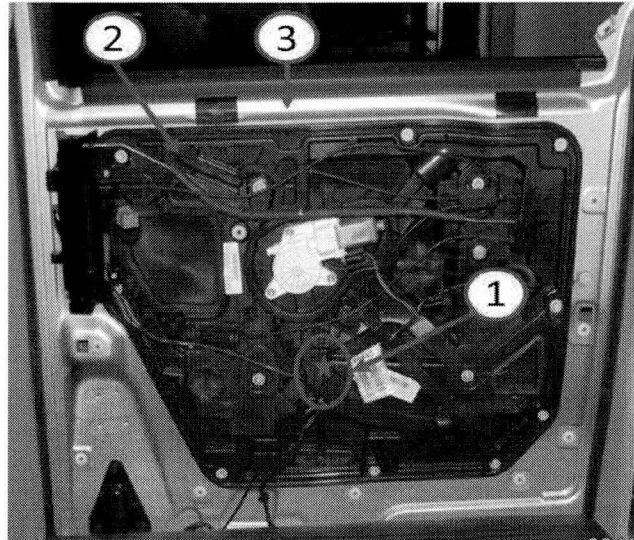
Fig. 4 Door Module Preparation

- 1 - Drill Location
 - 2 - Door Module
 - 3 - Sliding Door
-

- Carefully drill a 5/16" (8mm) hole through door module at the center of the formation/standoff (1) directly above the door module (if equipped) or just forward of the part number tag (Fig. 4).

NOTE: Make sure door window is in the full upward position before drilling hole in door module.

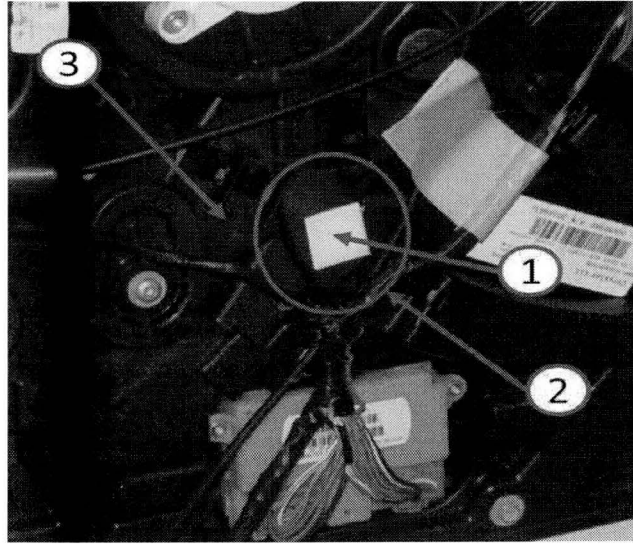
Fig. 5 Door Module Retainer Installation

- 1 - Dual Lock Push Clip
 - 2 - Drilled Hole Location
 - 3 - Door Module
-

6. Fully seat the white dual lock push clips (1) from repair kit into the 5/16" (8mm) hole in the door modules (Fig. 5).

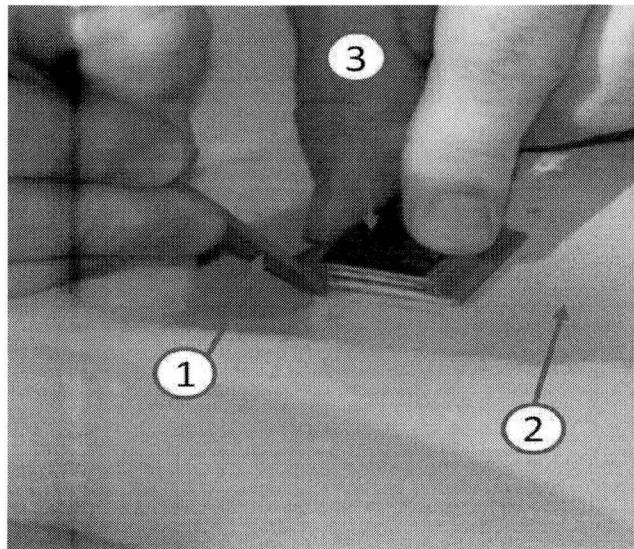
Fig. 6 Door Panel Preparation

- 1 - Scribe
 - 2 - Back Side of Door panel
 - 3 - Dual Lock Retaining Clip
-

7. Temporarily engage the dual lock halves in order to transfer the clip location from the module to the door panel using Kent Leak Trace Powder or equivalent and scribe the clip location on the back side of the door panel as shown in (Fig. 6).

NOTE: Door trim panel(s) will need to be rough set and pressurized to transfer the contact location. Leak trace powder should be applied to the approximate clip location on the back side of the door trim panel.

NOTE: Do not engage dual lock halves and remove peel-off backing to locate the door trim panel side of the clip as this could result in an improperly placed clip while reinstalling the door panel. Improperly placing the clip can possibly destroy it if removal or repositioning is required. Do not use grease to transfer clip location as this will leach into the plastic surface of the trim panel and affect clip adhesive retention.

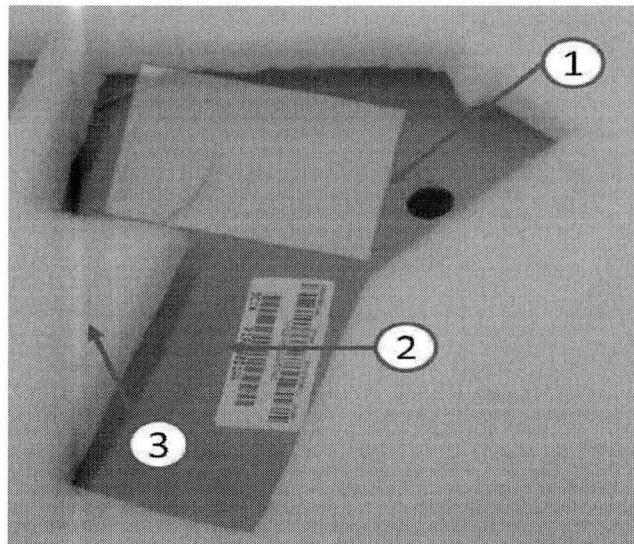
Fig. 7 Door Panel Preparation

- 1 - Clip Bonding Area
 - 2 - Back Side of Door Panel
 - 3 - Sound Deadener
-

8. Clean the surface area (1) of both door trim panels to be bonded with isopropyl alcohol (Fig. 7).
9. Once the alcohol has evaporated apply 3M 4298 adhesion promoter or equivalent to the surface area (1) where the dual lock adhesive backer will bond (Fig. 7).

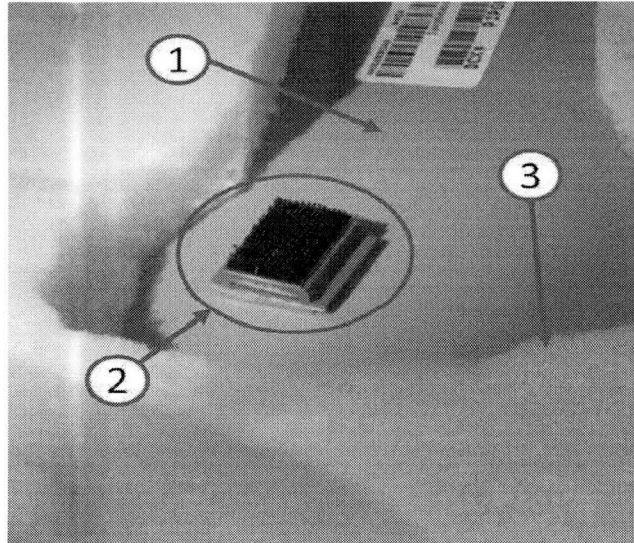
Fig. 8 Door Panel Retainer Installation

- 1 - Back Side of Door Panel
- 2 - Dual Lock Clip
- 3 - Sound Deadener

10. Firmly pressurize the blue dual lock clip at scribed location for 5 seconds after removing the protective backing off the adhesive side of the clip.

NOTE: Let the blue dual lock clip cure for 1 hour before reinstalling the door trim panels.

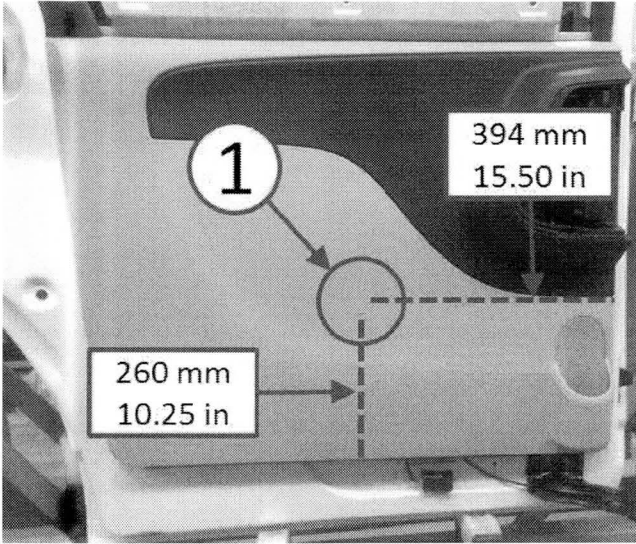
Fig. 9 Dual Lock Engagement Location

1 - Attachment Location

-
11. Reinstall both door trim panels. Refer to the detailed procedures available in DealerConnect>TechCONNECT> under: Service Info> 23-Body> Doors - Sliding> PANEL, Door Trim> Installation.
 12. ****Seat the door trim panel by pressing with firm pressure at the attachment location (1) a specified distance from bottom and leading edge of the door trim panel (Fig. 9).****

NOTE: An audible “click” should be heard when pressing the door trim panel in place.

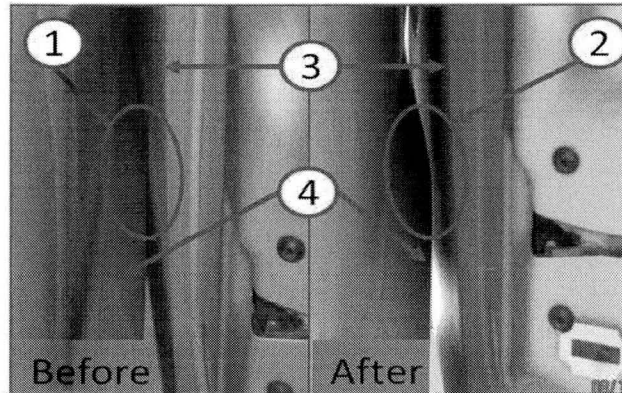
Fig. 10 Improved Panel Clearance

- 1 - Contact Point
- 2 - Panel Clearance
- 3 - Door Trim Panel
- 4 - Quarter Panel

13. Validate door trim panel clearance to rear quarter panel (Minimum Gap is 3/16 in / 6 mm) (Fig. 10).

NOTE: Gap can be checked by applying modeling clay to the suspect area of the quarter panel.

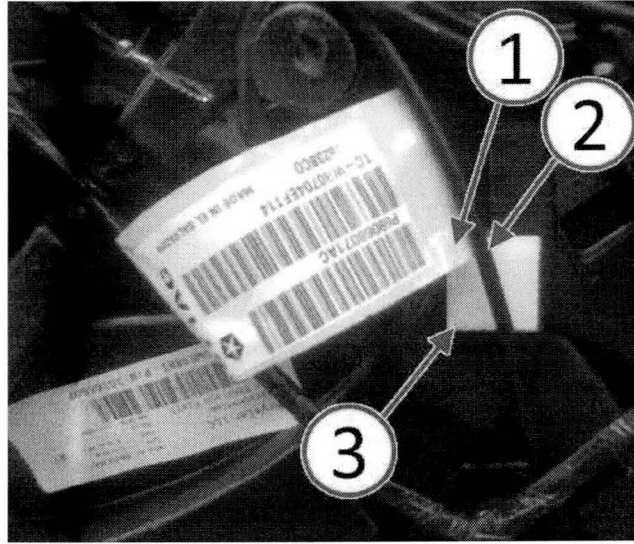
Fig. 11 Dual Lock Interference Conditions

- 1 - Label
- 2 - Cable
- 3 - Dual Lock

- a. YES>>> Repair is complete. Return the vehicle to the customer.
- b. NO>>> Remove one or both door trim panels that did not meet the clearance specification. Refer to the detailed procedures available in DealerConnect>TechCONNECT> under: Service Info> 23 - Body> Doors - Sliding> PANEL, Door Trim> Removal. Then inspect for any interference between the dual lock attachment point (3). Reposition and tape out of the way any cables (2) or labels (1) that may be interfering as shown in (Fig. 11). Then repeat Step #11 through Step #13.**
