<b>Topic</b>	Battery monitor control unit – software update (SC13/21)
<b>Market area</b>	Worldwide Bentley (1WBE)
<b>Brand</b>	Bentley
<b>Transaction No.</b>	2035952/4
<b>Campaign number</b>	E798
<b>Note</b>	
<b>Type</b>	Workshop Campaign
<b>US code</b>

Workshop Campaign E798

Transaction No.: 2035952/4

Battery monitor control unit – software update (SC13/21)

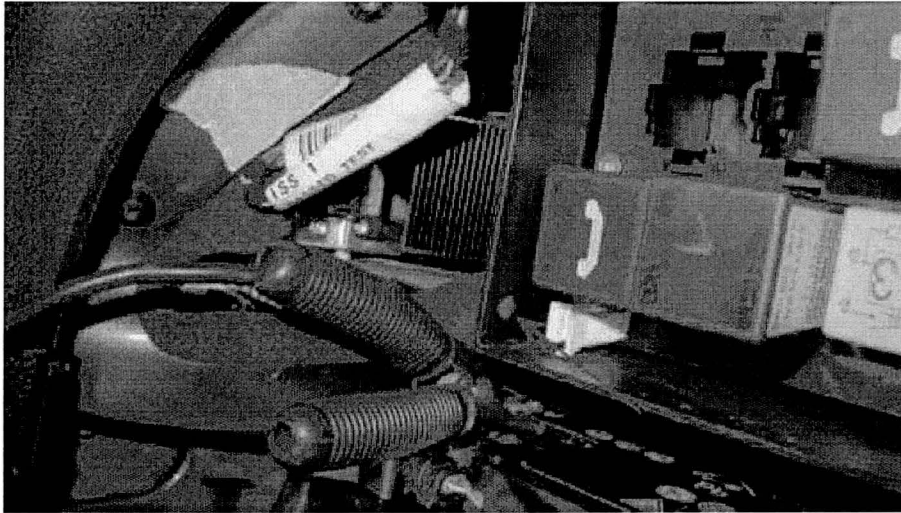
Figure 11

If the vehicle is not already listed as repaired in the 'Repair History' (ElsaPro), check the vehicle for the campaign identification mark, (see Figure 11), if this is not visible carry out the required work in accordance with these instructions

On completion apply a blue campaign completion mark to the boot mounted fuse box adjacent to the main system battery negative post (see Figure 11)
